# ENERGY AUDIT FINAL REPORT

## Results and Recommendations from Energy Audit of Holy Cross

### City of Holy Cross, Alaska

**April 29, 2011**

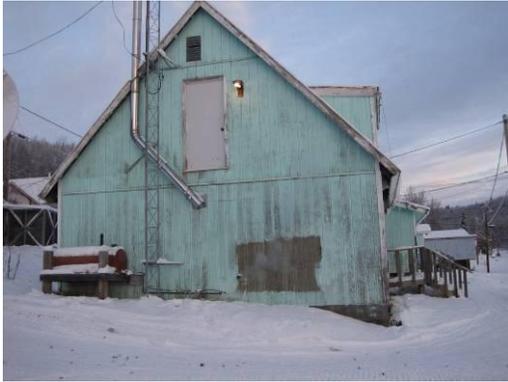
- ◆ **Building Envelope:** The building overall is in fair condition and could use many improvements. The roof is in poor condition and is leaking water into the building. The building exterior is showing many signs of weathering and age but it still holding up. The windows are in fair condition. Weather-stripping, when present, is in poor condition and needs to be replaced; the front entrance door has no weather-stripping at all. There is a potential safety hazard on the second floor of the building; an exterior door exists where there is no staircase or balcony for unknowing occupants to step out on.

*Exterior Door to Nowhere*

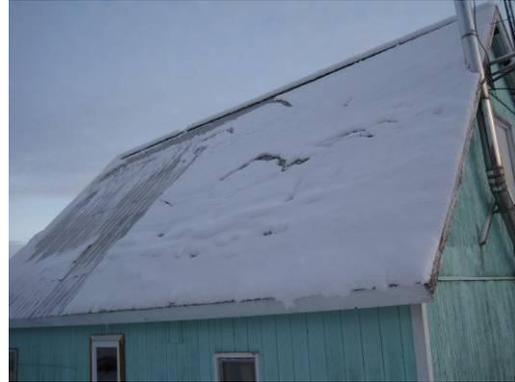
*Melting Snow – Poor Insulation*

This ECO proposes installing blown-in roof insulation on existing building envelopes to reduce energy consumption. Insulation can be added to roofs to increase or renew their insulating ratings (R-value).

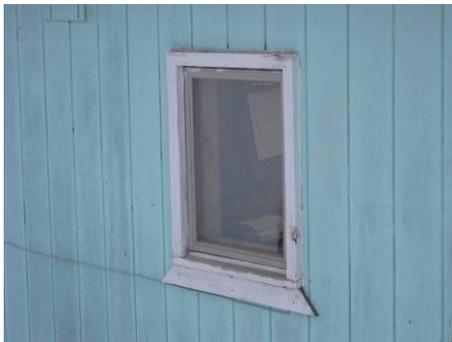
*Run-Down Exterior Window*

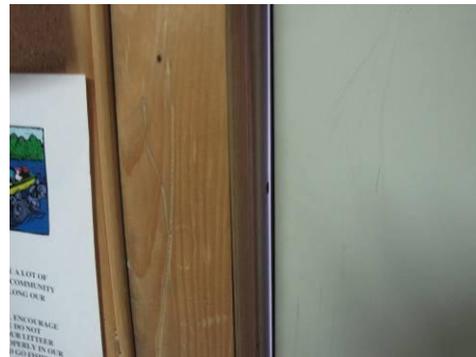
*No Weather-stripping on Front Door*

This ECO proposes applying weather stripping to exterior door perimeters to reduce air infiltration into the buildings. Many building doors have existing weather stripping material which is worn or missing.

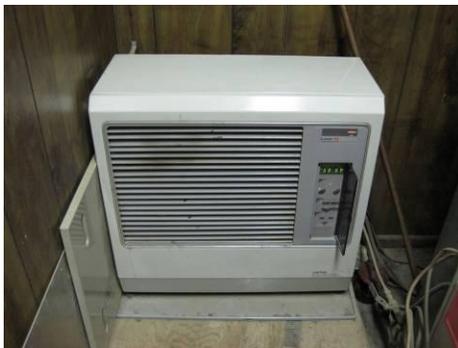
- ◆ **Heating:** Building heating is provided by a Toyostove Laser 73 oil burning unit heater. A Lennox oil furnace that is no longer used remains in the building. This furnace is kept as a backup in case the Toyostove heater breaks. The Toyostove heater, however, cannot heat the building to the setpoint of 68°F in cold weather.

*Toyostove Laser 73 Heater*

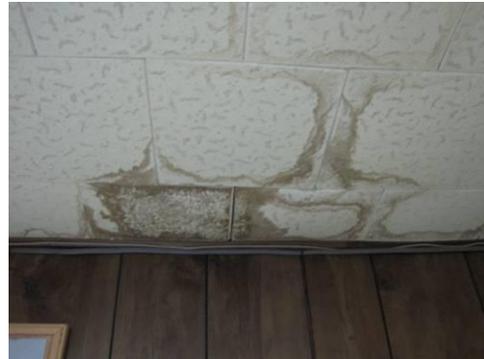
*Ceiling Water Damage From Leaky Roof*

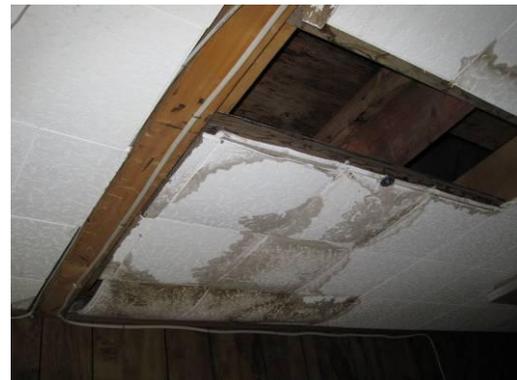
*More Water Damage*

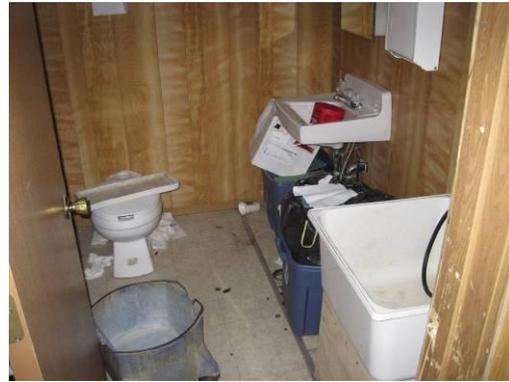
*Women's Restroom – No Longer Functional*

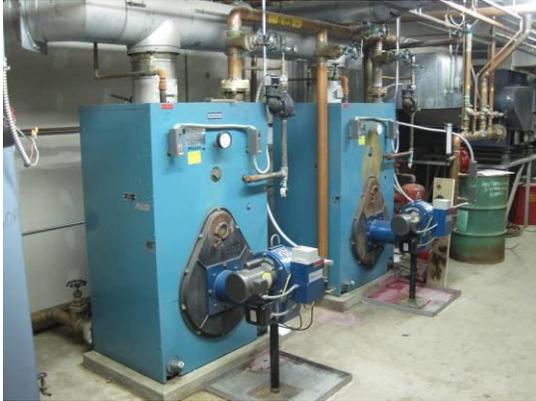
- ◆ **Heating:** Two Burnham PF 504 boilers rated at 80.5% thermal efficiency and 620 MBH each provide the building with space heating. A combustion analysis at the time of the audit showed these boilers to be operating at 78.6 and 82.2% combustion efficiency. The Holy Cross school, however, was clearly overheated at the time of the audit. Although the thermostat was set to 70°F, temperature measurements taken ranged from 75-80°F.

*Burnham Boilers*

This ECO proposes a comprehensive re-commissioning of the boilers in each building to optimize system operations. Such efforts include:

- ◆ Replace, repair, calibrate or install sensors or switches
- ◆ Repair air linkages
- ◆ Conduct combustion efficiency test services
- ◆ Clean combustion chambers and stacks

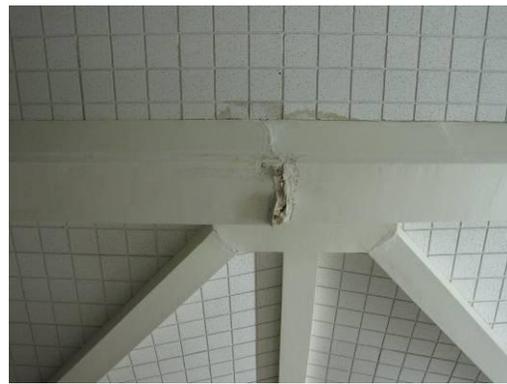
- ◆ **Building Envelope:** The building is in good condition overall and is well-maintained. The roof appears to be in good condition. In the library, there is evidence of some water damage on the dropped ceiling, but the source of the damage is uncertain. Windows are in fair condition, and some have been recently replaced; many have handles that have been broken off. Weather-stripping is in fair condition, but could be upgraded. Doors are in good condition.

*Water Damage in Library*

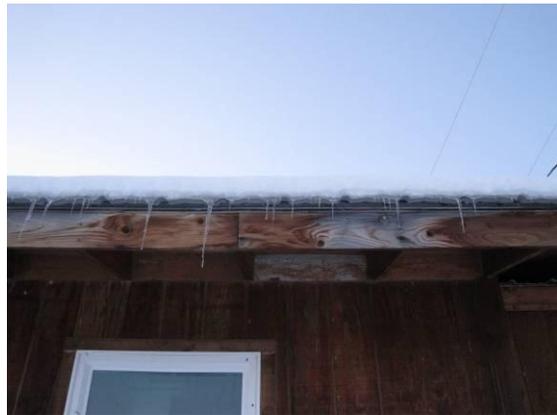
- ◆ **Building Envelope:** The building is showing many signs of weathering and age and is in fair condition overall. The roof is in fair condition, but is showing no signs of leakage. There is not enough insulation, however, to prevent building heat from escaping, and this is causing snow on the roof to melt. Additional attic insulation is needed to retain building heat. The exterior walls are in fair condition, but do not have any major structure faults or defects. Weather-stripping is in poor condition and is due to be replaced. Doors are in poor condition and need replacements.

*Roof – Melting Snow Evidence of Poor Insulation*

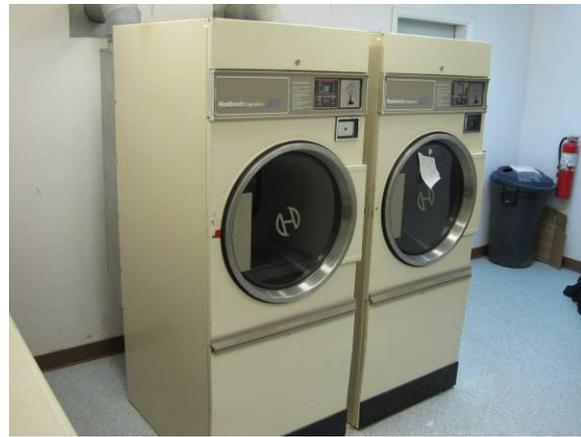
- ◆ **Laundry Equipment:** The Washeteria has 3 washers and 2 dryers. The washers run on electricity, while the dryers consume liquid propane for heat and use electricity for the motors. At the time of the audit, one of the dryers was out of order, and two of the washers were out of order. This leaves only one functional washer and dryer for the village Washeteria.

*Dryers*

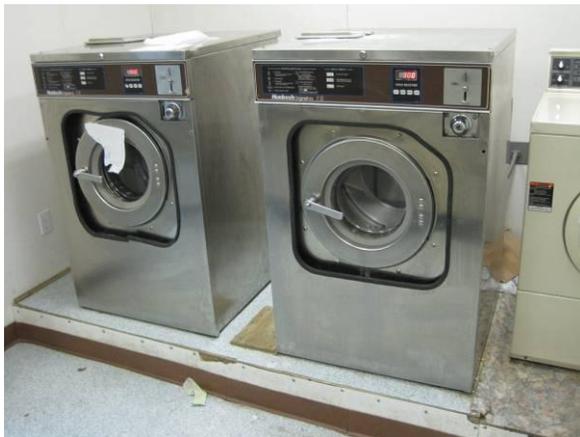
*Washers*

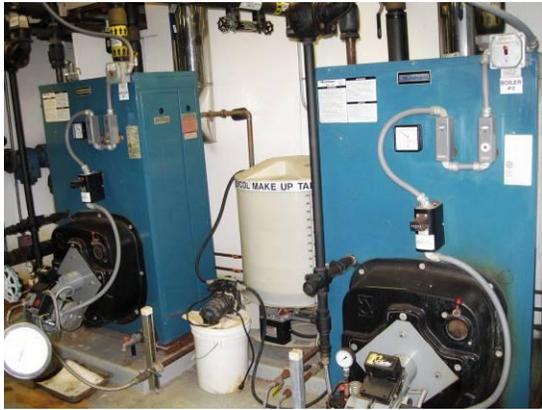
- ◆ **Heating:** Two Burnham V903 fuel oil boilers provide the building with heating; these boilers are rated 80.0% thermally efficient with a combustion efficiency of 85.2%. Combustion analyses of these two boilers showed them to be functioning at combustion efficiencies of 78% and 79.2%. At least one, if not both, of the boilers seems to have a crack in the combustion chamber or diffuser, and the inspection had to be completed with the main entrance doors open to abate the overwhelming fumes in the mechanical room. There are also several hydronic unit heaters and fuel oil forced air heaters in the facility as well.

*Burnham Boilers*

This ECO proposes replacing existing hot-water heating boilers with more energy efficient units. Many of the existing units in the village are original to the buildings they serve and have reached the end of their useful service life. Boilers employing modern technology can be installed to reduce energy consumption, improve system operations, and reduce maintenance costs.

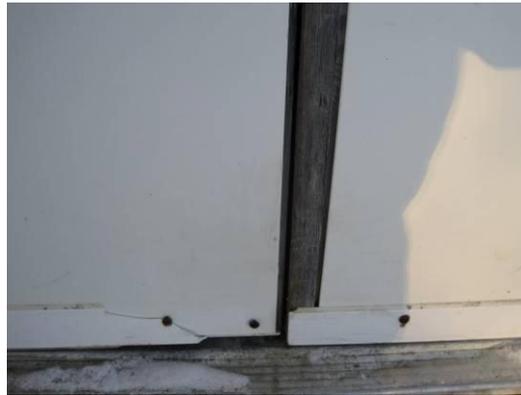
*Doors in Need of New Weather-stripping*

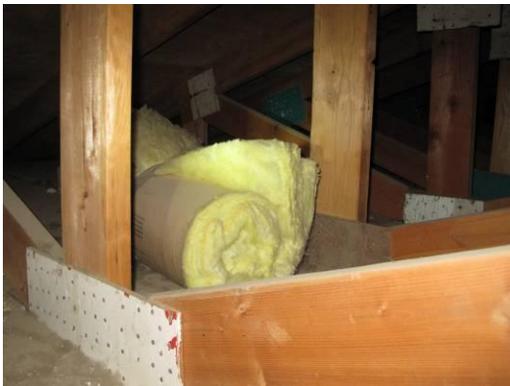
*Unused Insulation - Not Enough to Cover Attic*

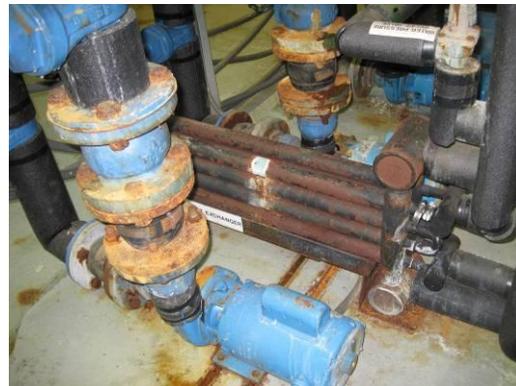
*Corroded Heat Exchanger*
