2023 GEOMORPHOLOGY OBSERVATIONS

AMENDMENT TO BRADLEY LAKE
HYDROELECTRIC PROJECT
(FERC No. 8221)

PROPOSED DIXON DIVERSION

Prepared by:
Watershed GeoDynamics
for Kleinschmidt

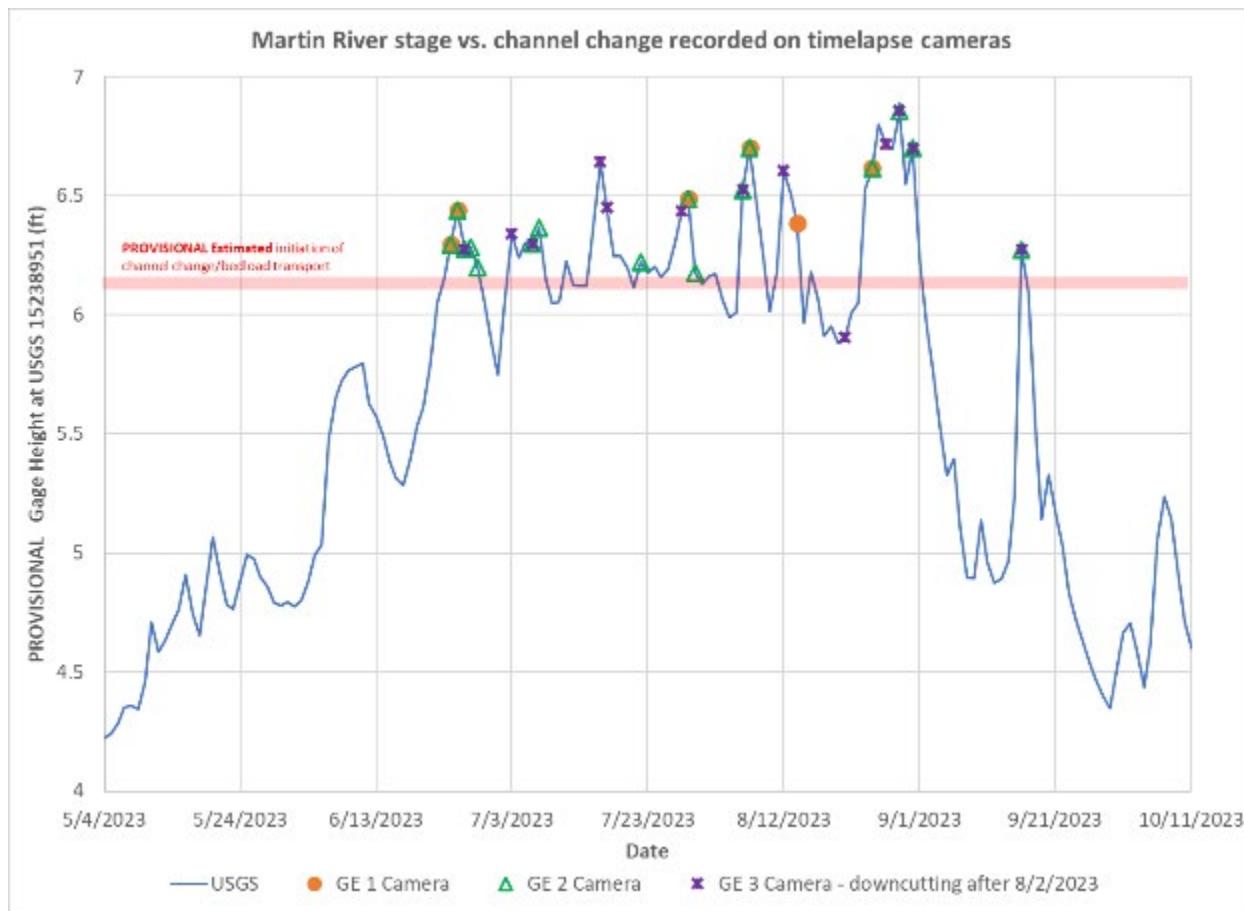
Figure 3-6 Martin River Stage vs. Channel Change; cameras deployed from May 16 to October 19, 2023

The provisional USGS gage heights (USGS Gage No. 15238951) were compared for each date that had channel change and showed that in general, flow events corresponding to gage heights above about 6.1 to 6.2 feet resulted in channel change (Figure 3-6). This analysis will be updated to help determine flow levels that result in bedload transport and channel change when an approved rating curve is developed for the USGS gage. It is anticipated that additional timelapse cameras will be deployed in 2024 to augment the 2023 data.

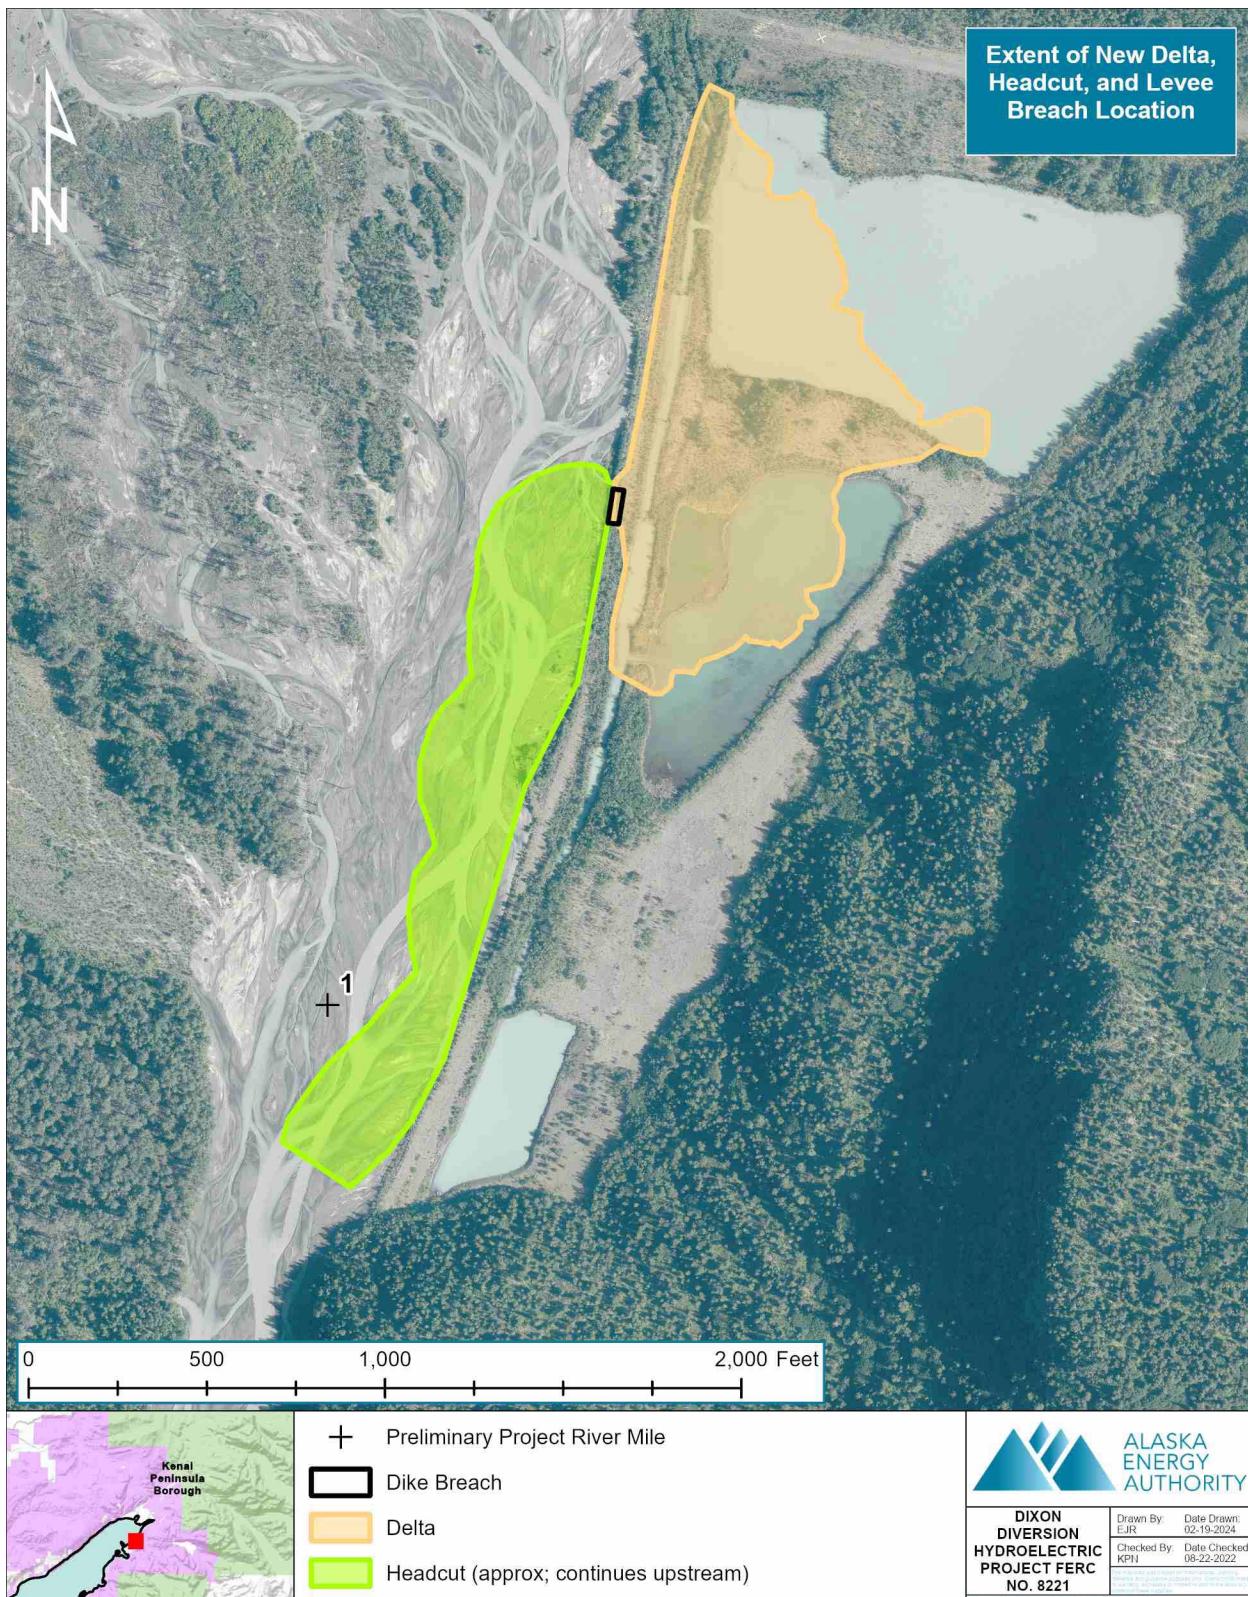
Figure 3-7 Extent of New Delta, Headcut, and Levee Breach Location near the Mouth of the Martin River, November 2023.

The right bank levee near the mouth of the Martin River (approximately RM 0.2) was overtopped and breached by the river at the beginning of August 2023 (Figure 3-7). A field visit on November 2, 2023 was conducted to delineate the new delta that is aggrading into the mitigation ponds on the east side of the levee, survey relative elevations of the breach and levee surface, and make observations of the headcut in the Martin River upstream from the levee breach.

Based on satellite imagery from July and August 2023, the breach occurred between July 31 and August 2, 2023. It is hypothesized that the levee overtopped with flow over the top and back side of the levee high enough to erode the fill on the back side of the levee, leading to eventual undercutting of the protective rip rap and breaching of the levee. Pieces of rip rap were observed in the newly cut channel downstream from the breach location. In November 2023, the bottom of the channel was approximately 10-12 feet below the top of the levee at the breach location.

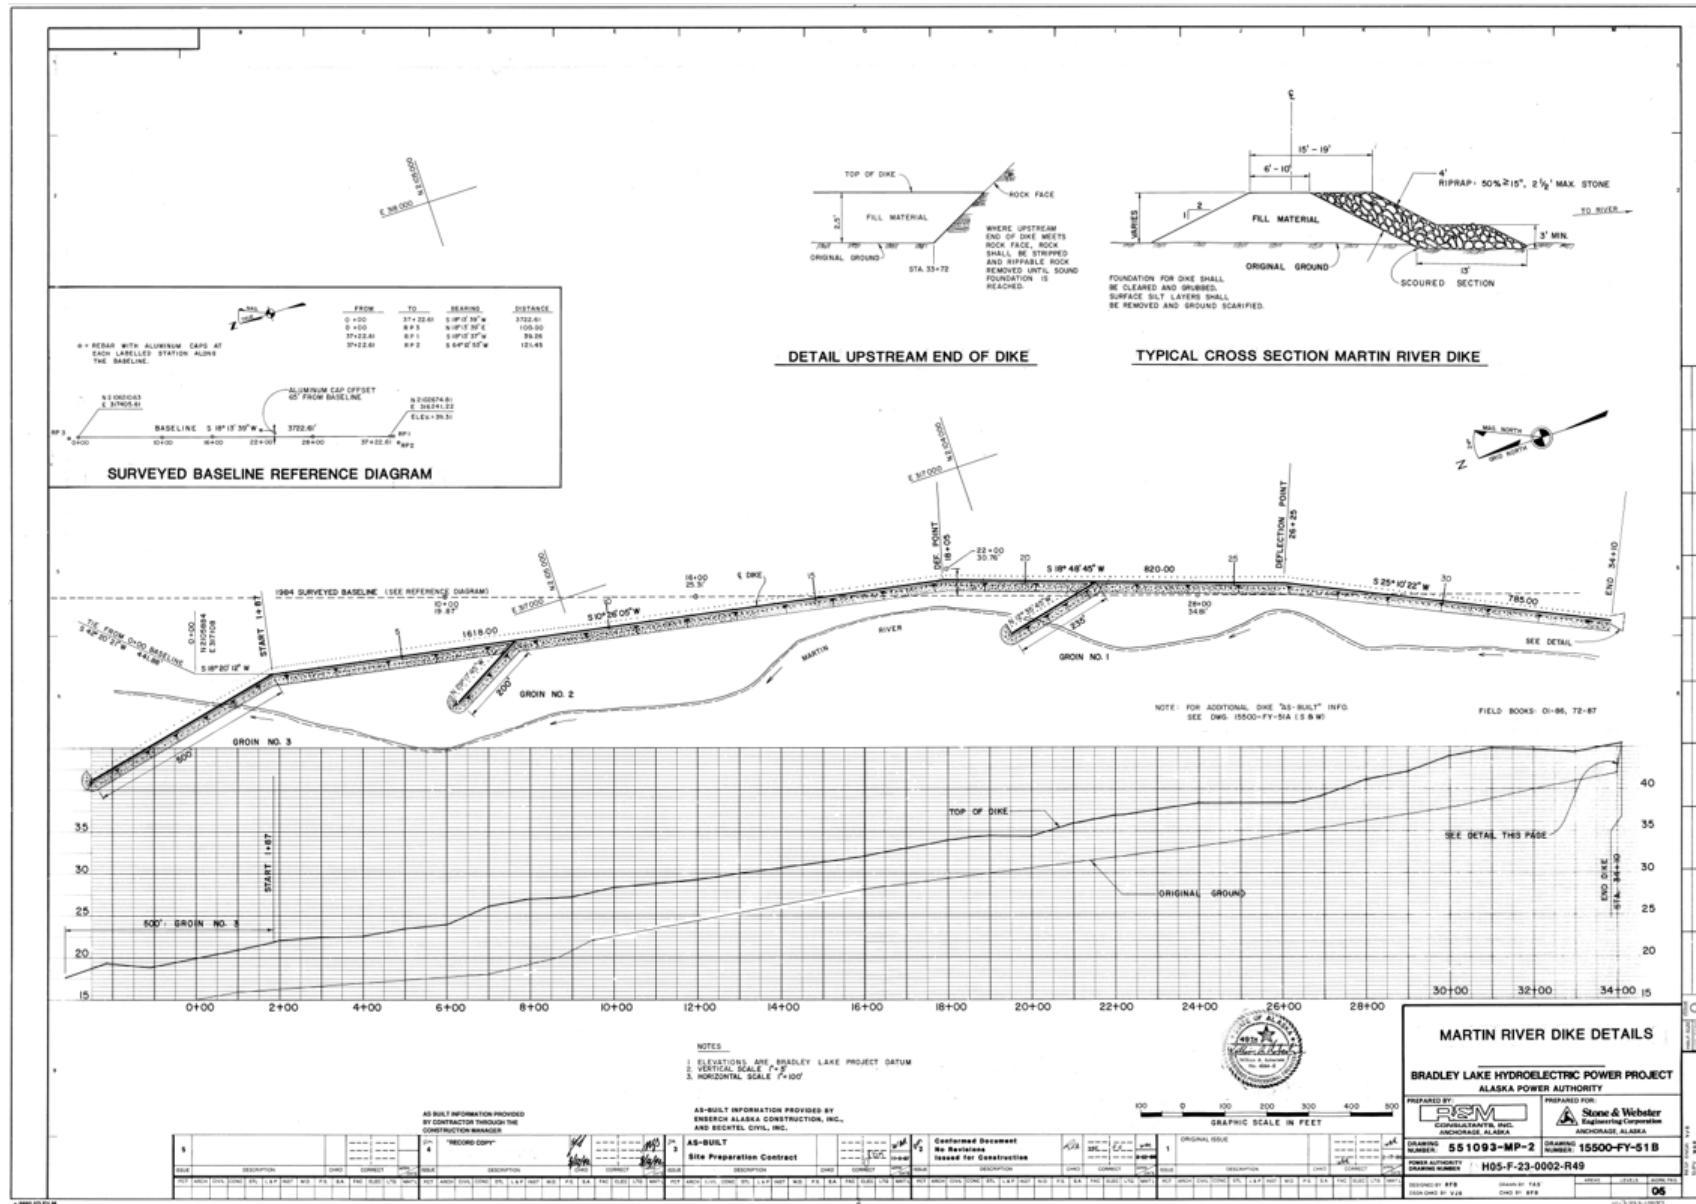
Figure 3-8 As-built Drawing of Martin River Levee.

The levee was constructed to separate the river from borrow pits that were dug to supply material used during construction of the Bradley Lake Hydroelectric Project in the 1980s. The borrow pits were rehabilitated for fish spawning and rearing ponds in 1991 by the Alaska Energy Authority (AEA). Prior to levee construction, the Martin River delta spread across the area that was used for the borrow pits/ponds. As-built drawings of the borrow pits/levee (dated March 12, 1992) show the levee was approximately five feet higher than

the river at the breach location at time of construction, and borrow pits were dug 15 to 35 feet deep (Figure 3-8 and Figure 3-9). The levee was constructed with rip rap armoring on the river side but filled and topped with native material. It was anticipated that the Martin River would aggrade and eventually breach the levee based on assessments at the time (Parry and Seaman 1994).

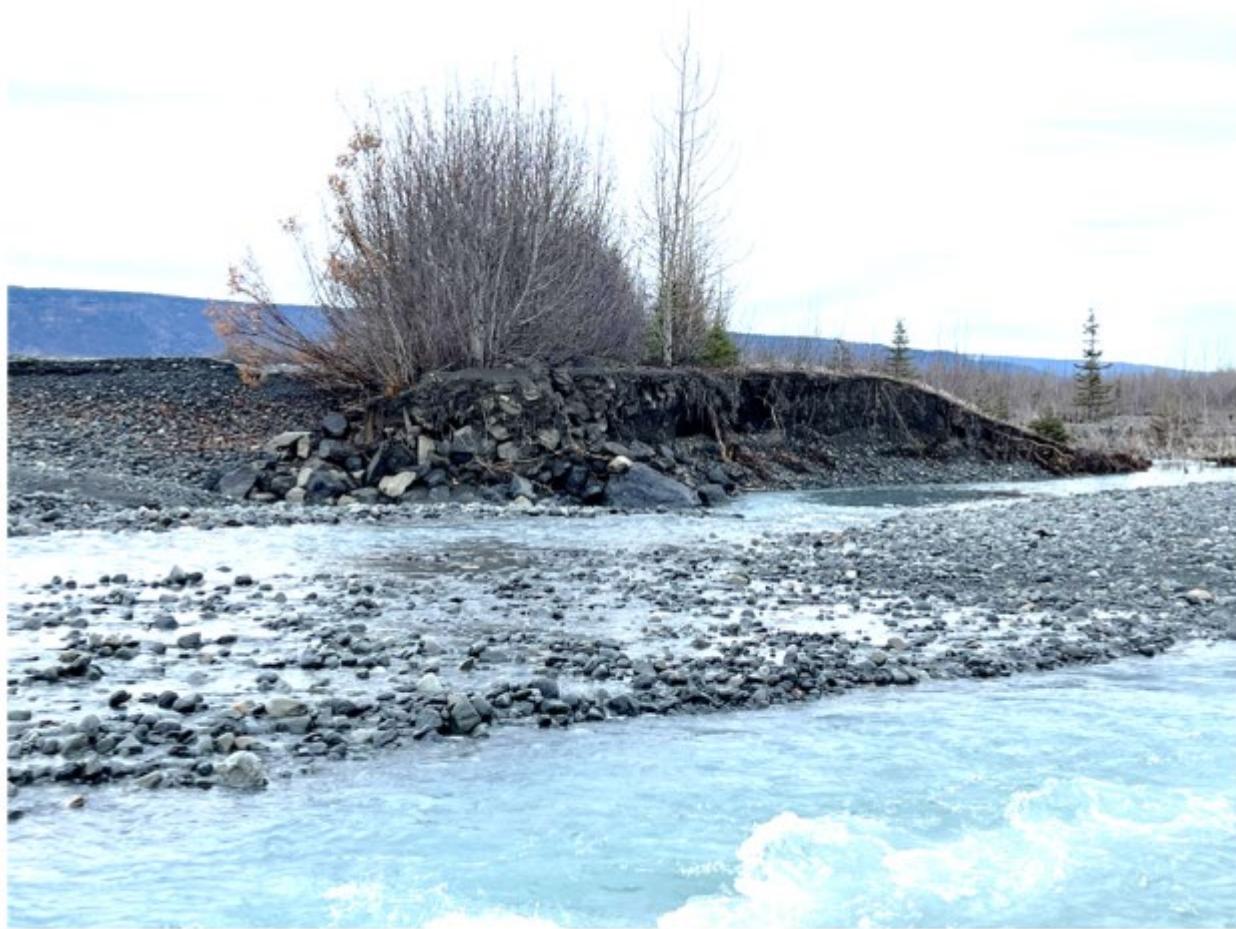
- Water was low/fairly clear.
- The Martin River eroded an approximately 100-foot-wide section of the existing levee; likely mechanism was aggradation on the river side of the levee, overtopping of levee during high flows, and erosion of the pond-side (unprotected) portions of the levee which then undercut rip rap protection on river side of levee. Depth of erosion from top of dike to bottom of channel on November 2, 2023 approximately 10-12 feet (based on estimated water depth in channel). Observations of levee cut showed rip rap blanket on river side, smaller fill material on pond side.
- Extensive gravel, sand, cobble deposits in middle and lower pond areas (deposits cover 19.5 acres).
- Extensive headcut upstream from dike breach (total extent of headcut not delineated). Width of headcut up to 350 feet.

Photo 3-1 Cross-section of Levee at Breach Location November 2, 2023.

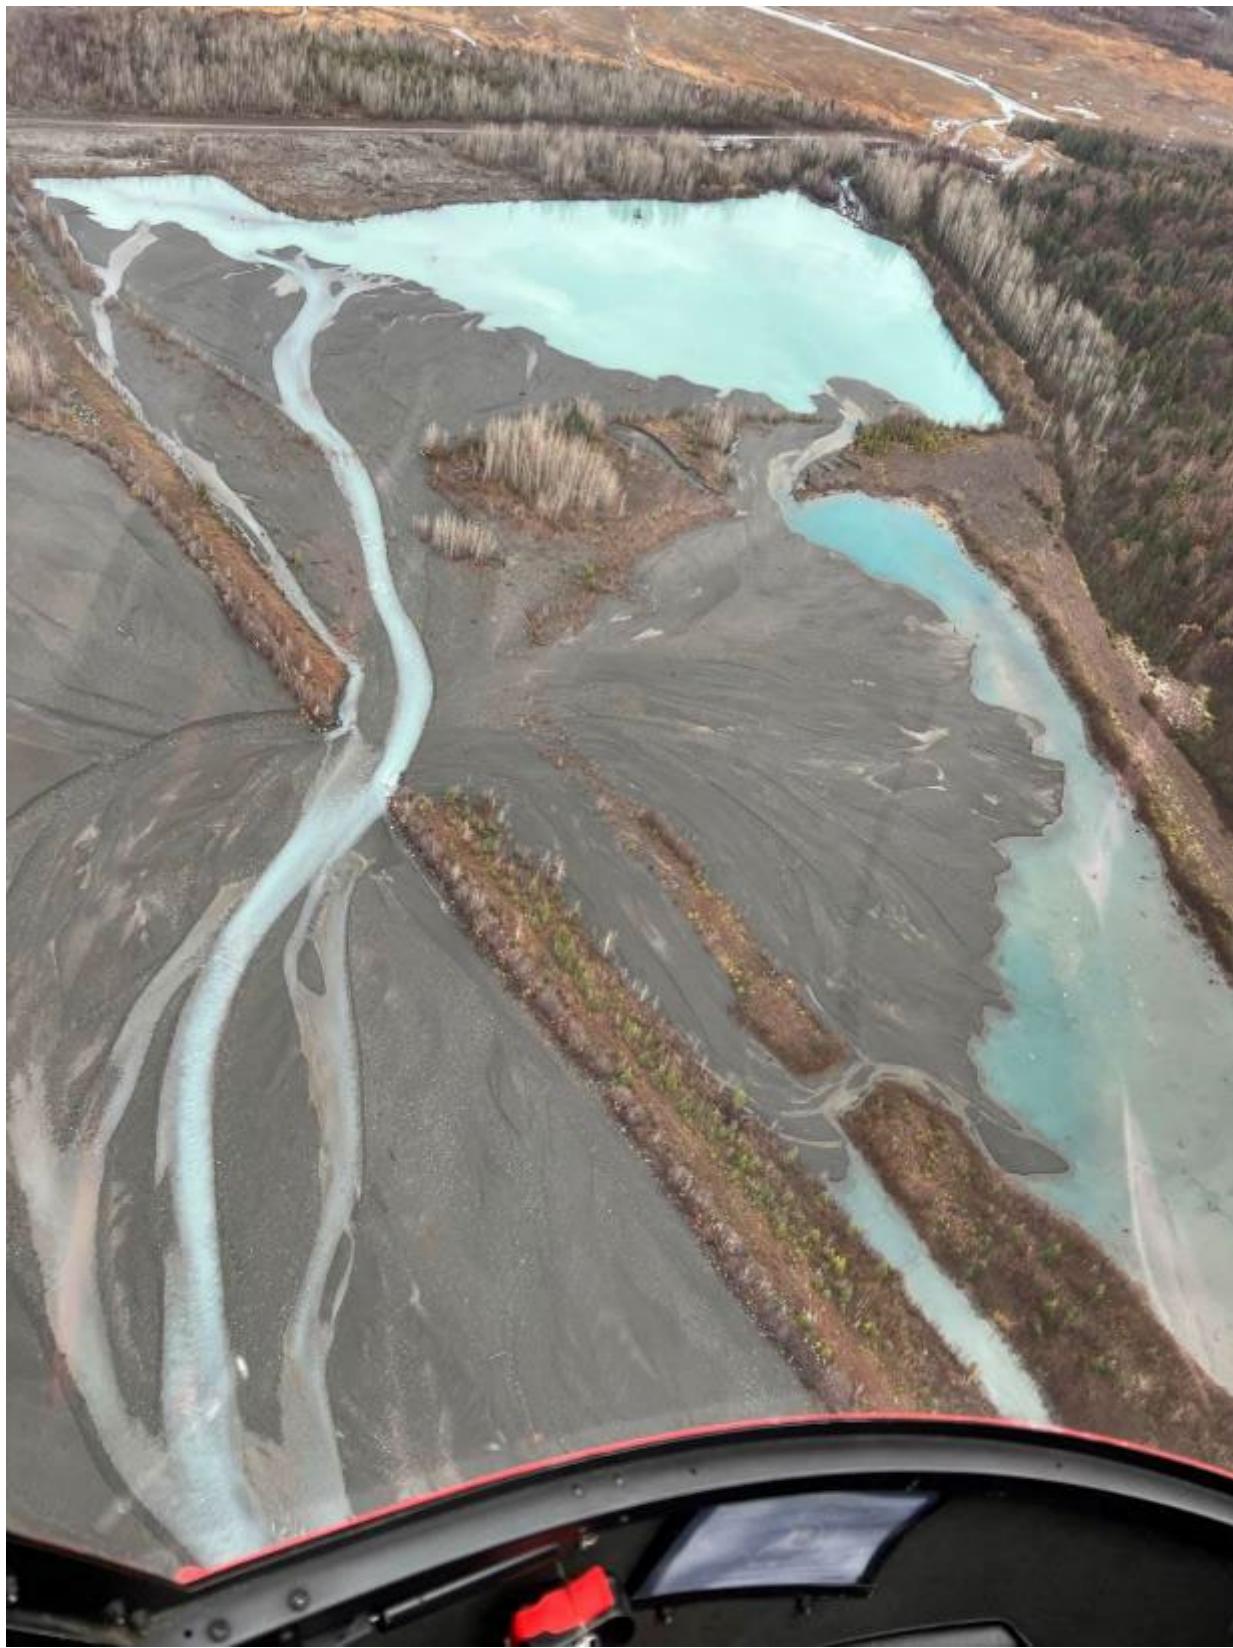
Since August 2, 2023, all flow from the Martin River flows through the levee breach, into the mitigation ponds, and out a low point at the northeast corner of the largest (northern) pond into Kachemak Bay (Photo 3-2 and Photo 3-3). The river has been building a delta into the ponds, with up to 15- to 35-foot-deep accumulations in some areas assuming the northern-most ponds were originally dug 15 to 35 feet below grade as shown on the as-built drawings. As of November 2023, the delta covered approximately 19.5 acres. Coho Salmon adults were observed in the ponds and just upstream of the levee breach during the November site visit, indicating that they were able to utilize and traverse the new river channel.

Photo 3-2 Extent of Deposition in Mitigation Ponds; New Martin River Outlet to Tidewater (top right) November 2, 2023.

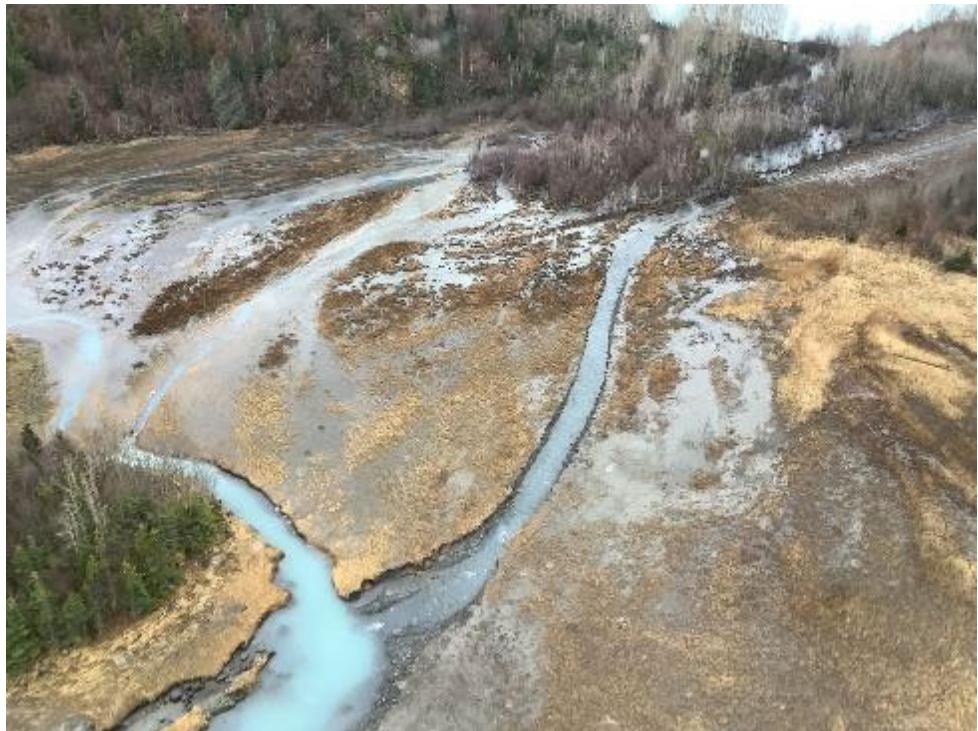
Photo 3-3 New Outlet of Martin River Looking Upstream from Tidewater to the Northeast Corner of the Lowermost Mitigation Pond November 2, 2023.

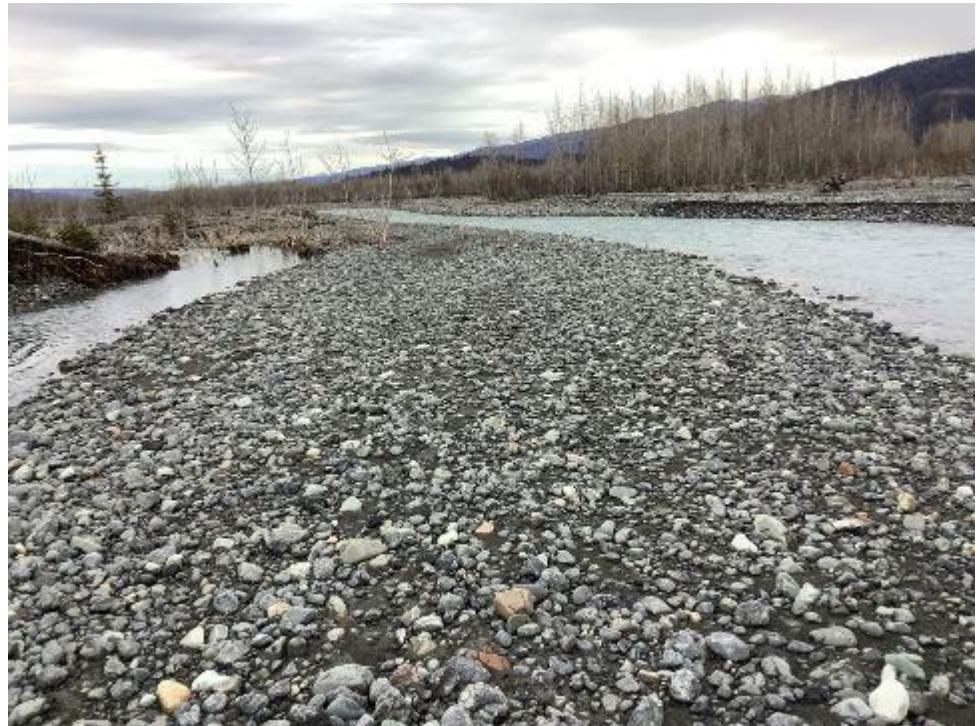
A pebble count was also made on the mid-channel bar at the levee breach location (Sample 2023-16); this sample is representative of bedload transported through the breach location under high flow conditions in late 2023. The material was primarily gravel with some cobble and sand. Median (D_{50}) grain size was 33 mm. Sub-surface material had a fine gravel/sand matrix.

As the river breached the levee, it eroded a new channel through the levee resulting in a new base level at the ponds (Photo 3-4). This resulted in continued downcutting of the river bed at the levee location and headcutting upstream of the levee. As of November 2023, the headcut proceeded at least half a mile upstream; there was not sufficient time during the November site visit to document the upstream extent of headcutting.

Photo 3-4 Mid-channel Bar just Downstream from Levee Breach (pebble count 2023-16 location), Looking downstream November 2, 2023.
