MEMORANDUM

Amendment to Bradley Lake Hydroelectric Project (FERC No. 8221), Bradley Lake Expansion Project – Bradley Lake Shoreline Erosion Observations and Analysis

Date: November 24, 2025

Purpose Describe existing conditions of the Bradley Lake shoreline erosion and assess potential future shoreline conditions with proposed dam raise.

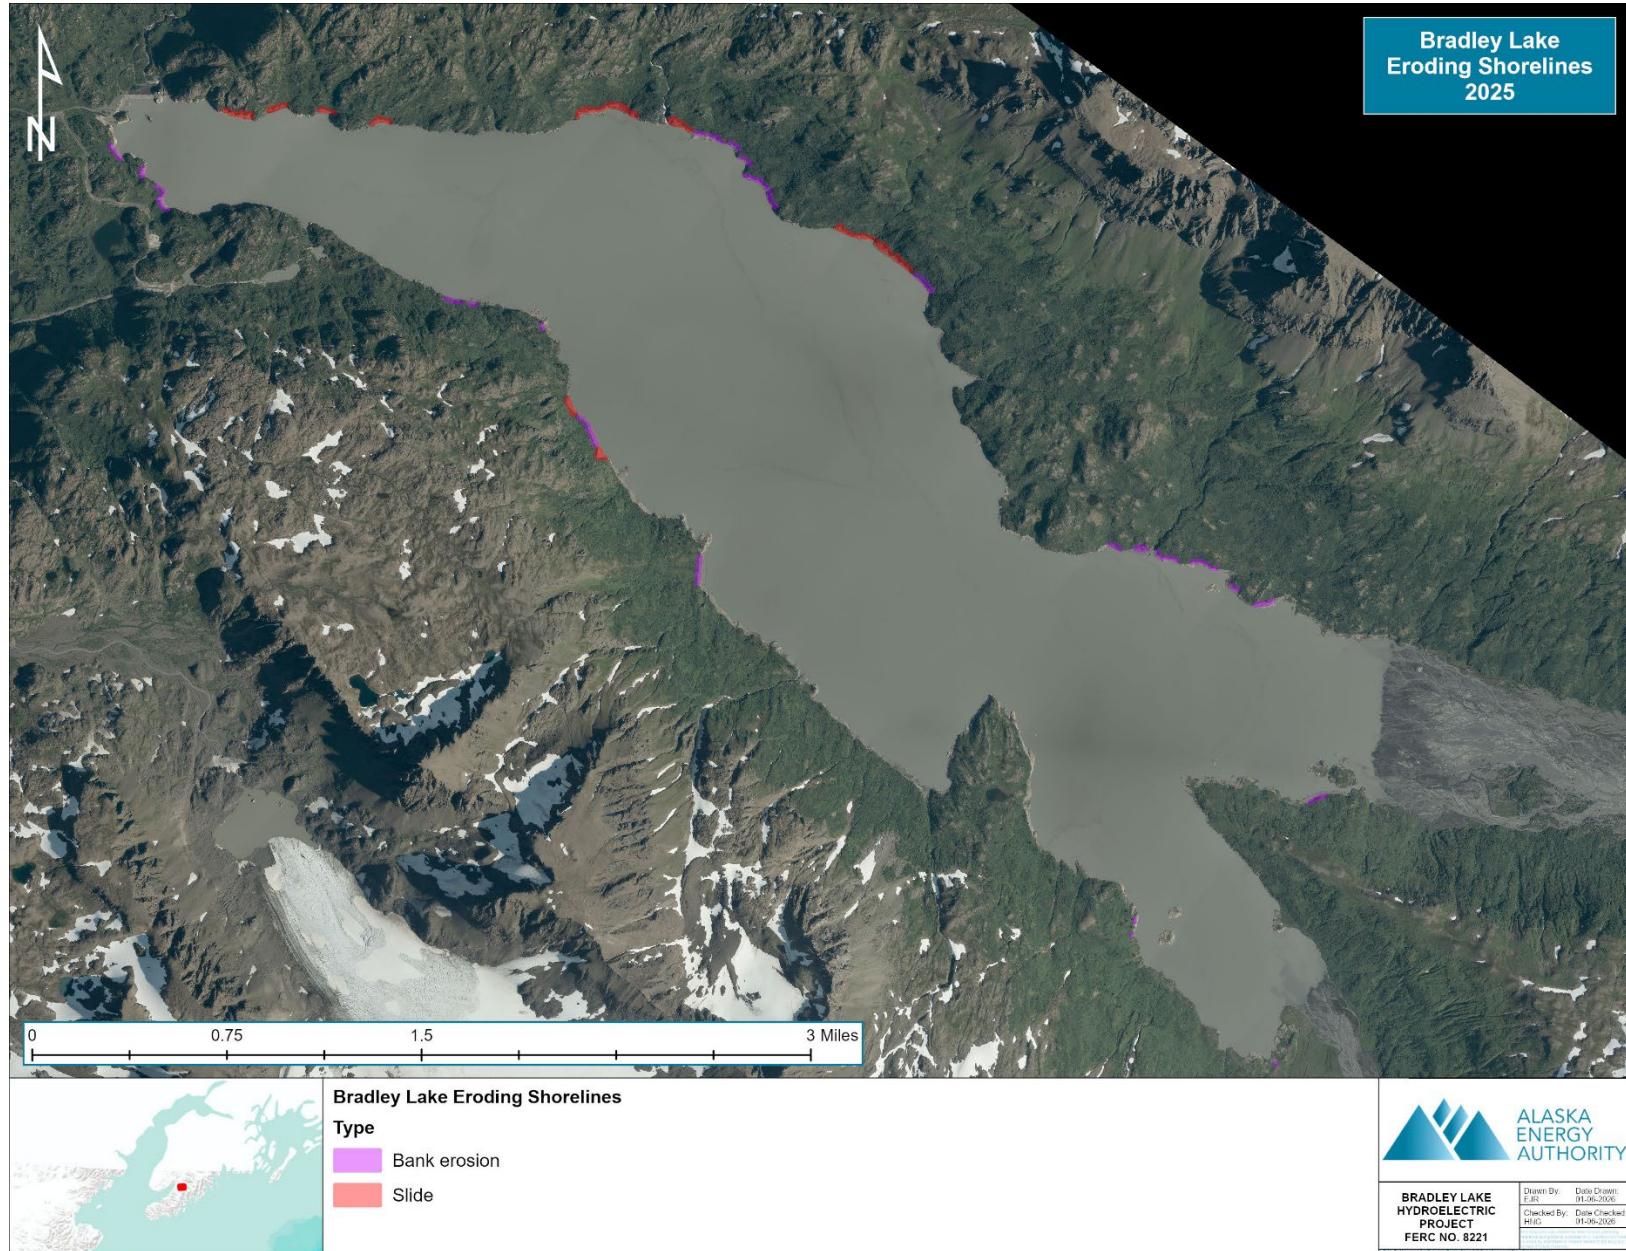
The current shoreline is 28 miles long at El. 1,180 feet. Mapping of eroding shoreline areas using remote sensing and aerial observations suggest approximately 10 percent of the shoreline is eroding under current operations. Mapped areas of erosion are shown on Figure 3-1 and include areas of bank erosion (approximately 1.7 miles of shoreline) and taller, shallow rapid landslides (approximately 1.2 miles of shoreline). Most eroding shorelines occur on the western half of the lake. The gentler sloping eastern half of the lake has fewer areas of erosion (Figure 3-2).

Figure 3-1 Mapped areas of Bradley Lake shoreline erosion.

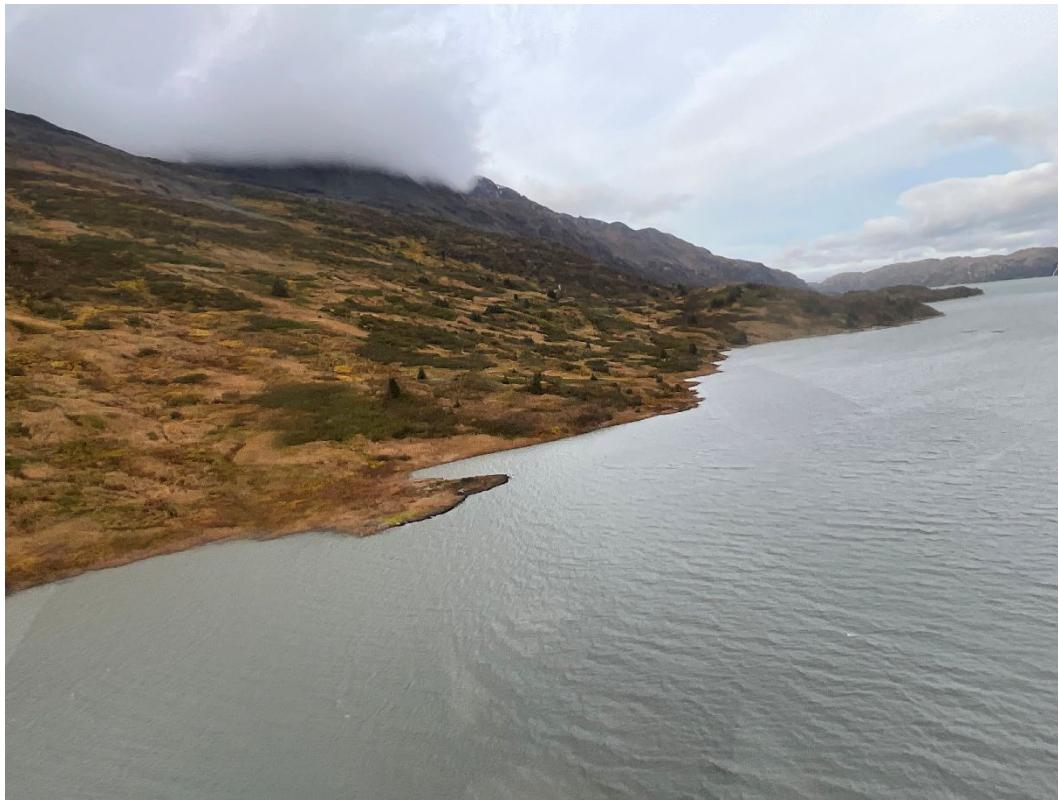
Figure 3-2 Example of stable, gently sloping area of Bradley Lake shoreline.

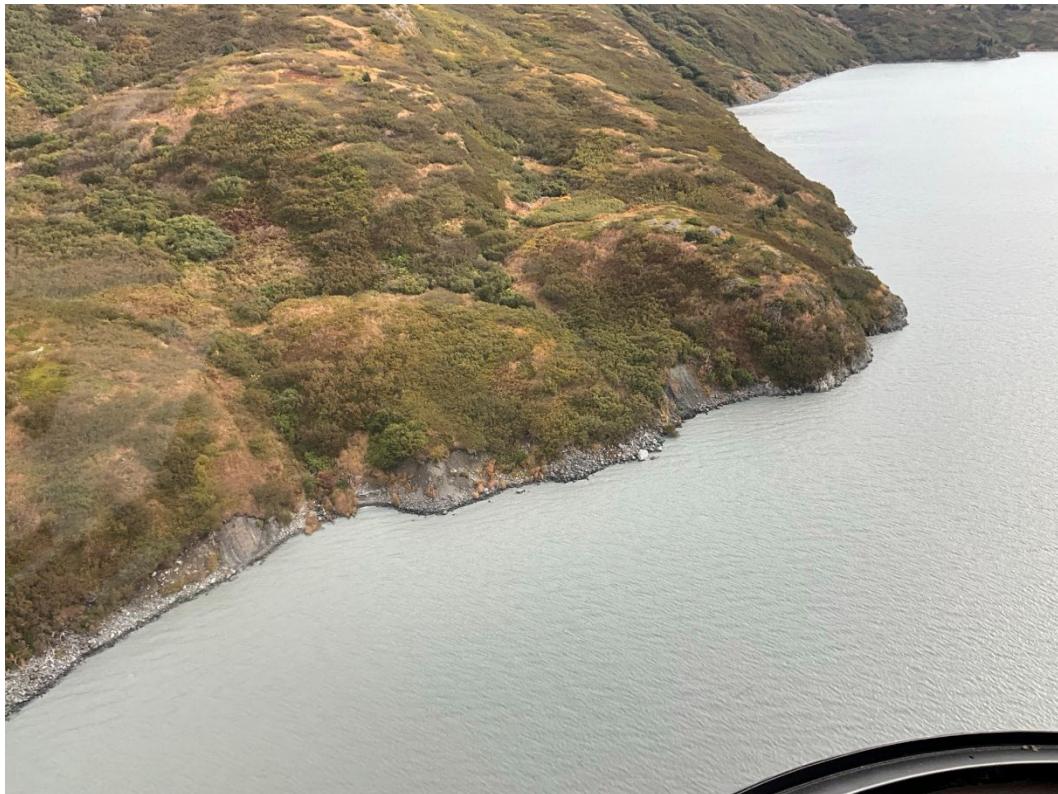
Areas classified as bank erosion have relatively shorter (less than 20 feet tall) eroding slopes with generally uniform bank heights (Figure 3-3). Areas classified as shallow rapid landslides have an arcuate eroding bank shape with heights up to 100 feet tall, and these areas appear to be primarily in colluvial deposits on very steep slopes (Figure 3-4 and Figure 3-5).

Erosion mechanisms for both the bank erosion and shallow rapid landslide areas are presumed to be similar: erosion of unconsolidated material (till or colluvium) along shoreline areas by wave action that removes material from the base of the slope. In areas of bank erosion, removal of material from the base of the slope results in an undercut slope followed by toppling and/or raveling of overlying material. In areas of shallow rapid landslides, removal of material from the base of the slope destabilized the slope and has resulted in sliding of overlying material. In both cases, continued erosion of the base of the slope by wave action keeps the slopes unstable and unvegetated.

Figure 3-3 Areas of bank erosion.

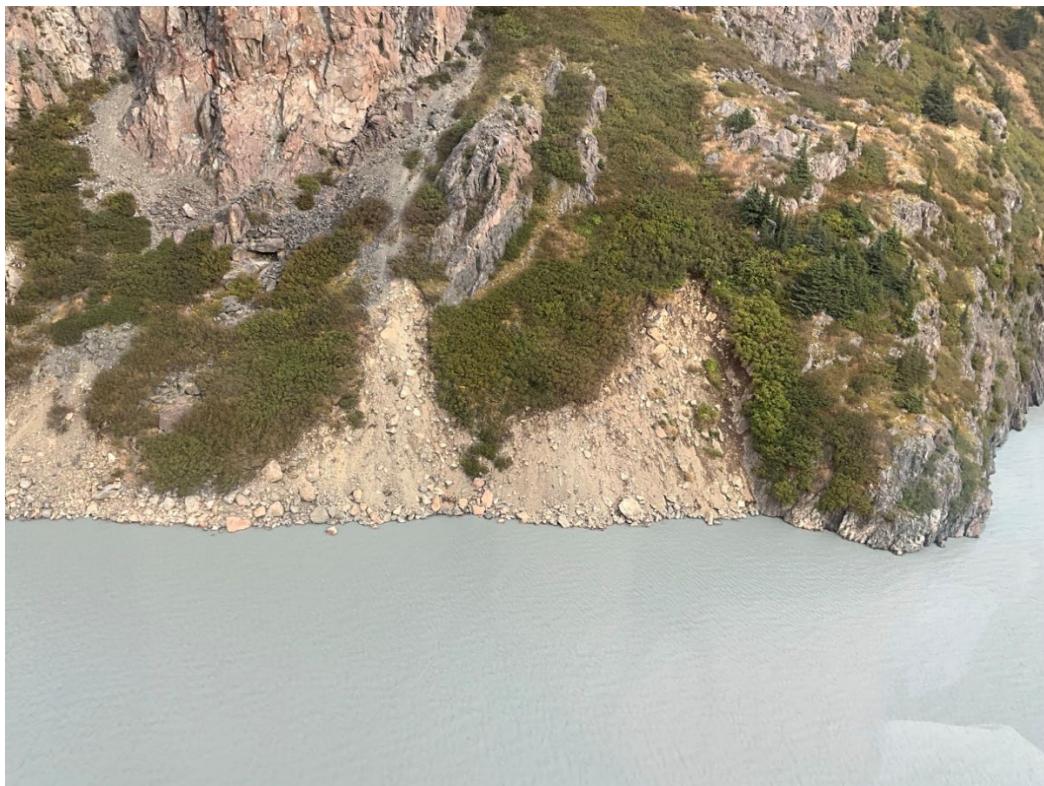
Figure 3-4 Example 1 of shallow rapid landslides in colluvium.

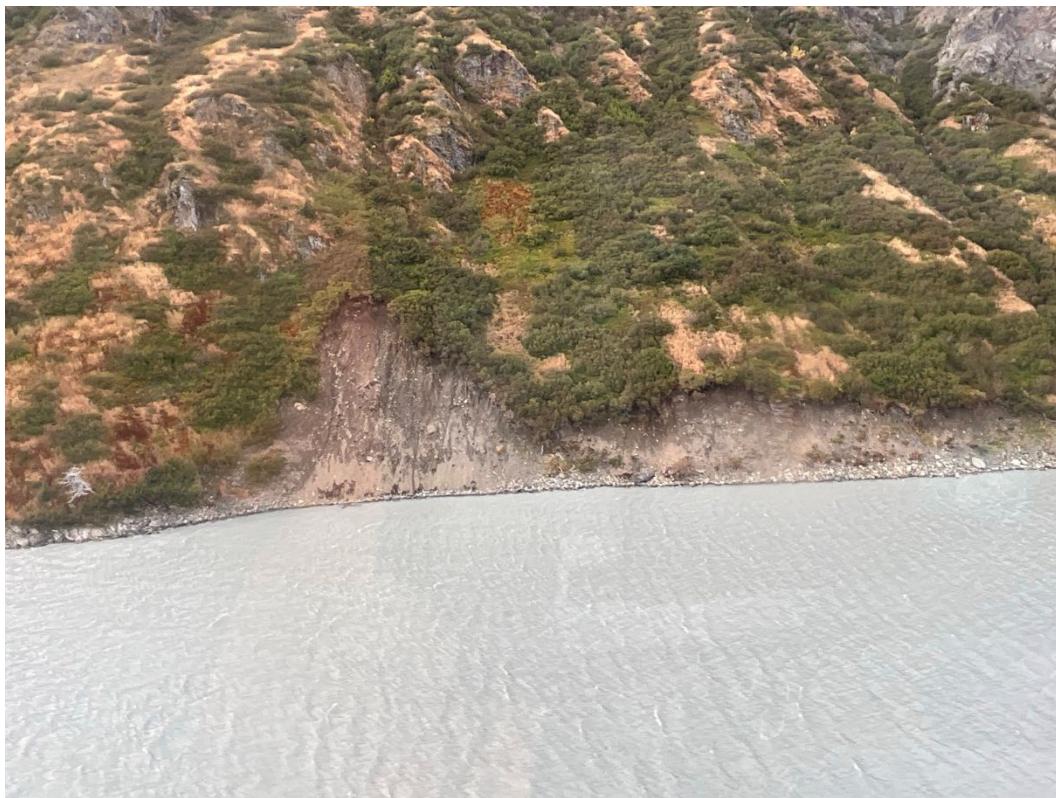
Figure 3-5 Example 2 of shallow rapid landslides in colluvium.
