ENERGY AUDIT FINAL POST INSTALLATION REPORT

**Results and Recommendations from
Energy Audit of Emmonak**

**For EECBG and VEEP Grants
City of Emmonak, Alaska**

July 23, 2012

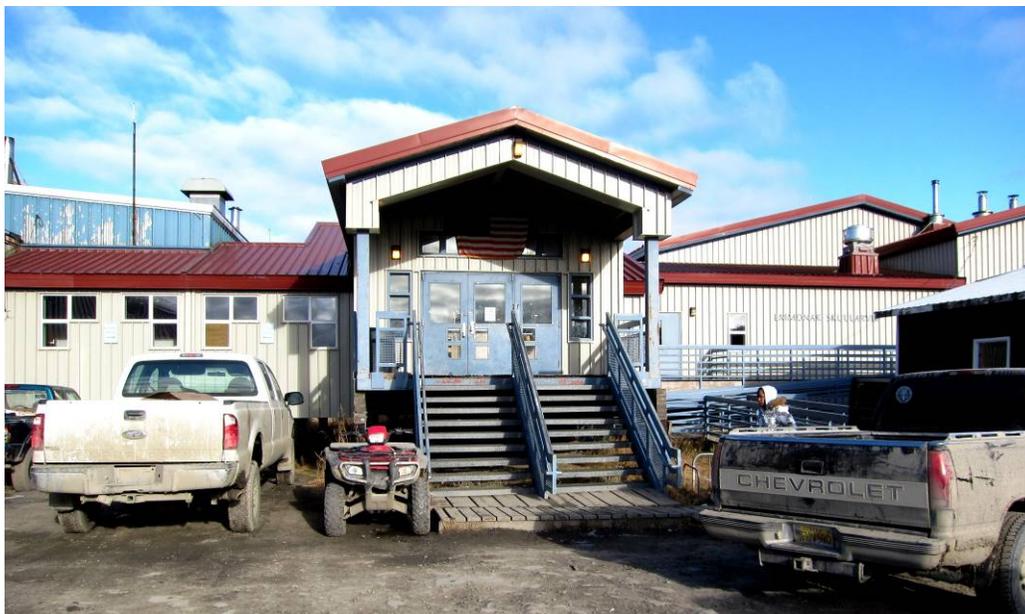
Description: The Emmonak School is a combination elementary, middle school, and high school building. The building space is a combination of classroom, office, library, gymnasium, and cafeteria space. Emmonak School caters to about 230 students and 30 staff members. The school is one of the best maintained buildings in the city, though many opportunities exist for improvement.

General Conditions: The building is comprised of two sections. The section of the building that currently contains the high school and gymnasium was the original school building. An addition was later built that currently houses the administrative offices, elementary, middle school, and cafeteria. The building appears to be in good condition, though there were several areas for improvement noticed throughout the audit.

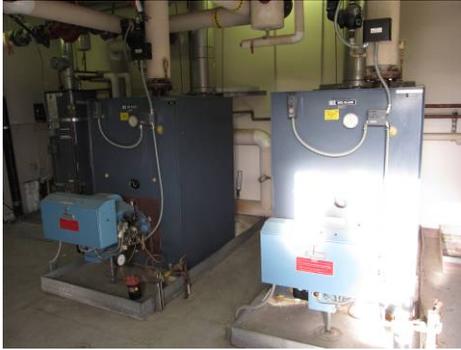
Heating: Two Weil-McLain fuel oil model 88 boilers provide heating to the building. These boilers are listed as 84% efficient. A combustion analysis found these boilers to be performing at 79% efficiency.

Weil-McLain Boilers

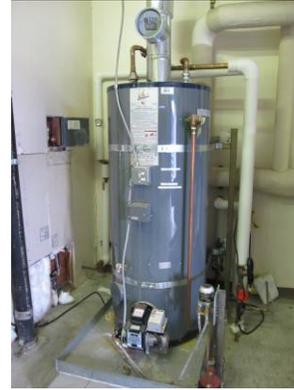
Bock Domestic Hot Water Heater

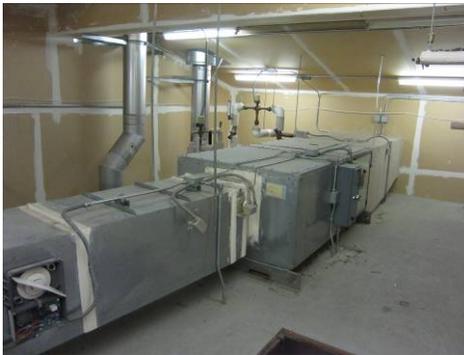
Air Distribution: A Trane makeup air unit (MAU) from 1991 handles the air distribution needs of the newer section of the building. This MAU is a Modular Climate Changer and provides 3240 cubic feet per

Trane Makeup Air Unit

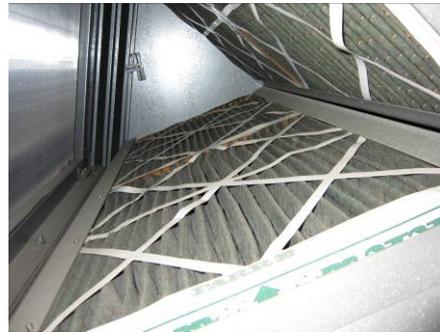
Filters in Need of Replacement

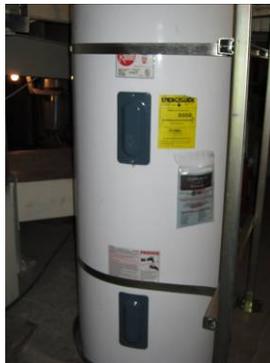
New Rheem Domestic Water Heater

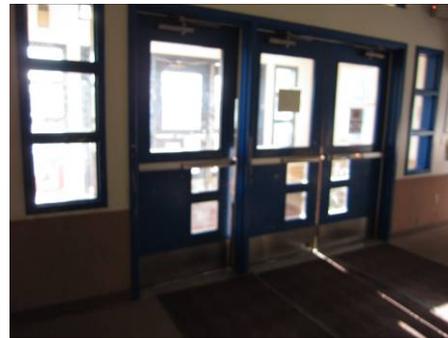
Building Envelope: The building structure overall appears to be in good condition. The double-pane clear glass windows are in excellent condition. Doors are insulated aluminum frame; most weather-stripping appears adequate, though some doors require weather-stripping repair or replacement. The roof is constructed from angled standing seam metal and appears to be in good condition. The building exterior walls are covered in standing seam metal; the newer portion of the building appears to be in excellent condition, while the older section of the building is showing signs of weathering. The walls appear to have about 6 inches of batt insulation and an inch of rigid insulation.

Missing Weather-stripping – Leaky Doors

This ECO proposes applying weather stripping to exterior door perimeters to reduce air infiltration into the buildings. Many building doors have existing weather stripping material which is worn or missing.

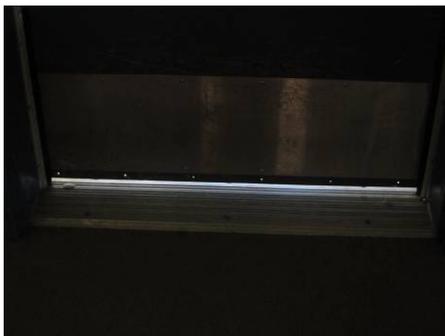
Missing Weather-stripping

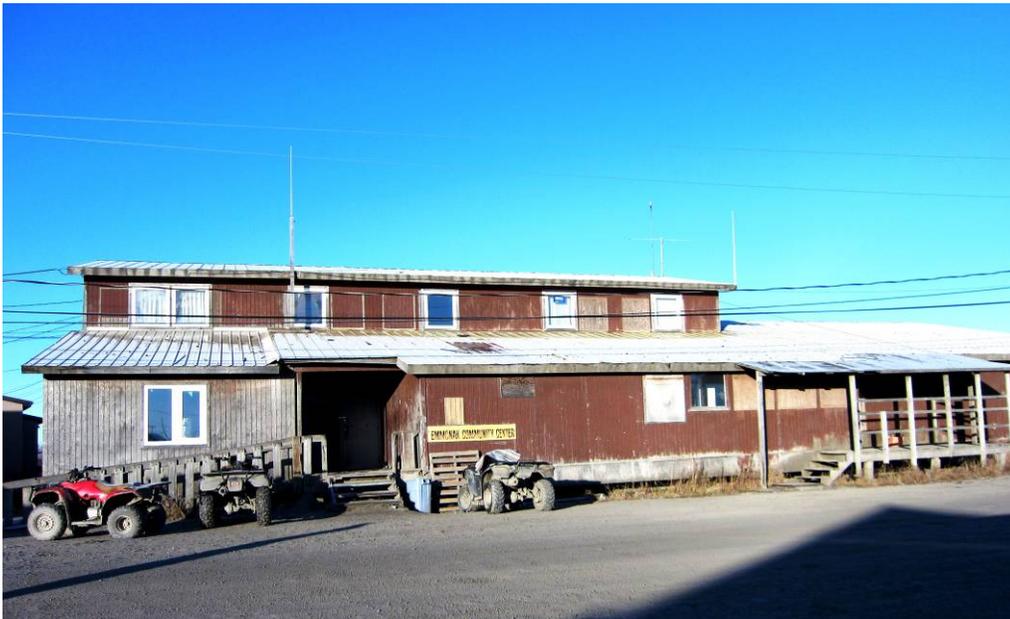
Description: The City Hall building in Emmonak is a multi-functional building that also houses the community center and City Hotel. The building has seen some wear and weathering over the years, but is holding up well. This building also sees much activity due to the busy nature of the office as well as almost daily use for evening gatherings in the community center portion of the building.

General Conditions: The structure overall is in fair condition, though it seems to still be holding up adequately. The exterior shows many signs of weathering and age, but it does not appear to be seriously compromised in any fashion. Some windows are boarded up, and there are some areas where the building façade is damaged and insulation is visible, but does not appear to be overly deteriorated. The condition of the HVAC equipment is in poor condition, though some is under repair.

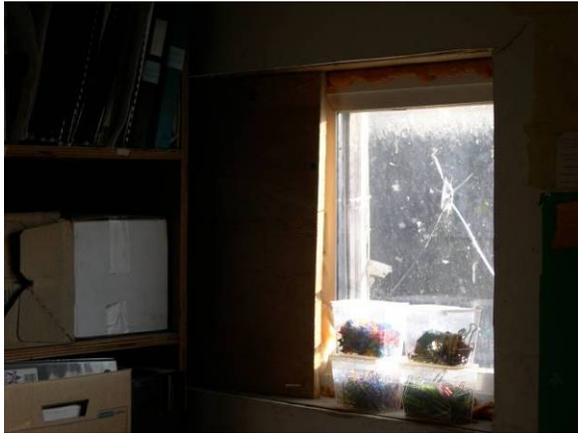
Building Envelope: The structure itself has many flaws, though most of these appear to be cosmetic in nature. The exterior of the building is covered in plywood that is showing age and weathering. The roof is standing seam metal and appears to still be in good condition with some batt insulation above the ceiling. The windows are double-pane clear glass and are in fair condition. The windows that are untouched by vandalism are in excellent condition, but many of the windows have one or more of their panes cracked or broken. Some have been covered by plexiglass because of the vandalism issues. Others have been boarded up completely. One window is closed off using Styrofoam and aluminum foil. Doors are aluminum frame and appear to be in good condition.

Typical Cracked Window

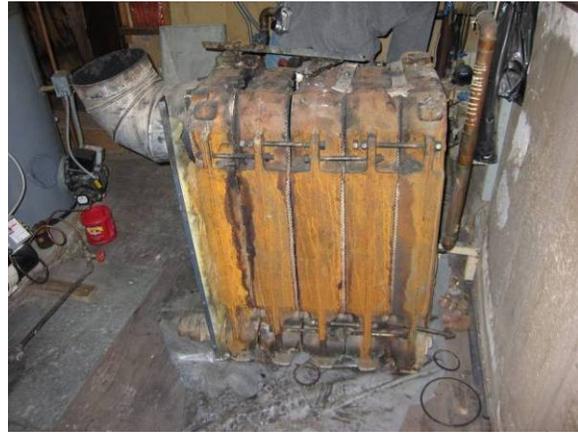
Heating: Two Weil-McLain boilers located in the building's mechanical room provide heating. One is currently inoperable and is under repair, so the remaining boiler is forced to supply the entire building's

heat. The age of these boilers is unknown, but based on product literature, they were probably manufactured in the mid-1990s. According to a product brochure, these boilers were 82-84% efficient at time of manufacture. A combustion analysis found the functional boiler to be 78% efficient.

Boiler Under Repair

Completed as planned in all buildings except for the City Hall. The boilers in the City Hall were replaced instead under the scope of M02.

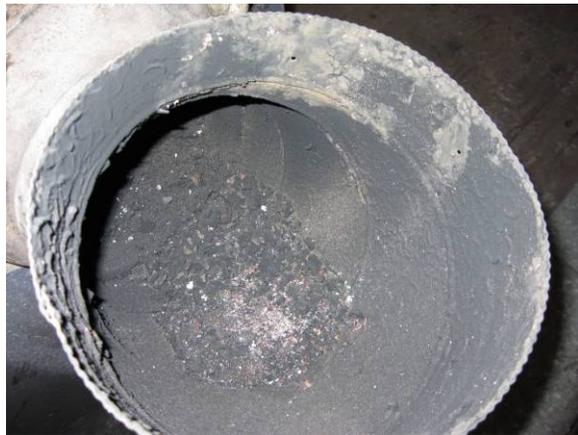
Debris in Boiler Flue

- ◆ Replace, repair, calibrate or install sensors or switches
- ◆ Repair air linkages
- ◆ Conduct combustion efficiency test services
- ◆ Clean combustion chambers and stacks

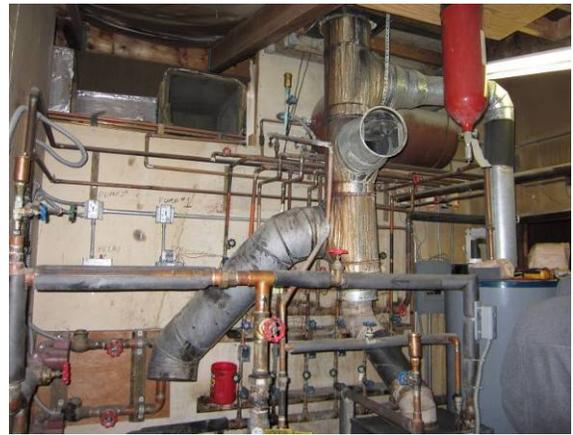
Boiler Stack and Mechanical Room

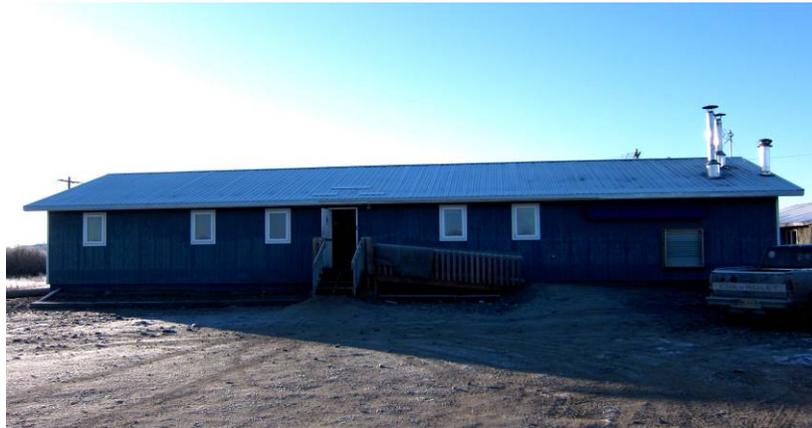
Description: The Emmonak Washeteria is used by most of the villagers for their laundering needs. The building is open 3 days each week to accommodate the needs of the villagers. There are also men's and women's saunas and showers located in the facility.

General Conditions: The building structurally appears to be kept in good condition. The interior spaces, however, are excessively overheated. The building is so hot, that villagers usually keep the front door and windows open while doing laundry to make the environment bearable. There are many reasons for the high temperature of the facility, from lack of dryer heat exchanger control to non-functioning room control. The village no longer utilizes the sauna heaters, as the space is now heated with the building system and kept over 110°F. During the audit, the women's sauna temperature reading was found to be 124°F. The dryers are on continuous heat loops, which create excess heat in an already overheated interior space. The only comfortable room in the facility is one which houses an HRV, yet appears to be used only for storage. This facility is ripe with opportunities for energy improvements.

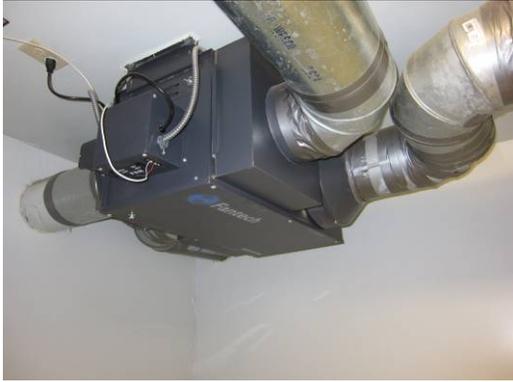
expected. A combustion analysis of the boilers found them to be 82% efficient. The Fantech HRV is located in a side room across the building from the mechanical room and was set to a medium airflow rate at the time of the audit. Four air vents located throughout the building tie into the ductwork of this HRV unit. A mechanical thermostat is also located in this side room; the thermostat was set to 70 degrees at the time of the audit, but the temperature reading was found to be well over 80 degrees due to the excess heat in the building. Four Beacon Morris unit heaters rated at 900 cfm heat the crawl space beneath the building. These heaters are tied into a single mechanical thermostat set to 60 degrees and appear to be functioning normally.

Fantech HRV

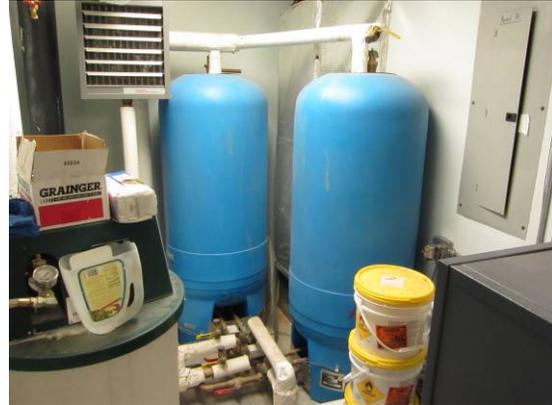
Amtrol Boilermate Indirect Water Heaters

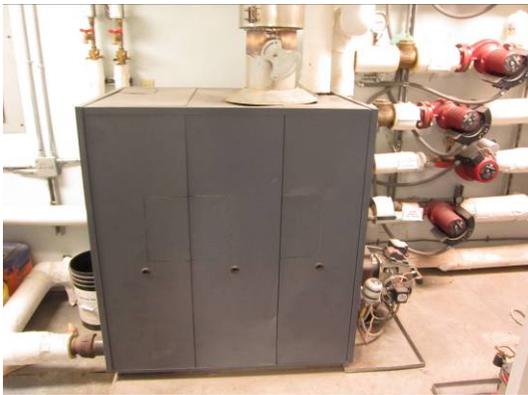
Heating: Two Weil-McLain Model 80 boilers provide the building with heating, along with 5 unit heaters (1 in the mechanical room and 4 in the crawl space below the building) and one heat recovery ventilator (HRV). One boiler is a 6-section unit, while the other is a 4-section unit. The 6-section unit runs continuously, while the 4-section unit has been manually turned off. In discussions with site maintenance personnel, Ameresco engineers were told that the smaller boiler is turned on once the temperature drops, as they cannot maintain the high building temperatures. During mild conditions, such as those encountered during the audit (38 deg.F day/ 28 deg. F night), the opposite operational sequence is

Weil-McLain 480 Model Boiler

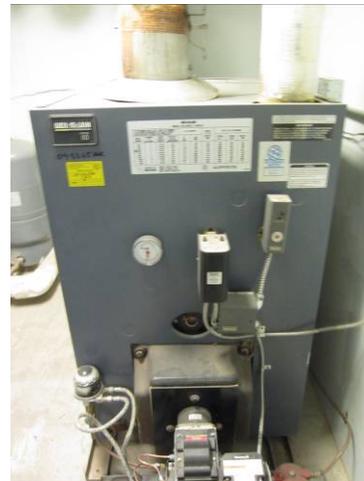
Weil-McLain 680 Model Boiler

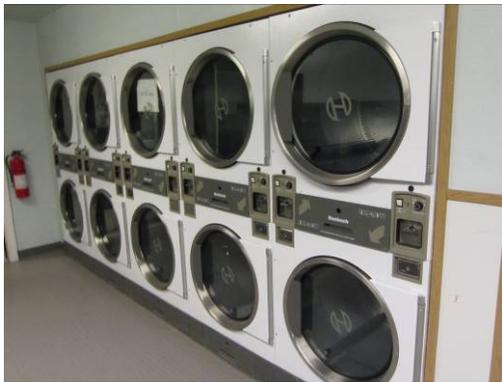
Laundry Equipment: There are a total of 7 Continental Girbau washers (40-pound) and 10 Huebsch dryers (actually 5 units, where each unit has 2 dryers, 30-pound capacity) located in the Emmonak Washeteria. The washers currently meet ENERGY STAR performance requirements. The Continental Girbau washers have a modified energy factor (MEF) of 1.96 and a water factor (WF) of 5.04. Current ENERGY STAR requirements stipulate a MEF of 1.8 or greater and a WF of 7.5 or less. In January of 2011, however, the requirements will change to a MEF of 2.0 or greater and a WF of 6.0 or less. ENERGY STAR does not currently offer a label for clothes dryers because most models use similar amount of energy. Because the Huebsch dryers are relatively new, they are most likely on the same efficiency level as other commercial dryers on the market. These dryers, however, are currently consuming a large amount of energy because they are not being properly controlled.

Huebsch Dryers – Constantly Heated

This ECO proposes installing or repairing existing control systems to effectively minimize energy demand and consumption. A properly operational control system will also result in O&M savings, improved comfort, and energy savings. In many cases, this ECO also includes installing programmable thermostats in village buildings to ensure proper HVAC scheduling. This ECO also encompasses the dryer heating system in the Emmonak Washeteria.

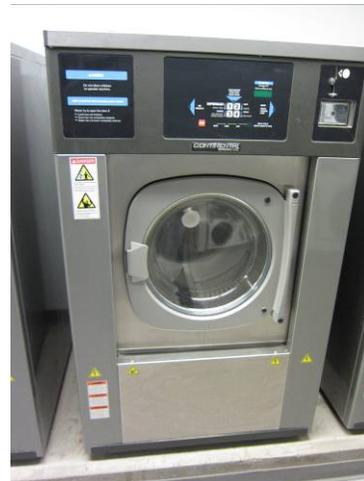
Continental Girbau Washer

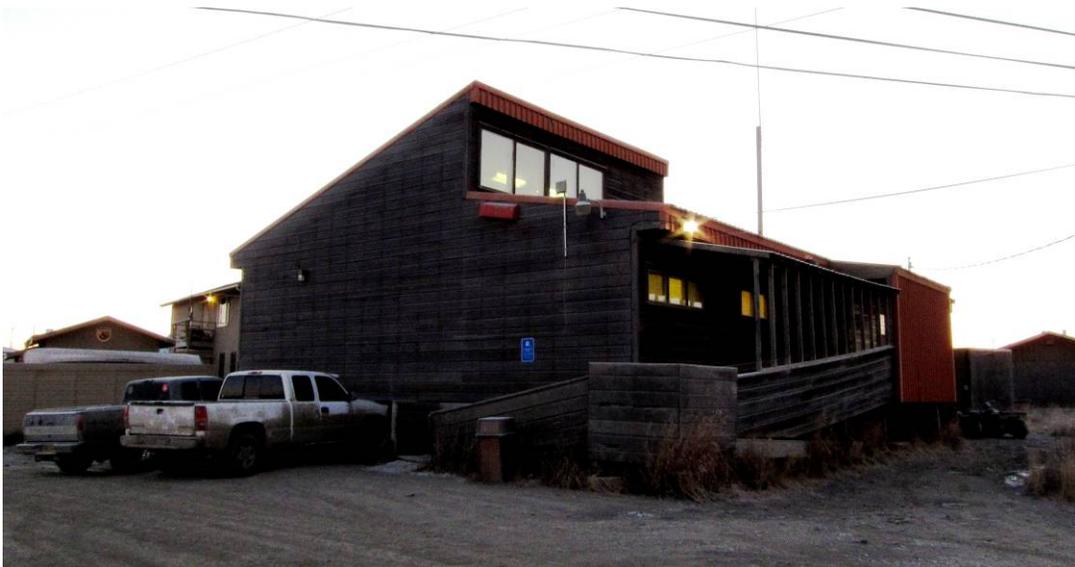
Description: The Emmonak Police Department building houses the police department offices, the jailhouse, and the courtroom. Emmonak Court operates Monday through Friday, 8 am to noon, and 1 pm to 4:30 pm.

General Conditions: Structurally, the building appears to be in good condition, with a few cosmetic flaws. The building is riddled with mechanical thermostats, but only one appears to be working at this time. The heating system is in need of maintenance and repair. The facility overall, however, appears to be in usable condition.

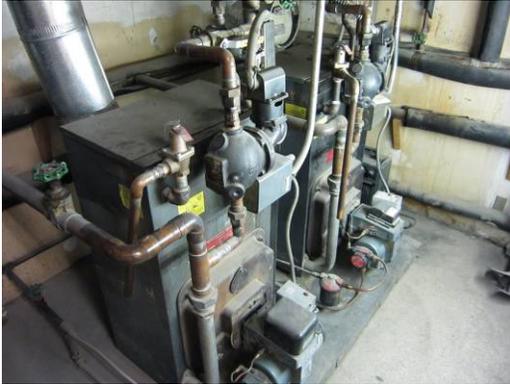
Heating: Two oil fired Weil-McLain boilers provide the building with heating, though they are not operating effectively at this time. A combustion analysis was performed on both of these boilers. One boiler was found to have a combustion efficiency of 81.1%. The second boiler was found to have a combustion efficiency of 80.2%, with high carbon monoxide levels. The combustion efficiency will increase with increased excess air, until the heat loss in the excess air is larger than the heat provided by more efficient combustion. When fuel and oxygen in the air are in perfect balance, the combustion is said to be stoichiometric. Proper maintenance and system calibration will increase and maintain higher efficiency levels and reduce operating costs.

Upon further investigation, Ameresco found this particular model of Weil-McLain boiler to be discontinued. Because these boilers and associated systems are functioning so ineffectively, two electric room heaters are used to keep the building warm. According to occupants, the electric heaters cannot overcome the colder temperatures experienced during the winter, and the building becomes exceedingly cold during these months, especially in the jailhouse.

Old Weil-McLain Boilers

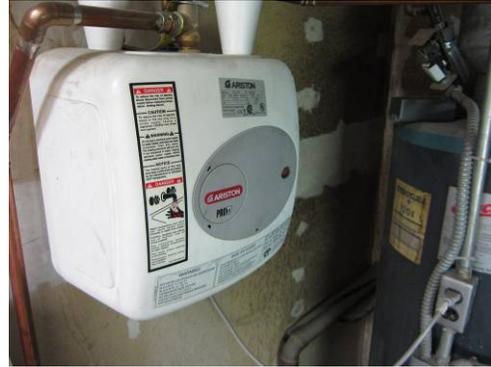
Domestic Water: An Ariston point-of-use 4 gallon electric water heater has replaced the now-defunct Bock domestic water heater. This Ariston water heater appears to be fairly new and is in good condition. The plumbing fixtures in the jailhouse are no longer operational, so prisoners must be escorted out of their cells to use the restroom. The water heater currently meets the requirements of the limited fixtures. Should the restrooms be repaired, the domestic hot water system will need to be revised.

Ariston Domestic Water Heater

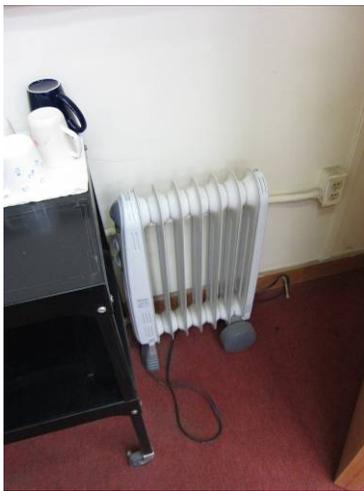
Oil-Filled Heater (for Courtroom)

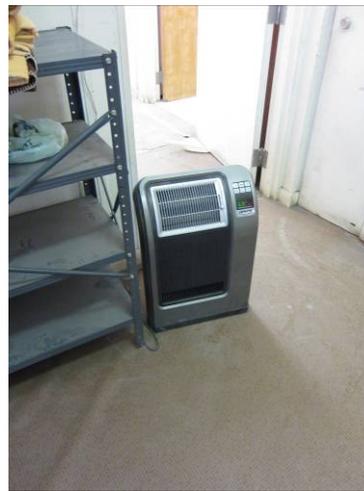
Lasko Electric Heater (for Jailhouse)

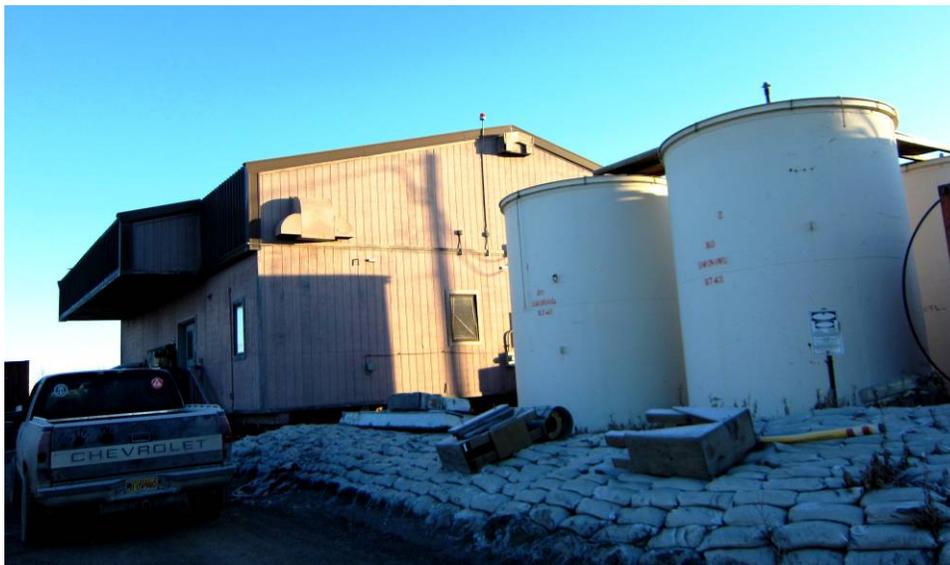
Description: The Emmonak Water Treatment Plant provides clean water to the entire city. The plant has a single operator, but receives extra maintenance help when needed. The building is in good condition. Most of the equipment housed at the facility has been well-maintained, though there are several outdated pumps and motors that could be replaced with more efficient models.

General Conditions: The water treatment plant is in good condition overall. All of the mechanical equipment has been kept in good condition, even though some the HVAC is somewhat dated. No major defects were noticed during the audit walkthrough.

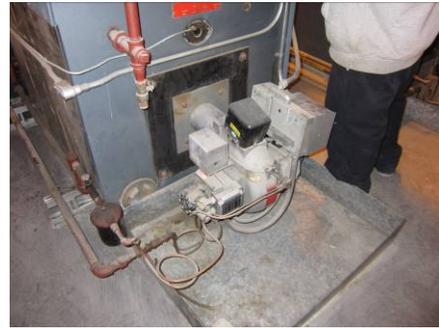
Heating: Two oil-fired Weil-McLain Model 688 Series 3 boilers provide the building with heating; heat is also added from the power plant. A combustion analysis was performed and found the boilers to be 80.1% efficient. One of the boilers, however, constantly drifts out of combustion requirements, as the burner oxygen linkage is damaged and currently held together by bail wire. These boilers are also discontinued Weil-McLain models.

Boiler Furnace – Missing Linkage

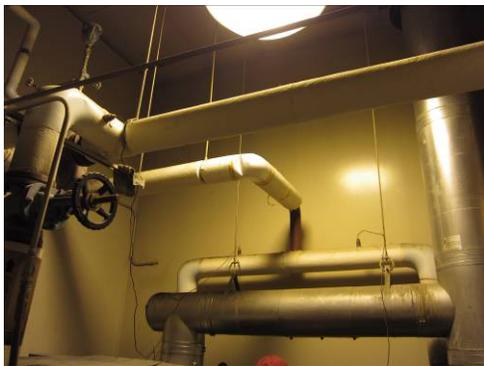
Boiler Room – Missing Insulation

Un-insulated or poorly insulated hot water pipes and result in unnecessary heat gain/loss and lead to longer runs times for boilers. This ECO proposes to add insulation where it is non-existent or to replace damaged insulation.

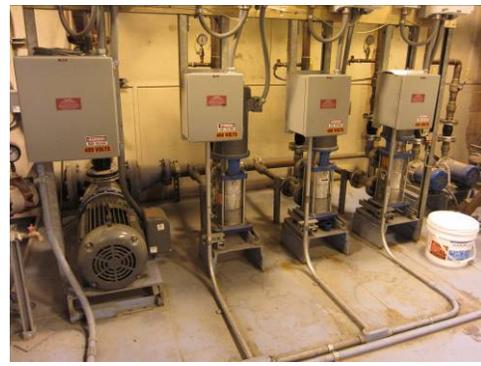
Domestic Water: The water treatment plant houses many pumps and motors of varying ages and efficiencies. Opportunities exist here for more efficient replacements.

Water Treatment Pumps

This ECO proposes installing National Electrical Manufacturers Association (NEMA) premium efficiency motors to replace standard and high efficiency motors. There are various mechanical systems

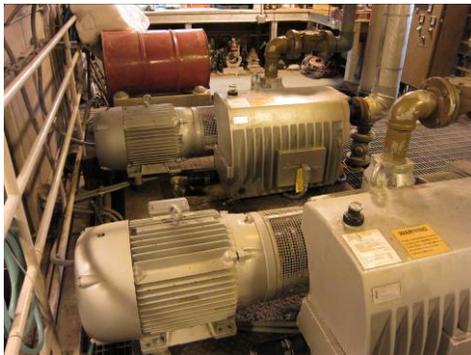
Vacuum System: Vacuum sewage systems are installed in bush Alaska due to permafrost and lack of available pitch. The system originates at the treatment facility and is in good operational condition. The vacuum pump motor runs 24/7 to meet village requirements. A higher efficiency motor will result in measurable savings for this system.

Vacuum Pumps

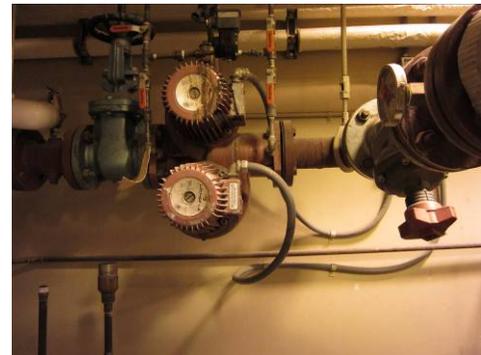
Heat Trace System: To prevent system freeze ups, hot water heat trace pumps that run throughout the water and sewer distribution system originate from this facility. The system is manually controlled and runs at all times or at operators' discretion. Limiting the operation of the heat trace based on outside air or ground temperatures will provide significant savings to the village.

Circulating Pumps

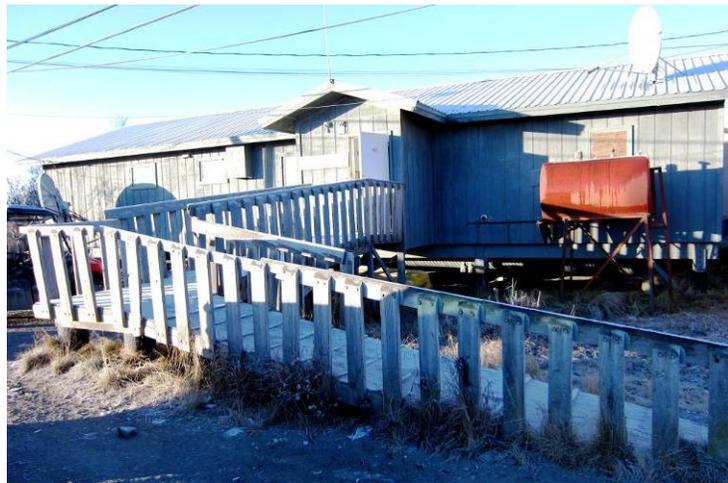
Chuloonawick Native Village Office: The Chuloonawick Native Village office in Emmonak is in fair condition. Some of the windows have been boarded up, but the remaining windows (with the exception of one broken one) are in good condition. The building exterior and roof are still in good condition. The doors seal adequately when closed. A Toyo stove space heater is used to heat the building. There is a non-function LifeBreath heat exchange ventilator in a side room. If this ventilator were to be repaired, it would greatly improve the building's interior comfort level. Lighting has already been retrofit to T8 lamps with electronic ballasts.

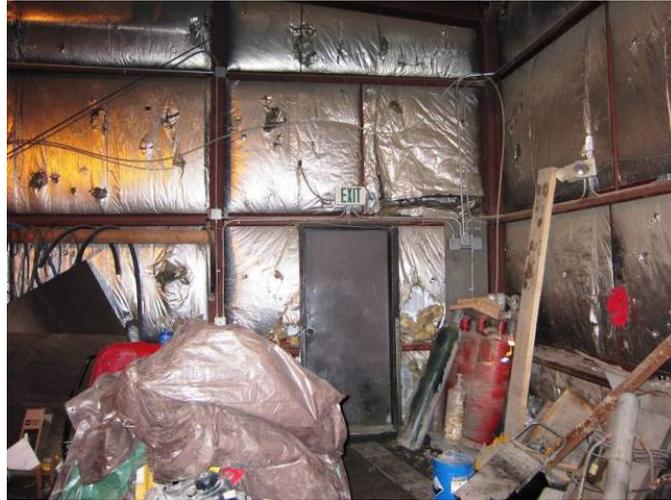
Public Works: The Public Works building is a pre-fabricated steel frame building with deteriorating insulation constructed on a dirt base. All of the doors are extremely leaky, and there are many areas of insulation that have become damaged and are no longer adequate. A scavenged Modine unit heater provides some space heating. Lighting to the main work bay is provided by 4,250 watt HPS hanging fixtures. The office area is lit by two T12 fluorescent fixtures with magnetic ballasts.

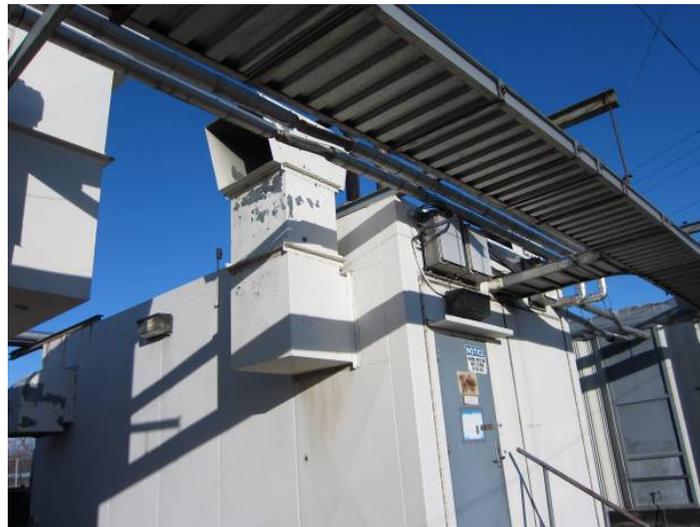
Emmonak Power Plant: The Emmonak power plant is under the authority of the Alaskan Village Electric Cooperative (AVEC). A lighting retrofit opportunity exists here, as there are 20 T12 fixtures lighting the various buildings.

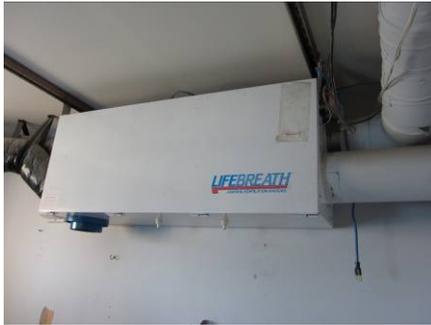
Chuloonawick – Heat Exchange Ventilator

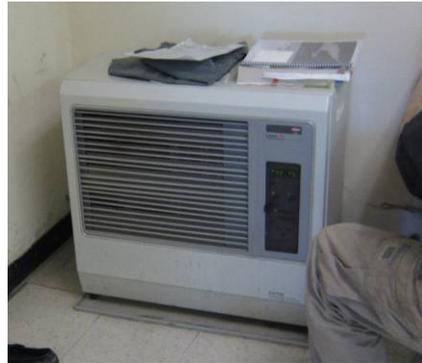
Chuloonawick – Toyostove Heater

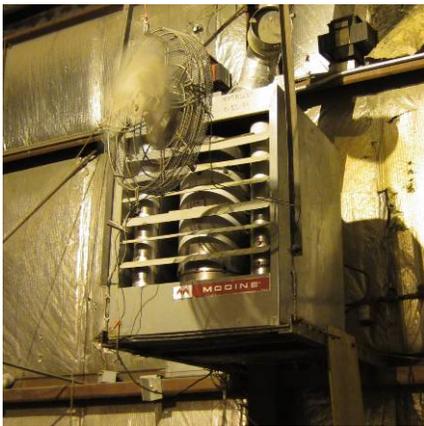
Public Works – Scavenged Modine Heater

Ameresco proposed to install a new fuel oil unit heater at the city Public Works building and eliminate the currently installed model. The current fuel oil burner is a Modine model POR145B with a heating capacity of 145MBH. The burner has a hand-written install date of 1999, but occupants informed Ameresco that this particular heater had been scavenged for the Public Works building at another date, so this install date is inaccurate. A more efficient Reznor model has been chosen as the replacement.

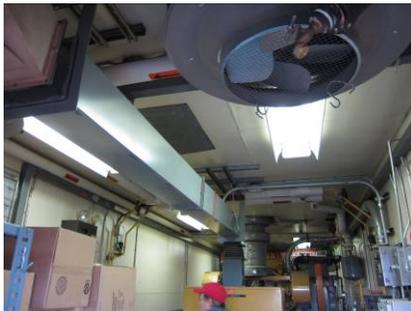
Power Plant - Lighting

Installed as planned in all buildings except for the Power Plant. Power Plant fixtures were high output (HO) fixtures and could not be replaced with typical T8 fixtures.

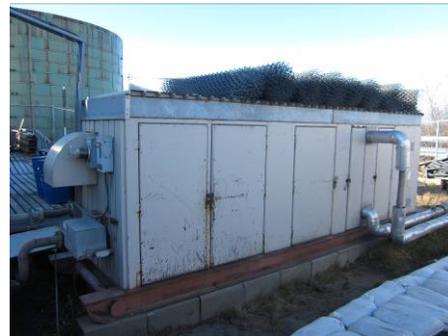
Power Plant – Heat Exchanger for Jacket Water

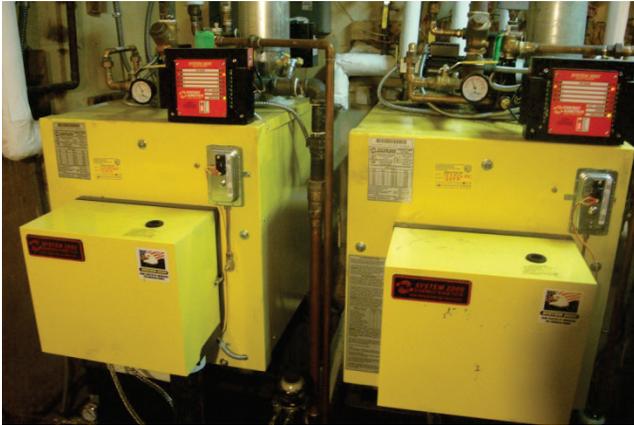
Boiler Upgrade

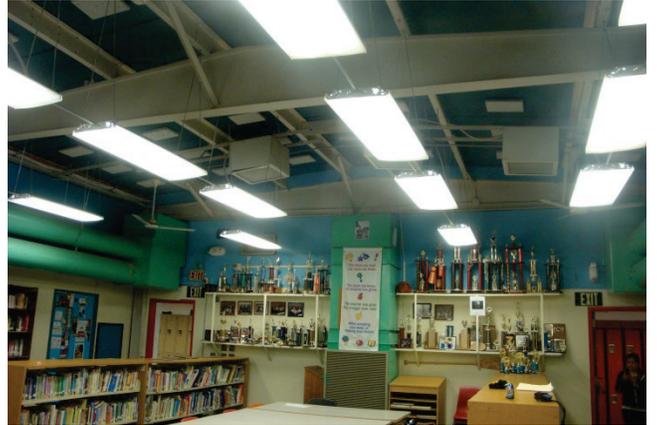
T8 Lighting Upgrade

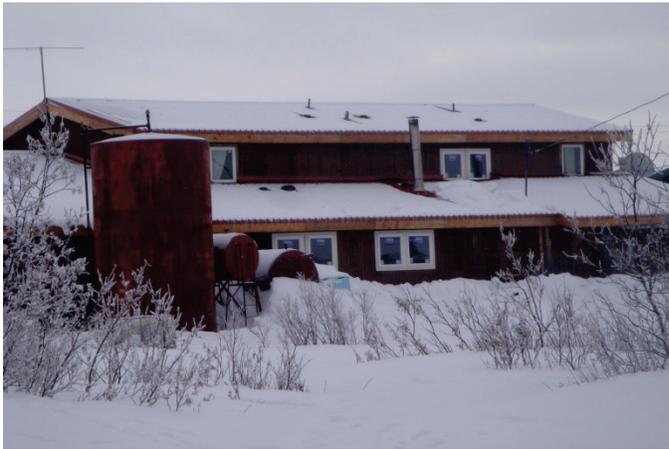
Window Upgrade

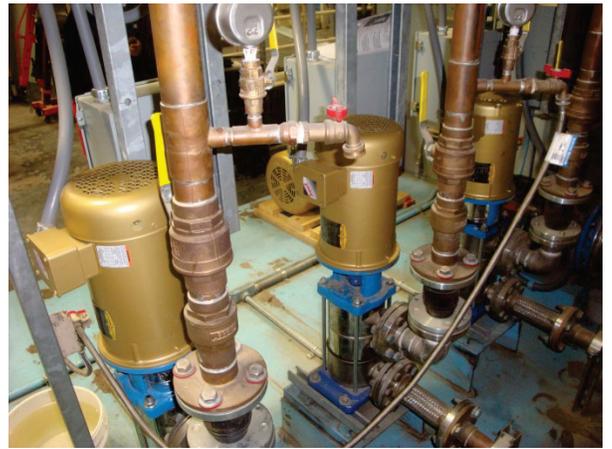
High Efficiency Motor Upgrade

Installed as planned for 9 of the originally proposed 11 motors. Stripped isolation valves prevented 2 of the motors from being replaced.
