This Report is for Permit # SF2009-160
Location: Yukon River near Ruby, AK
Species collected: Local Species

Abstract:

In late July and early August 2009, the Yukon River Inter-Tribal Watershed Council's 5kW hydrokinetic turbine was deployed on the Yukon River near the village of Ruby Alaska. As part of this project Fish Sampling was conducted by Ed Sarten, environmental technician from Ruby, Alaska and Robert DuBey, fish biologist from the Yukon River Fisheries Drainage Association (YRFDA). The AK Department of Fish and Game (ADFG) biologist for this area, was notified on July 20th, before sampling commenced. Sampling was conducted periodically between July 25th and August 4th 2009. During that time the turbine's rotor was submerged in the water and the turbine was producing power. Due to power transmission problems between the turbine and the shore-based grid connection, the turbine rotor was pulled from the water on August 6th and fish sampling ceased.

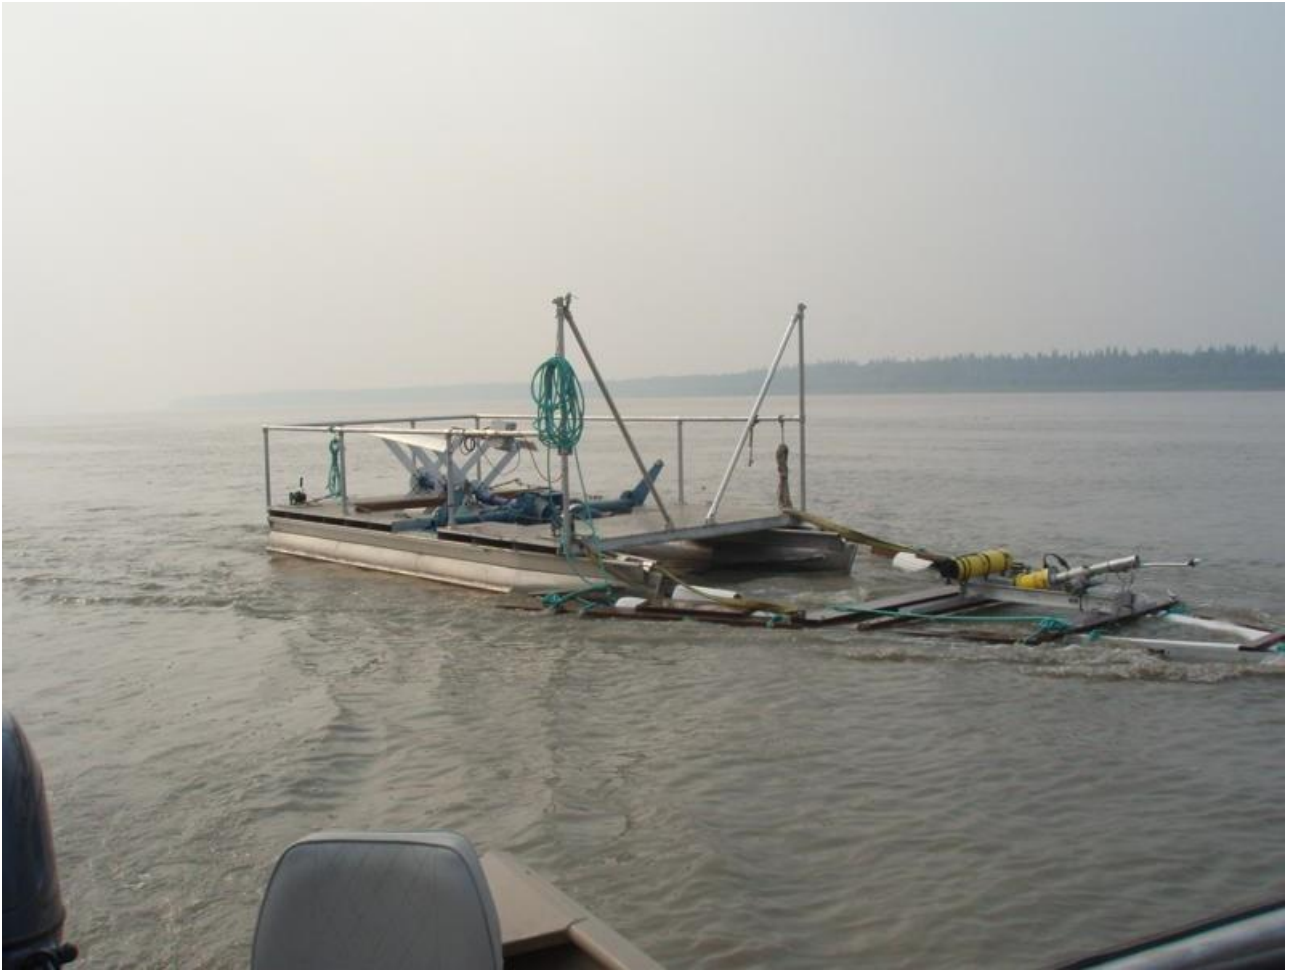
Hydrokinetic Turbine in Yukon outside of Ruby, AK

A hydrokinetic turbine is a method of producing power from running water without the use of dams or water diversion systems. The study at Ruby was conducted using an en-current turbine designed by New Energy LLC, with a generating capacity of 5kW of electrical power. The turbine resembles an upside-down vertical-axis wind turbine suspended below the surface of the river from a pontoon-boat-barge. The barge is tethered to a debris diversion device on the upstream side. The debris diversion device is then anchored to the river bottom via steel cables.

When the turbine is in the water, its rotor extends approximately 2 meters below the river surface into the water column. The rotor has a swept diameter of ~1m. The pontoon barge is tethered downstream of a debris diversion device, which resembles an V with the tip pointed upstream. This diversion device is connected to the anchoring system with steel cable and chain. The power cord is hung from the backside of the barge, straight down to the river bottom then along the riverbed to shore.

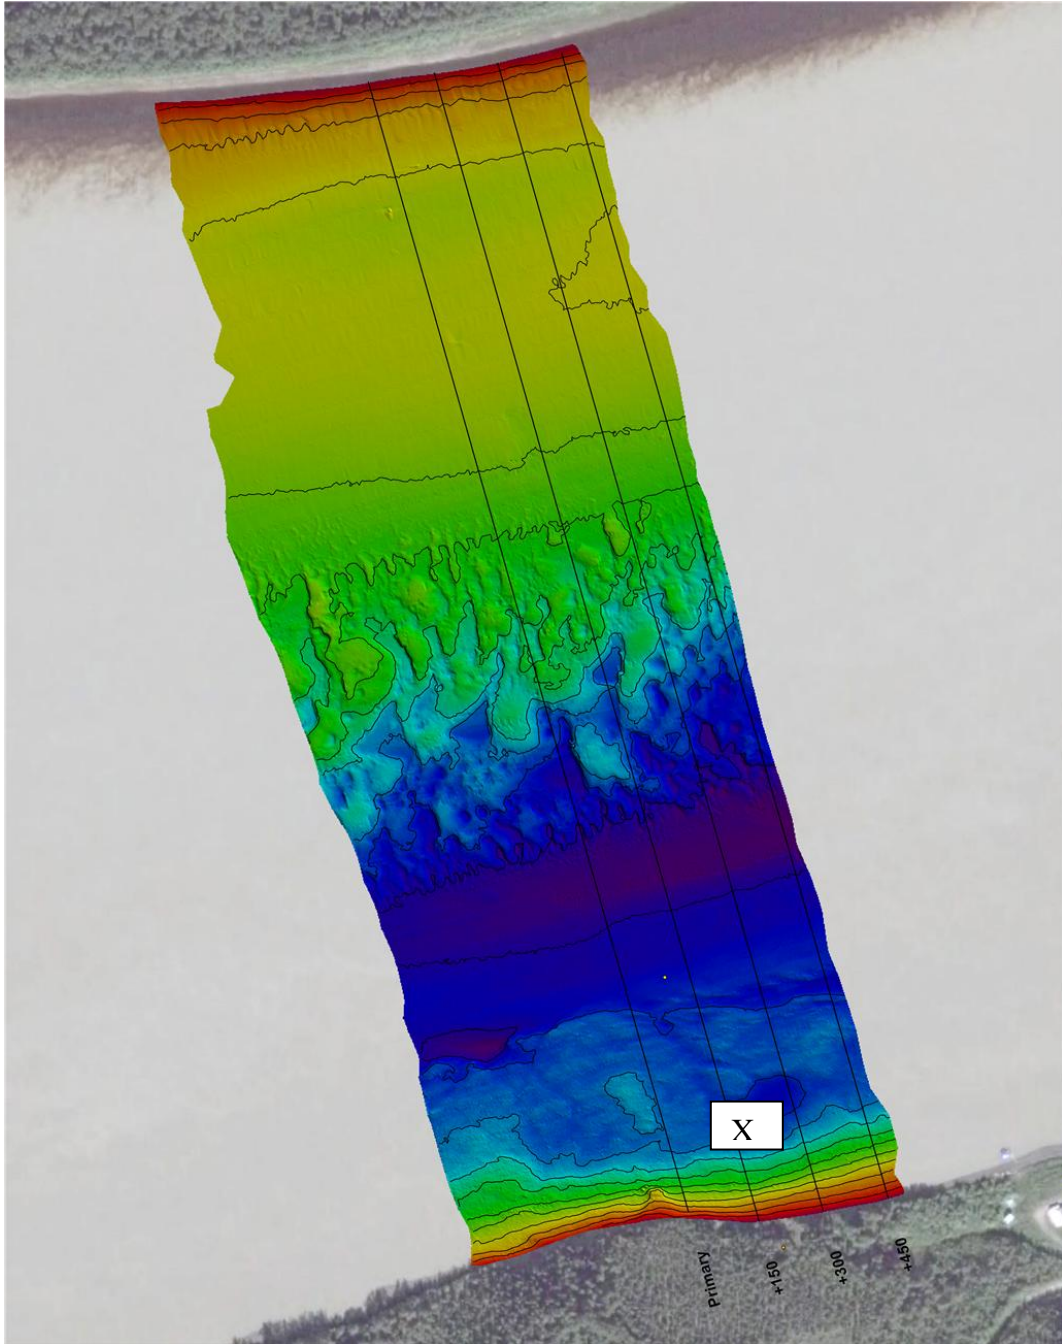
Transect of Yukon River just downstream of Ruby, AK. "X" in this picture marks the approximate location of the turbine. The image shows an outline of the River Thalweg (the deepest points are dark blue and purple, the shallowest areas are red). The Ruby barge dock is barely visible at the bottom R. corner of the screen.

Our ADP revealed a steady rise from the Thalweg to the south bank of the river, which ends in steep, cliffs just downstream of Ruby village. By contrast, the riverbed to the north of the Thalweg rises at a gradual rate. Current velocity in the north half of the river is also shown to be weaker than in the southern half (see ADP image included at the end of this report). This could suggest that fish species are more likely to hug the north bank of the Yukon as they pass Ruby.
