RE: Bradley Lake Project FERC Project No. 8221  
Dixon Diversion Amendment Terrestrial Study Reports

The Alaska Energy Authority (AEA) is pursuing a Federal Energy Regulatory Commission (FERC) license amendment associated with the existing 120-megawatt Bradley Lake Hydroelectric Project (Bradley Lake Project, FERC No. P-8221). The purpose of the amendment is to gain authorization to increase the Bradley Lake Dam height and divert meltwater from the Dixon Glacier to Bradley Lake to generate additional power. The Bradley Lake Project is located on the Bradley River in the Kenai Peninsula Borough northeast of the town of Homer in Southcentral Alaska. AEA is providing study reports related to terrestrial resources for the proposed license amendment.

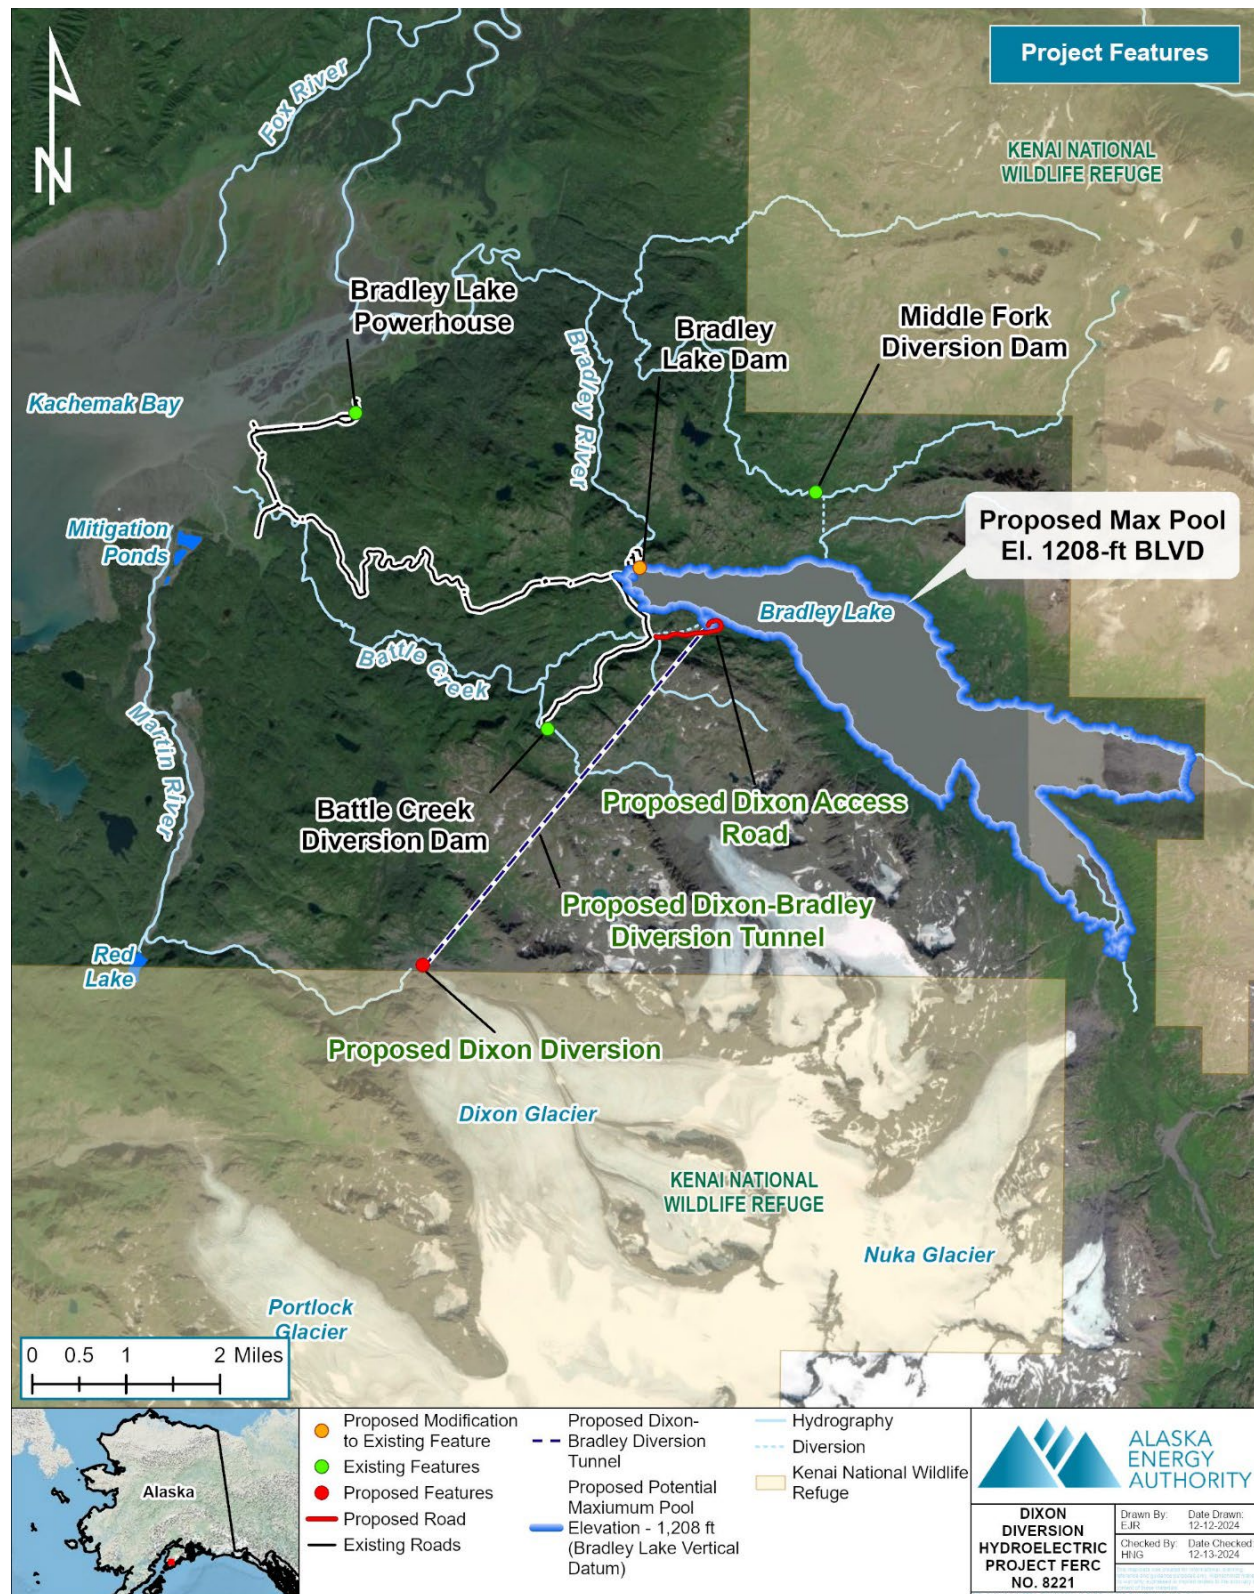
**Figure 2-1 Location of the proposed Dixon Diversion Project at the Bradley Lake Hydroelectric Project (FERC No. P-8221) near Kachemak Bay, Alaska.**

As part of the Project, AEA is proposing to raise the Bradley Lake Dam and spillway by 7, 14 or 28 feet from current heights. An increase of 28 feet would increase the normal full pool of Bradley Lake elevation from 1,180 feet up to 1,208 feet, the surface area from 3,820 acres up to 4,224 acres, and the storage capacity from 284,000 acre-feet up to 386,000 acre-feet. The Dixon Diversion structure would be constructed below the toe of the Dixon Glacier at an elevation of approximately 1,275 feet Bradley Lake Vertical Datum (BLVD). Water would be diverted to Bradley Lake via a 4.9-mile-long tunnel bored through the mountain extending from the Dixon Diversion structure. Approximately 1 mile of new, 16-foot-wide, gravel-surfaced access road would be constructed from the existing Upper Battle Creek diversion access road to the outlet of the proposed diversion tunnel. No new overhead transmission is proposed; The additional power generated from the proposed diversion would be transmitted from the existing Bradley Lake powerhouse substation and connect to the Homer Electric Association line between Fritz Creek and Soldotna via the existing 115-kV transmission line.

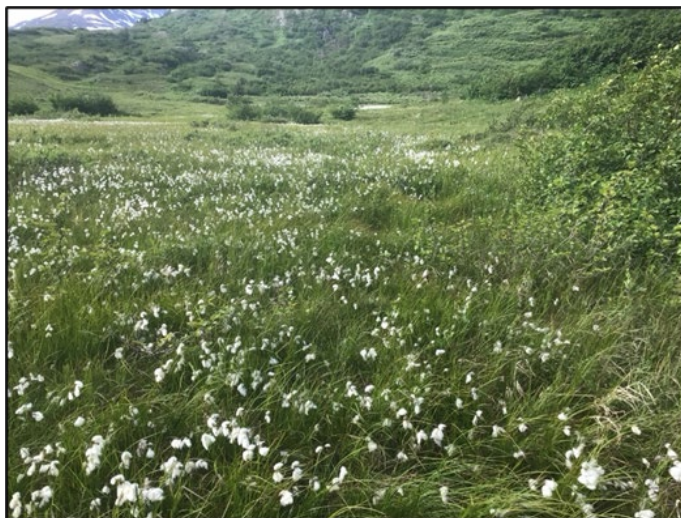
**Photo 5-1 Typical wetlands within the study area (SP17).**

Study area wetlands consist of the following dominant vegetation: speckled alder (*Alnus incana*), Sitka alder (*A. viridis*), bluejoint (*Calamagrostis canadensis*), leafy tussock sedge (*Carex aquatilis*), Alaska long-awn sedge (*C. macrochaeta*), alpine-tundra sedge (*C. macrochaeta*), narrow-leaf fireweed (*Chamaenerion angustifolium*), black crowberry (*Empetrum nigrum*), marsh willowherb (*Epilobium palustre*), tall cotton-grass (*Eriophorum angustifolium*), tussock cotton-grass (*E. vaginatum*), strawberry-leaf raspberry (*Rubus pedatus*), felt-leaf willow (*Salix alaxensis*), diamond-leaf willow (*S. pulchra*), Sitka willow (*S. barclayi*), Canadian burnet (*Sanguisorba canadensis*), Arctic starflower (*Trientalis europaea*), alpine blueberry (*Vaccinium uliginosum*), and alpine-marsh violet (*Viola palustris*). Hydrophytic vegetation met dominance and/or prevalence index indicators. Typical wetlands within the study area are shown in Photo 5-1.

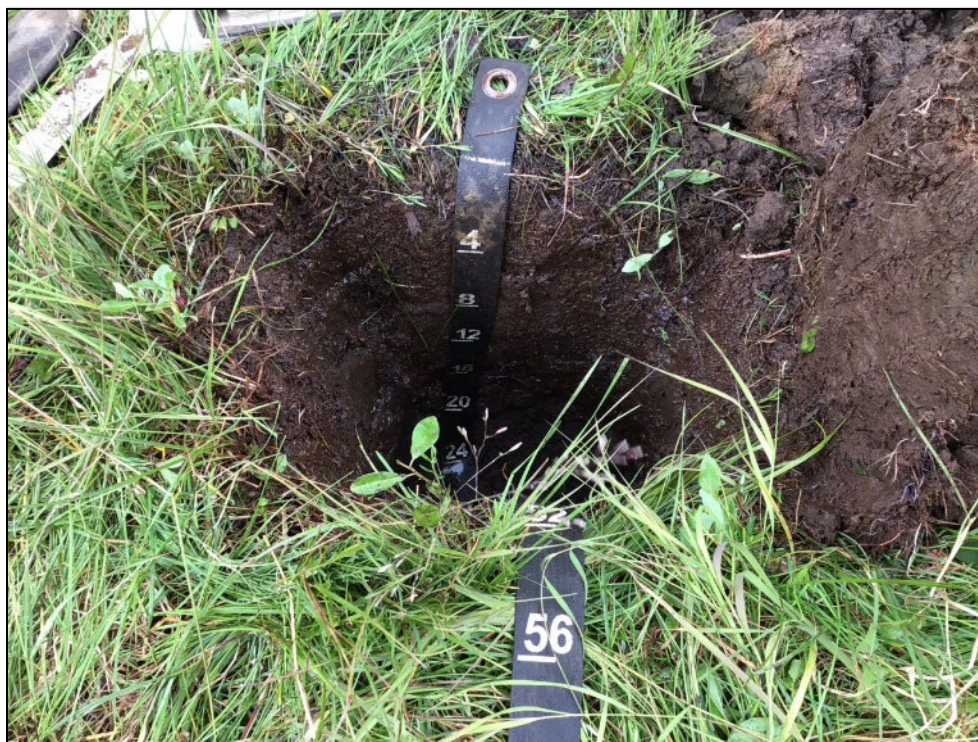
**Photo 5-2 Typical wetland soils within the study area (SP7).**

Hydrologic indicators consisted of high-water table, soil saturation, dry season water table, algal mat, inundation visible on aerial imagery, water-stained leaves, drainage patterns, presence of reduced iron, geomorphic position, microtopographic relief, and passing the FAC-neutral test. The most common primary indicators were high water table and soil saturation. Typical wetlands soil and hydrology (soil saturation, dry season water table) in the study area are shown in Photo 5-2.

In general, soils in wetlands had a thick organic layer and met Histosol or Histic Epipedon. Soils without a thick organic layer but considered hydric soil based on best professional judgment include SP5 and SP11. SP5 contained gravelly soils with low organic-carbon content. SP11 contained problematic hydric soils within a stream channel with drift deposits, geomorphic position, FAC-neutral, and hydrophytic vegetation. Table 5-2 lists soil characteristics observed at sampling points.

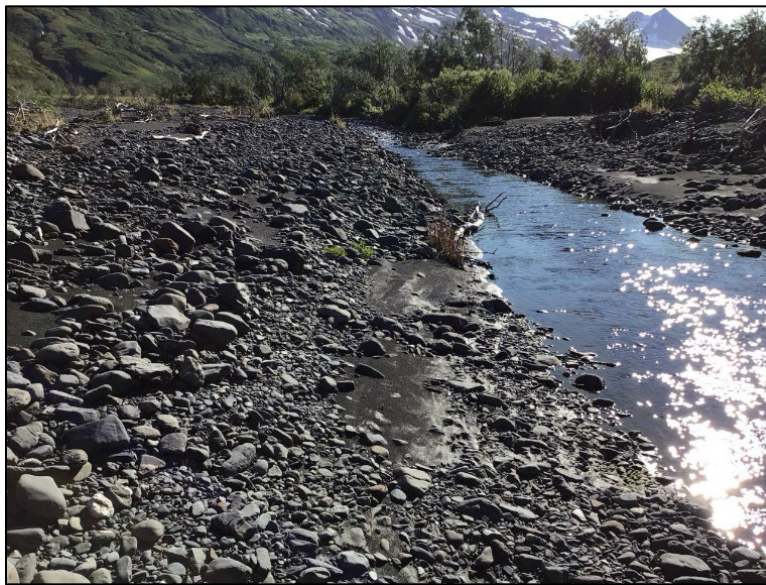
**Photo 5-3 Typical stream within the study area (Photo Point 43).**

The major tributaries (Nuka River, Kachemak Creek) that discharge into Bradley Lake are braided streams with multi-threaded channels consisting of vegetated or non-vegetated areas that seasonally flood during high water and have dynamic channels with large sediment movement. In braided streams, the outer channel banks and everything in between are considered the extent of the Riverine System (Federal Geographic Data Committee 2013). The Ordinary High Water (OHW) of the outermost channels in the braided streams were considered the base elevation for stream classification. One of the braided tributaries feeding Bradley Lake contained two islands with elevations above the OHW. Any vegetated areas below the OHW elevation within the stream braids were considered stream channel and not wetlands. No mineral or organic soils were present in these areas. Signs of hydrology flow through these areas included drift deposits and shrubs stripped of leaves from recent flow events. A typical stream within the study area is shown in Photo 5-3.

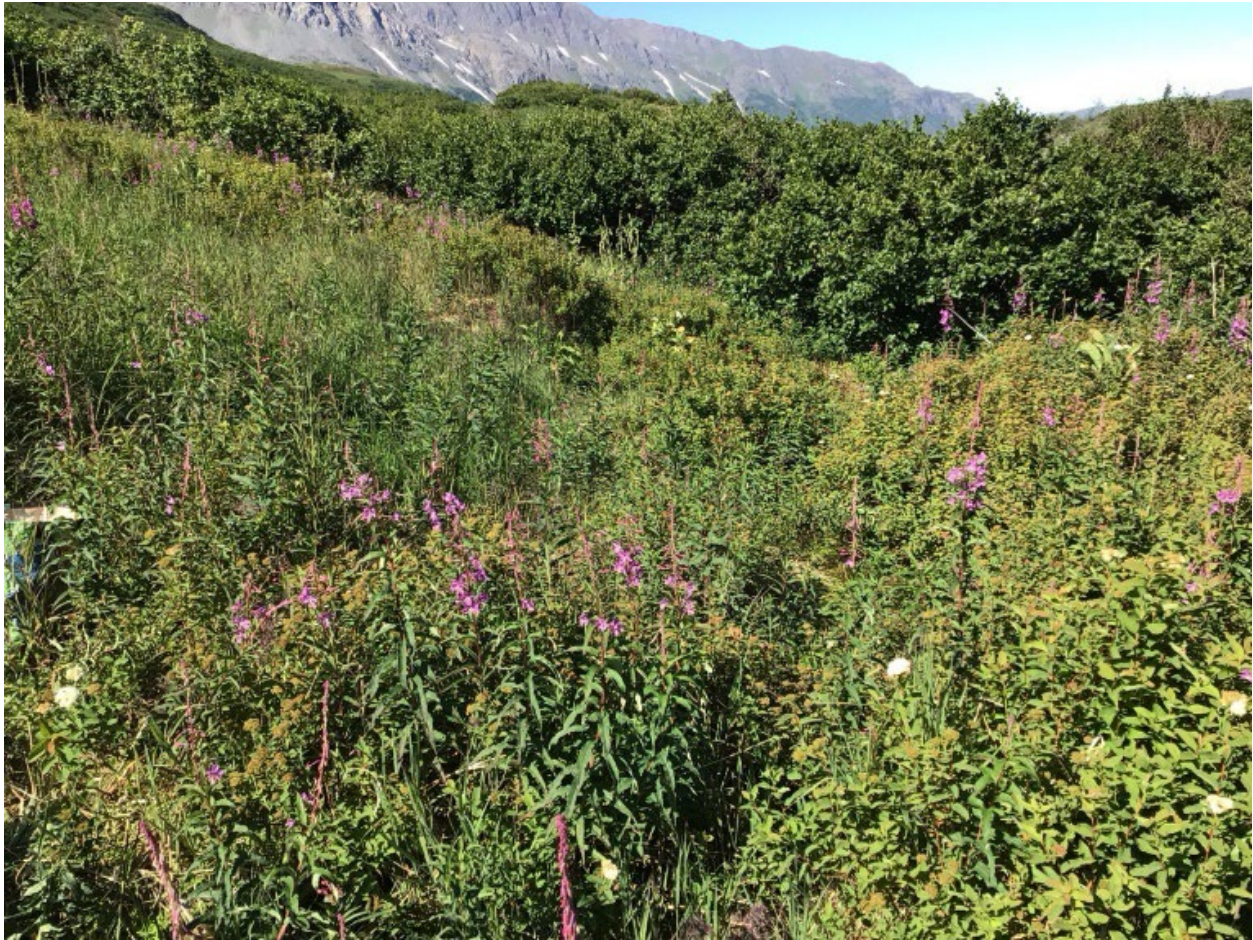
**Photo 5-4 Typical uplands within the study area (SP12).**

northern blackberry (*Rubus arcticus*), strawberry-leaf raspberry (*R. pedatus*), diamond-leaf willow, Sitka willow, spearleaf stonecrop (*Sedum lanceolatum*), Steven's meadowsweet (*Spiraea stevenii*), tufted leafless-bulrush (*Trichophorum caespitosum*), Arctic starflower, northern mountain-cranberry (*V. vitis-idaea*), and American false hellebore (*Veratrum viride*). Typical uplands within the study area are shown in Photo 5-4. Typical upland soil and lack of hydrologic indicators are shown in Photo 5-5.

Uplands typically meet the dominance or prevalence index indicators of hydrophytic vegetation. However, usually no primary hydrologic indicators were observed, and no hydric soil indicators were met. Upland sampling points matched NRCS upland soil mapping.

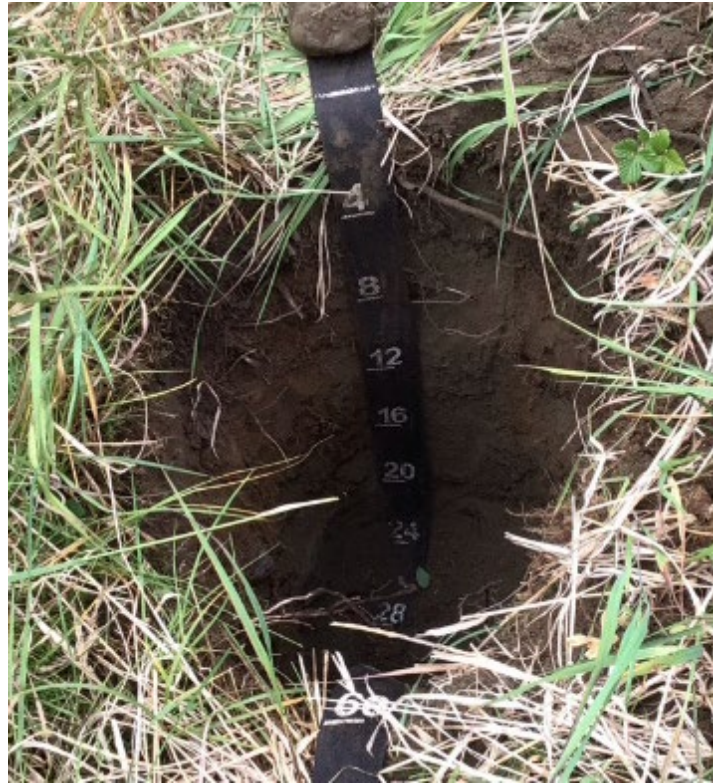
**Photo 5-5 Typical upland soil with lack of hydrologic indicators (SP9).**

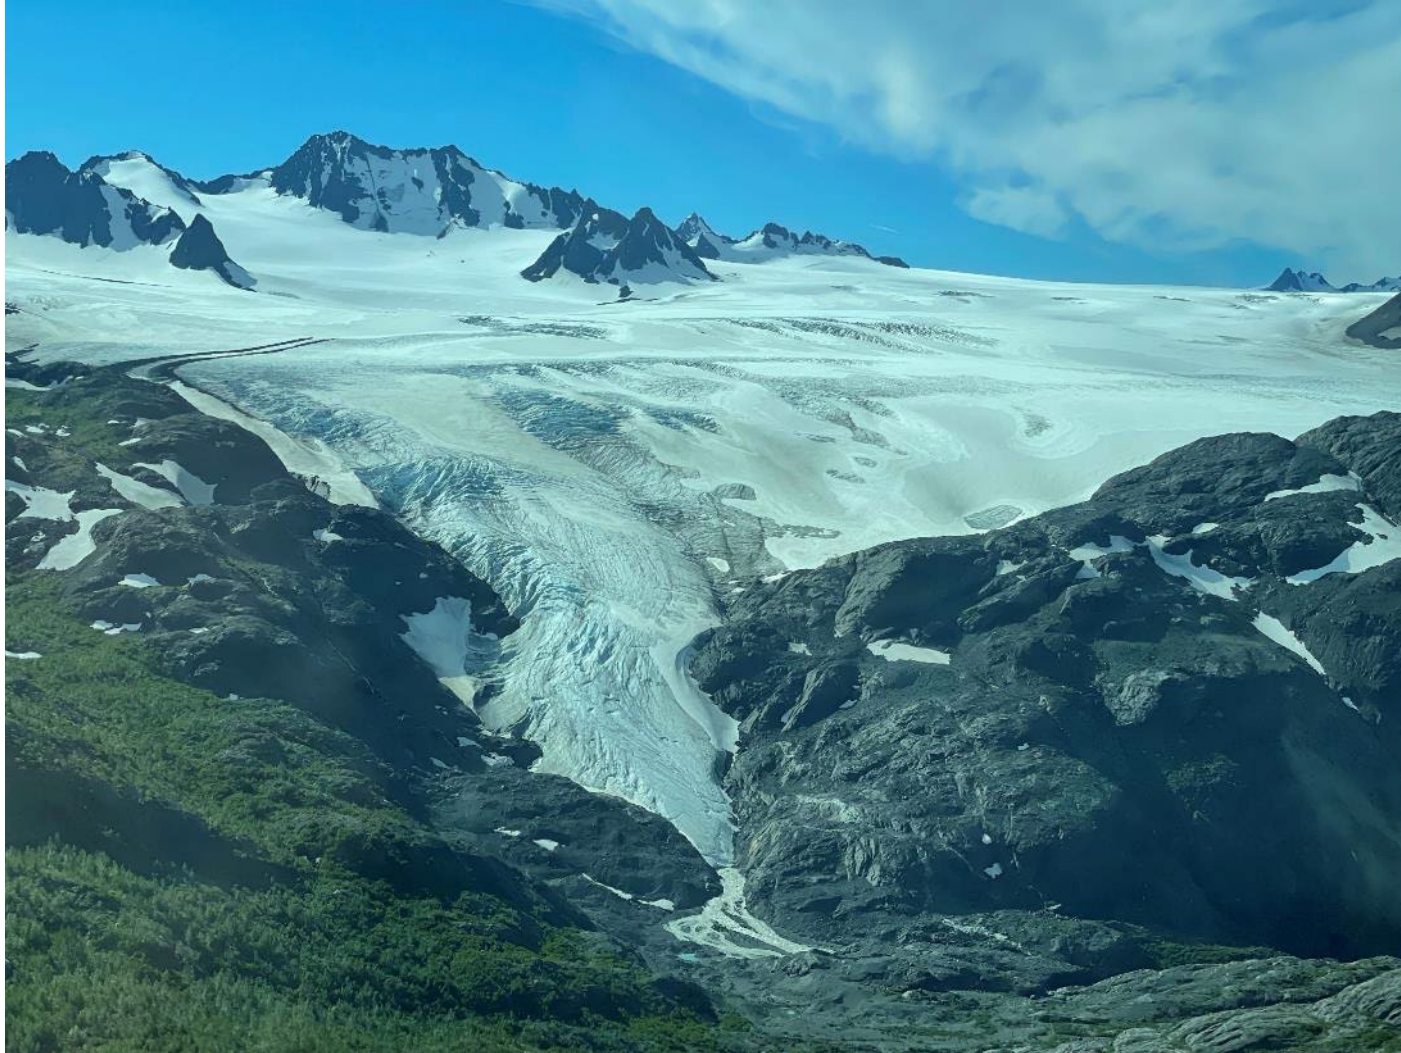
# Dixon Diversion Dam and Intake Location

- 25 ft high, ~75 ft long diversion dam near toe of Dixon Glacier

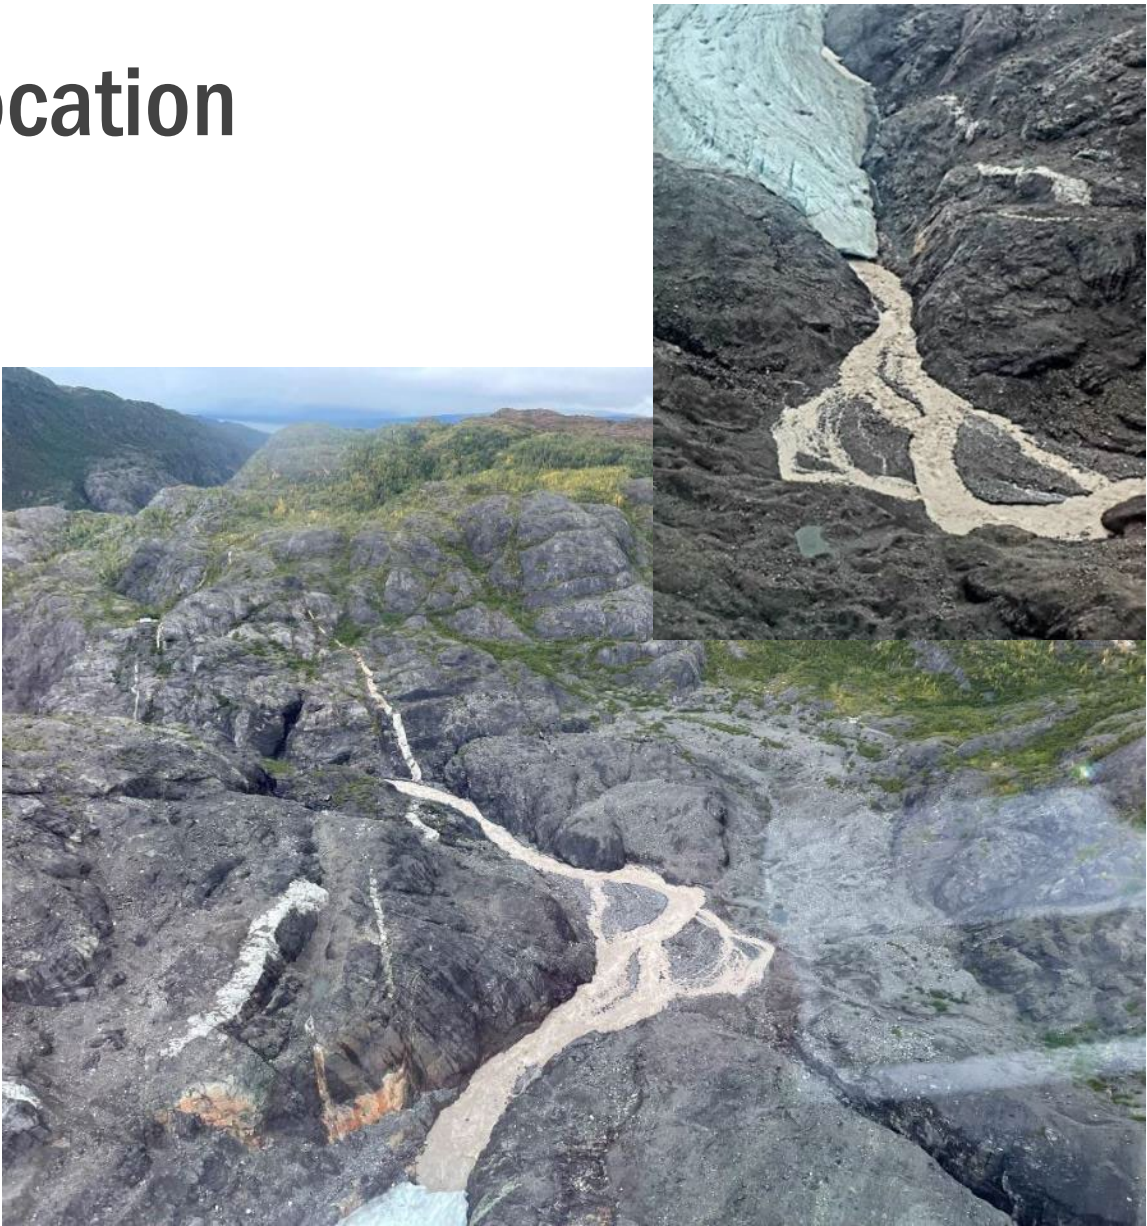
# Diversion Tunnel

- Diversion Dam to Bradley Lake
- 4.7 miles long

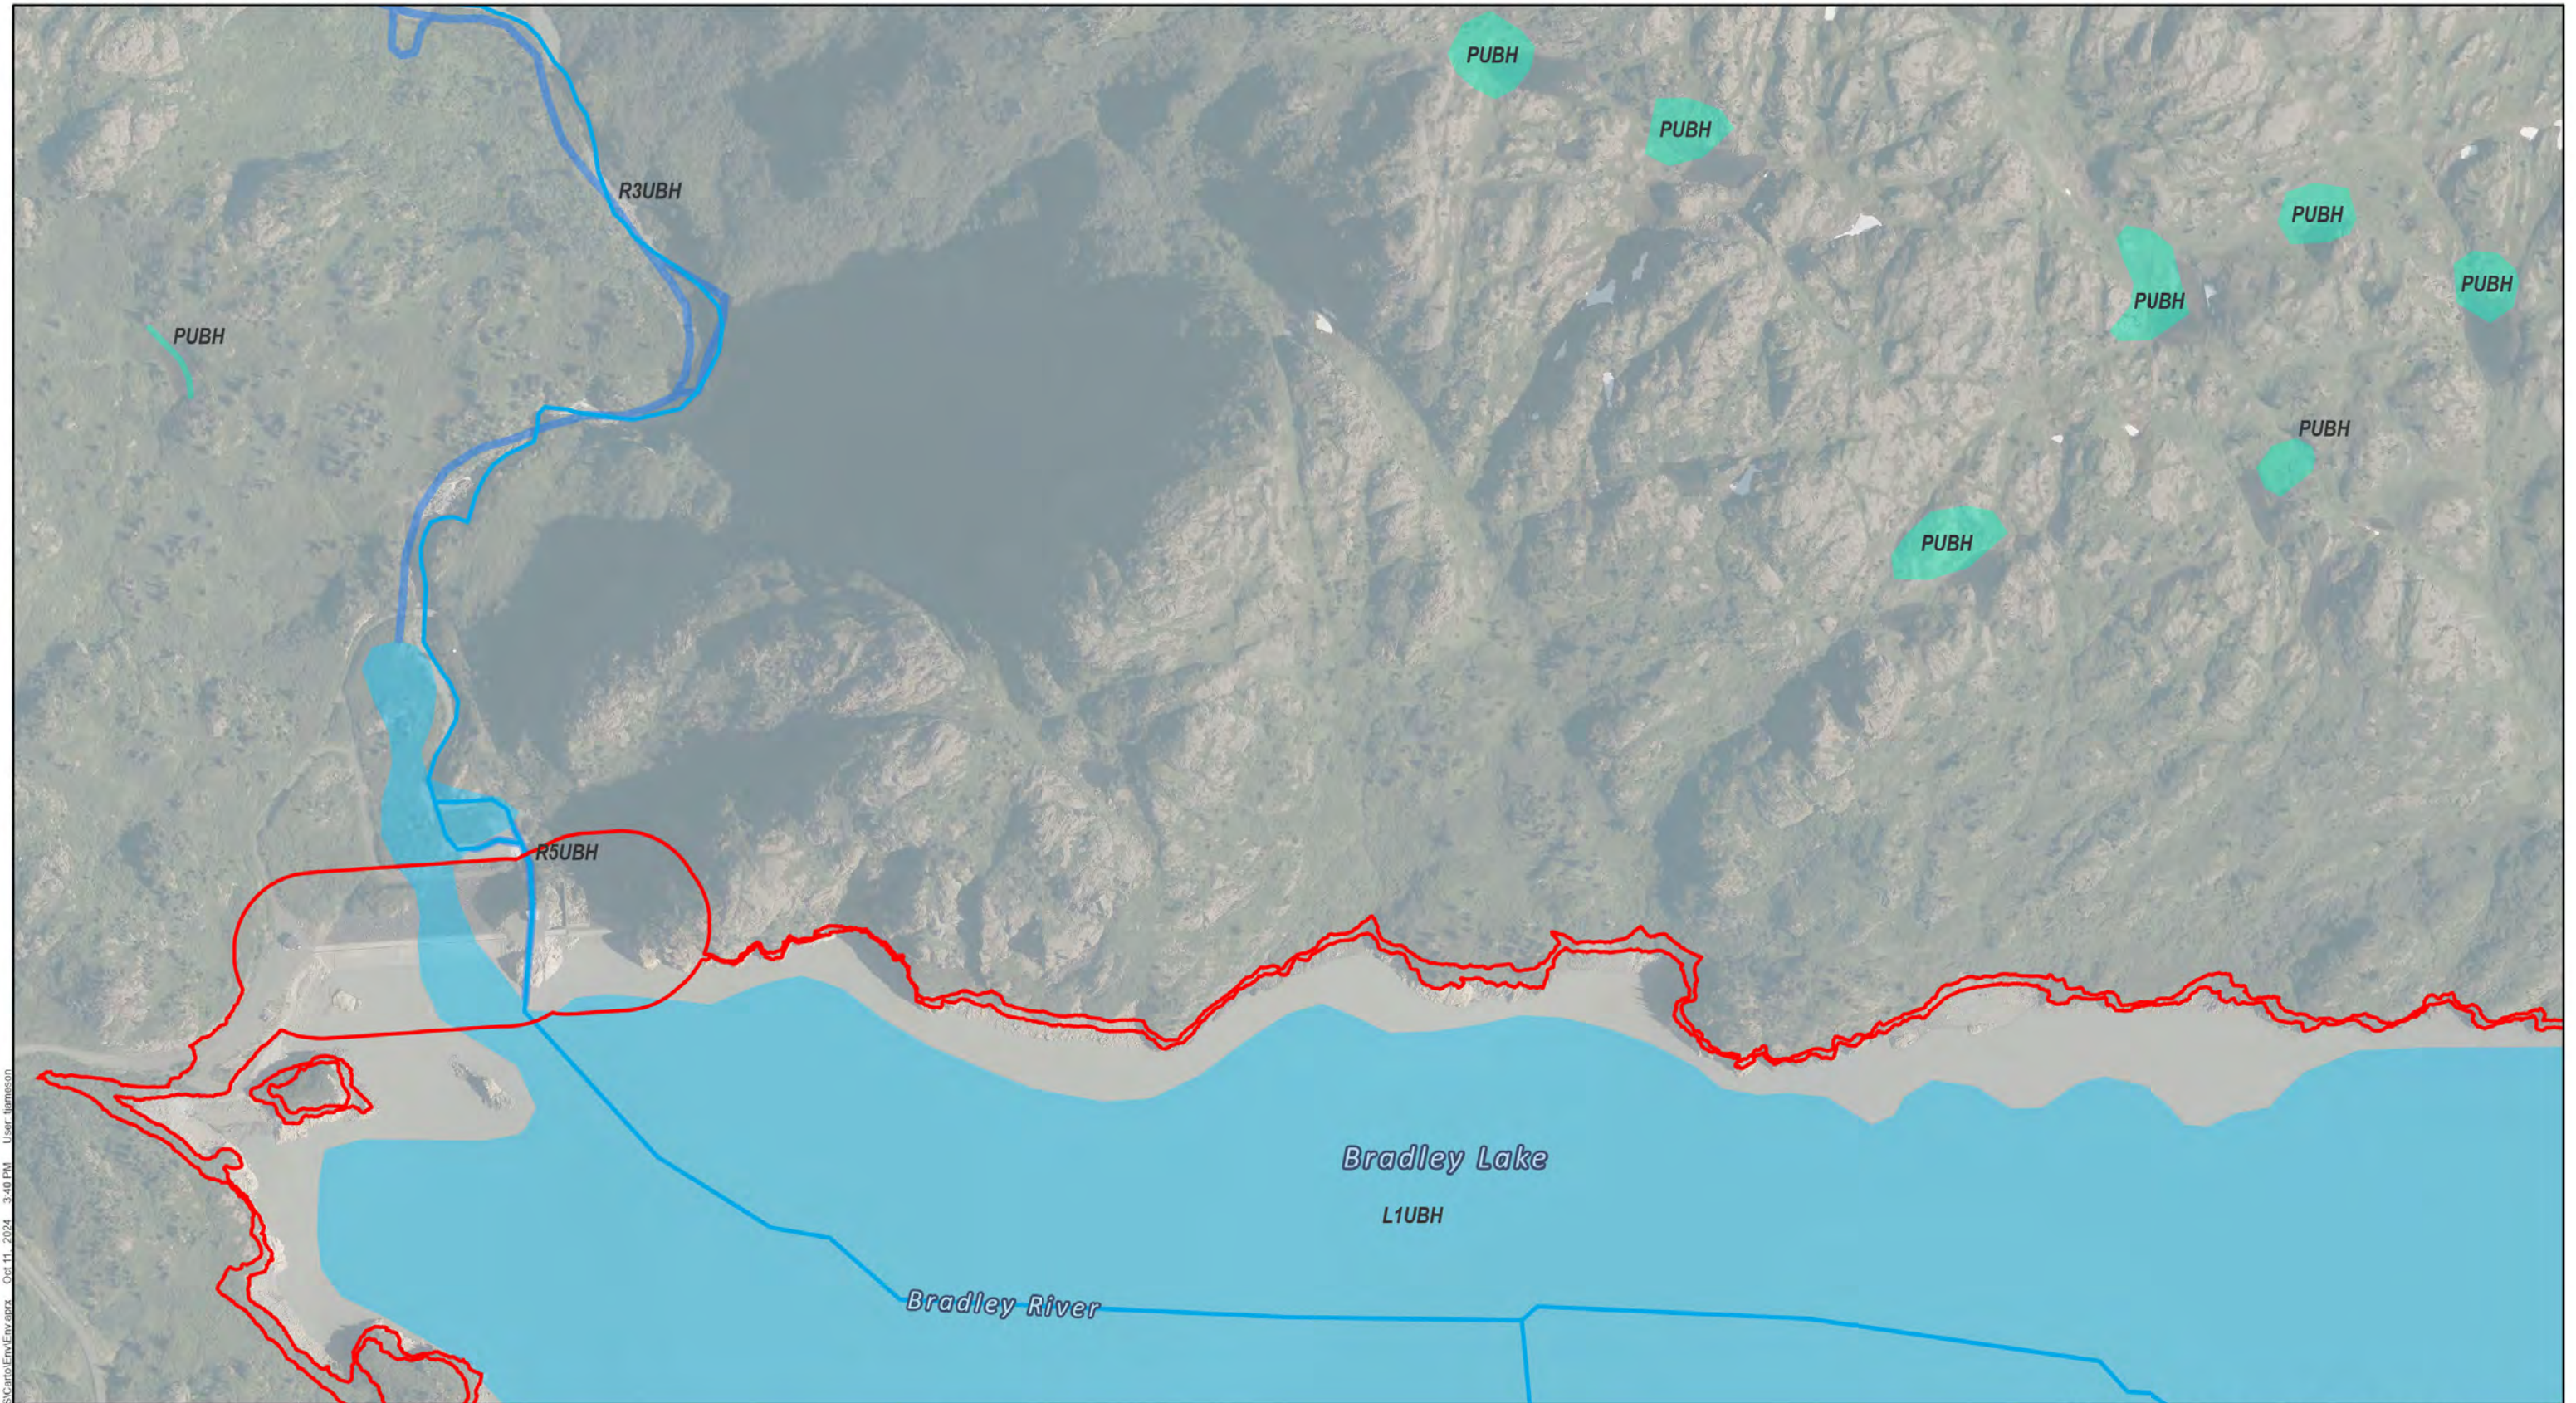
Figure 1

The total study area evaluated for wetlands and aquatic resources is 456.4 acres (Appendix B: Figure 1). The study area is within the Township, Range, and Sections in the Seward Meridian listed in Table 3-1.

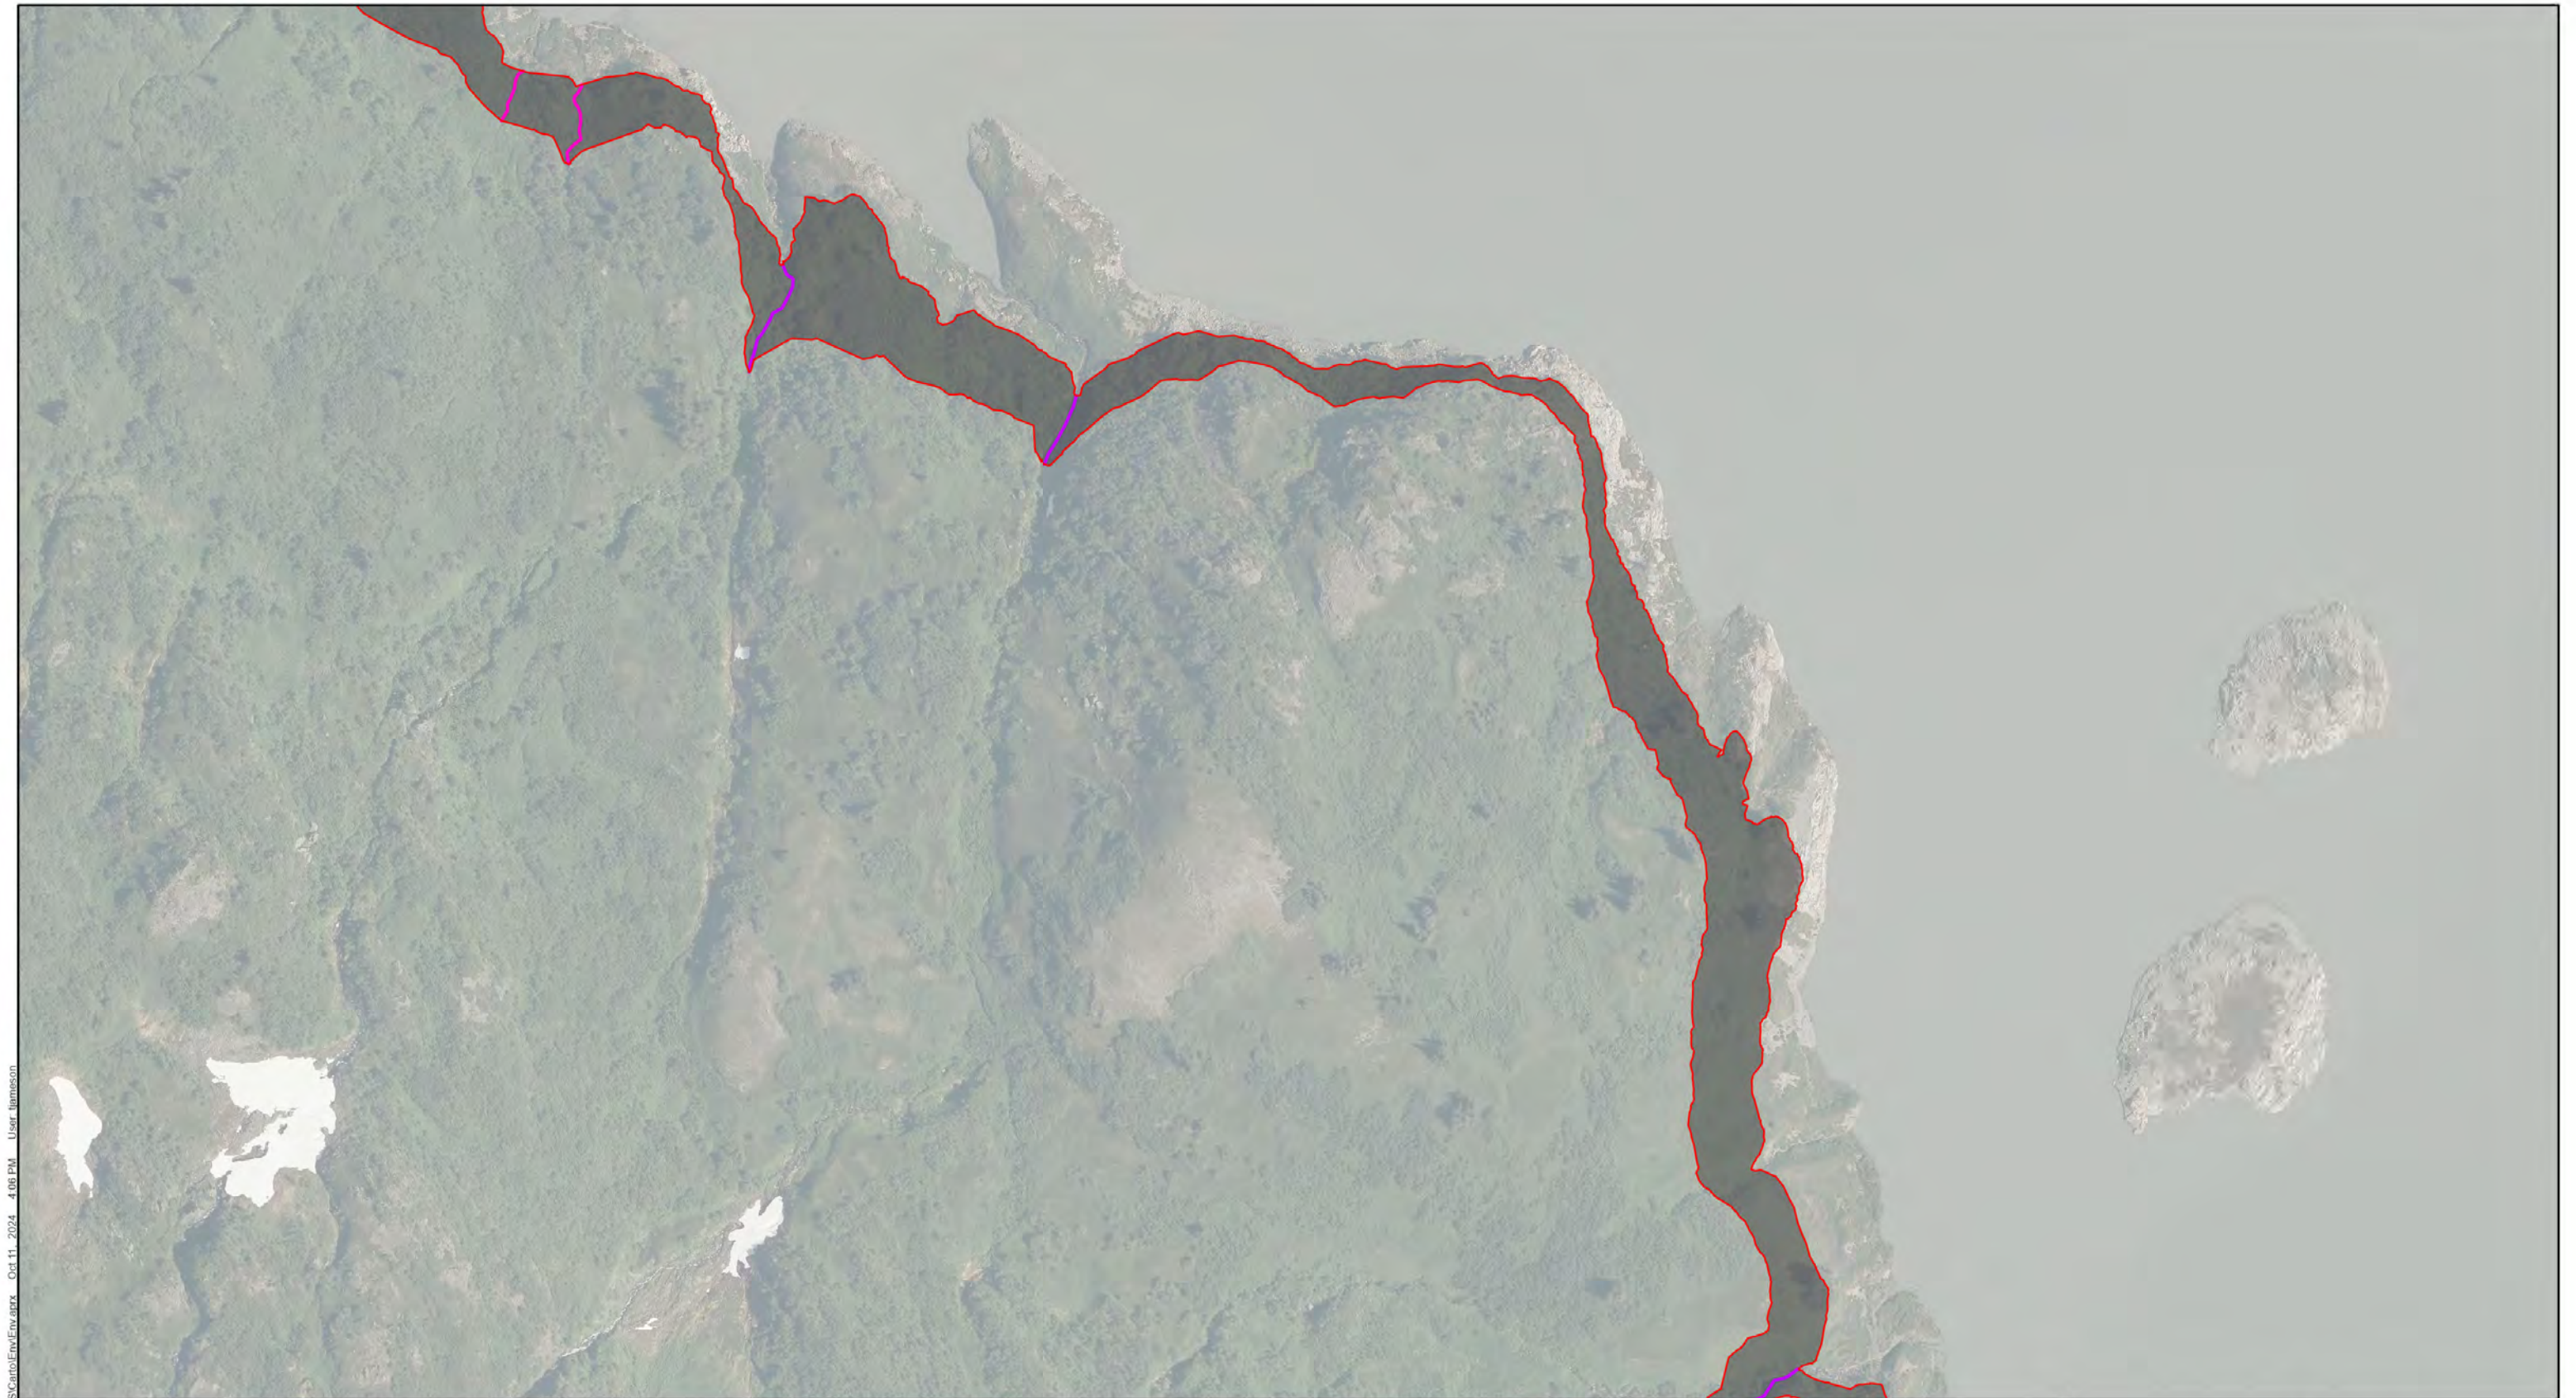
Date: October 2024  
Figure 4.20

<b>Study Area</b> Study Area	<b>Field Point</b> Photo Point (Upland) Sample Point (Wetland)	<b>DOWL Mapped Stream (Cowardin)</b> R3UBH R4SBC	<b>DOWL Mapped Wetland (Cowardin)</b> PSS1B Upland	<b>DOWL Mapped HGM</b> Slope Slope <b>Wetland Mapping</b> <b>DOWL Mapped HGM</b> Depressional Riverine	
	<b>Wetland Delineation</b>					
	Bradley Lake Wetland Delineation

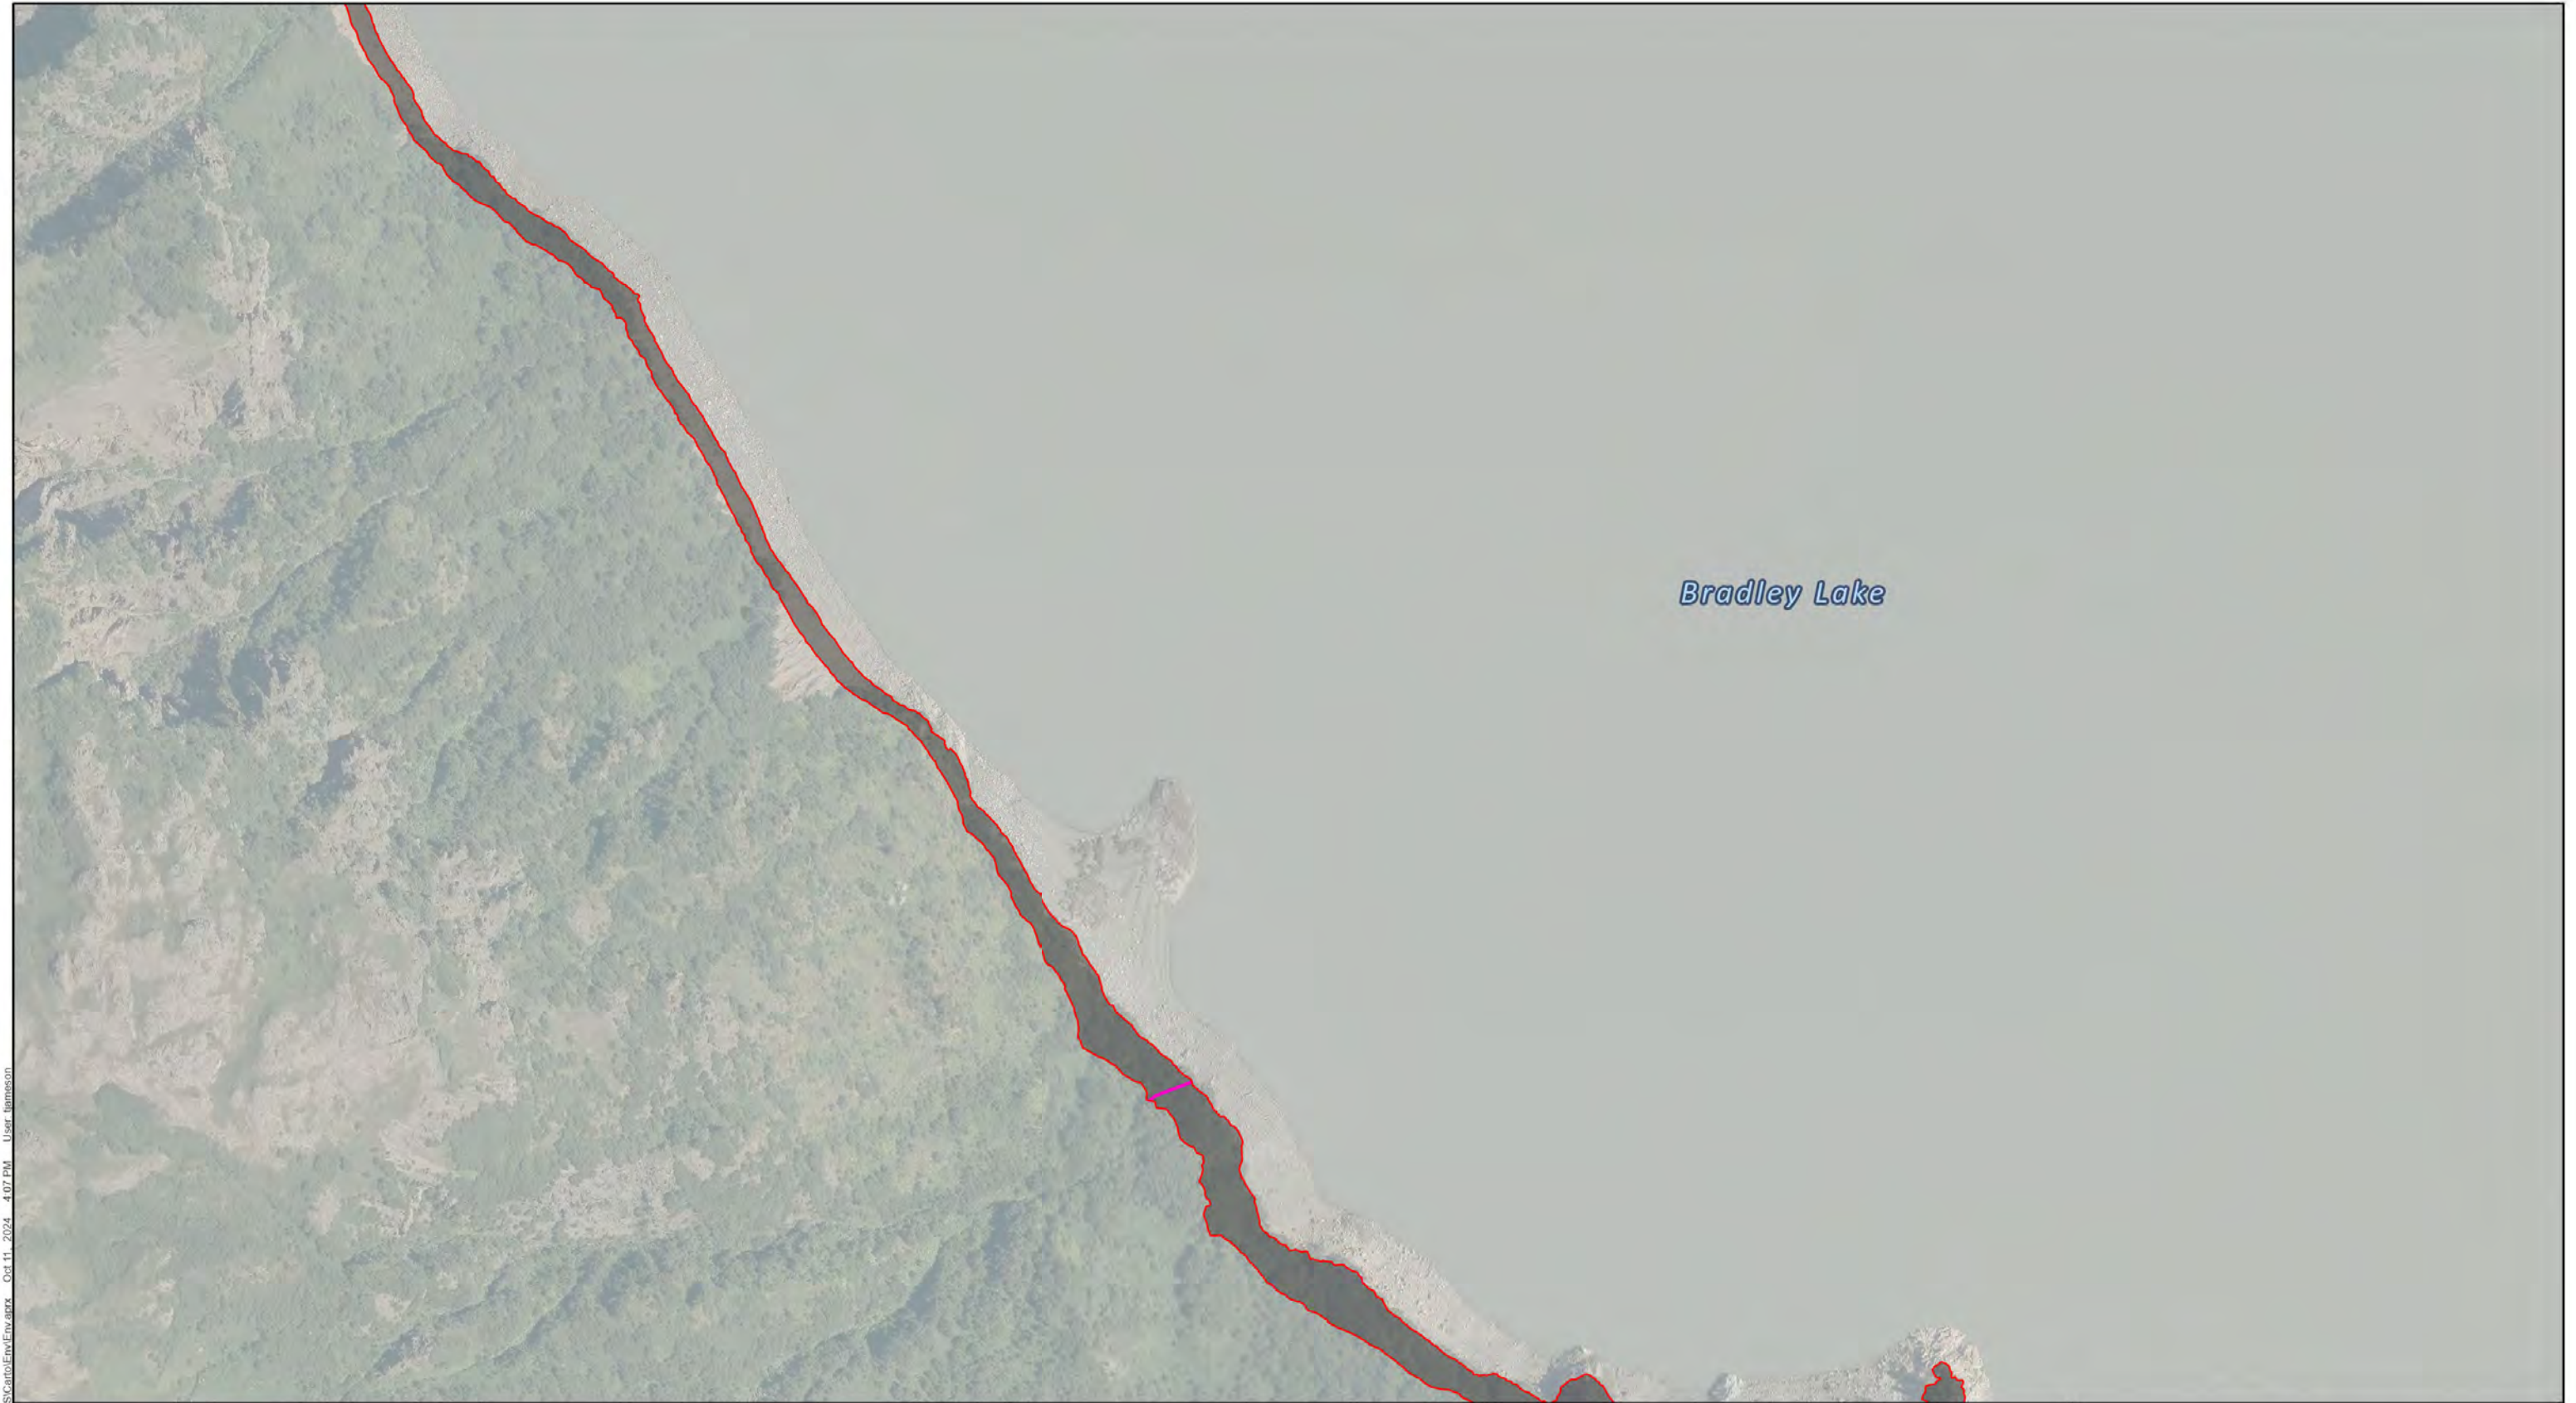
Study Area	<b>DOWL Mapped Stream (Cowardin)</b> R3UBH	<b>DOWL Mapped Wetland (Cowardin)</b> Upland	Riverine Slope		<b>Wetland Delineation</b>	
	<b>Wetland Mapping</b> <b>DOWL Mapped HGM</b> Depressional					Bradley Lake Wetland Delineation	
							Date: October 2024 Figure 4.25
