RE: Bradley Lake Project FERC Project No. 8221  
Dixon Diversion Amendment Terrestrial Study Reports

The Alaska Energy Authority (AEA) is pursuing a Federal Energy Regulatory Commission (FERC) license amendment associated with the existing 120-megawatt Bradley Lake Hydroelectric Project (Bradley Lake Project, FERC No. P-8221). The purpose of the amendment is to gain authorization to increase the Bradley Lake Dam height and divert meltwater from the Dixon Glacier to Bradley Lake to generate additional power. The Bradley Lake Project is located on the Bradley River in the Kenai Peninsula Borough northeast of the town of Homer in Southcentral Alaska. AEA is providing study reports related to terrestrial resources for the proposed license amendment.

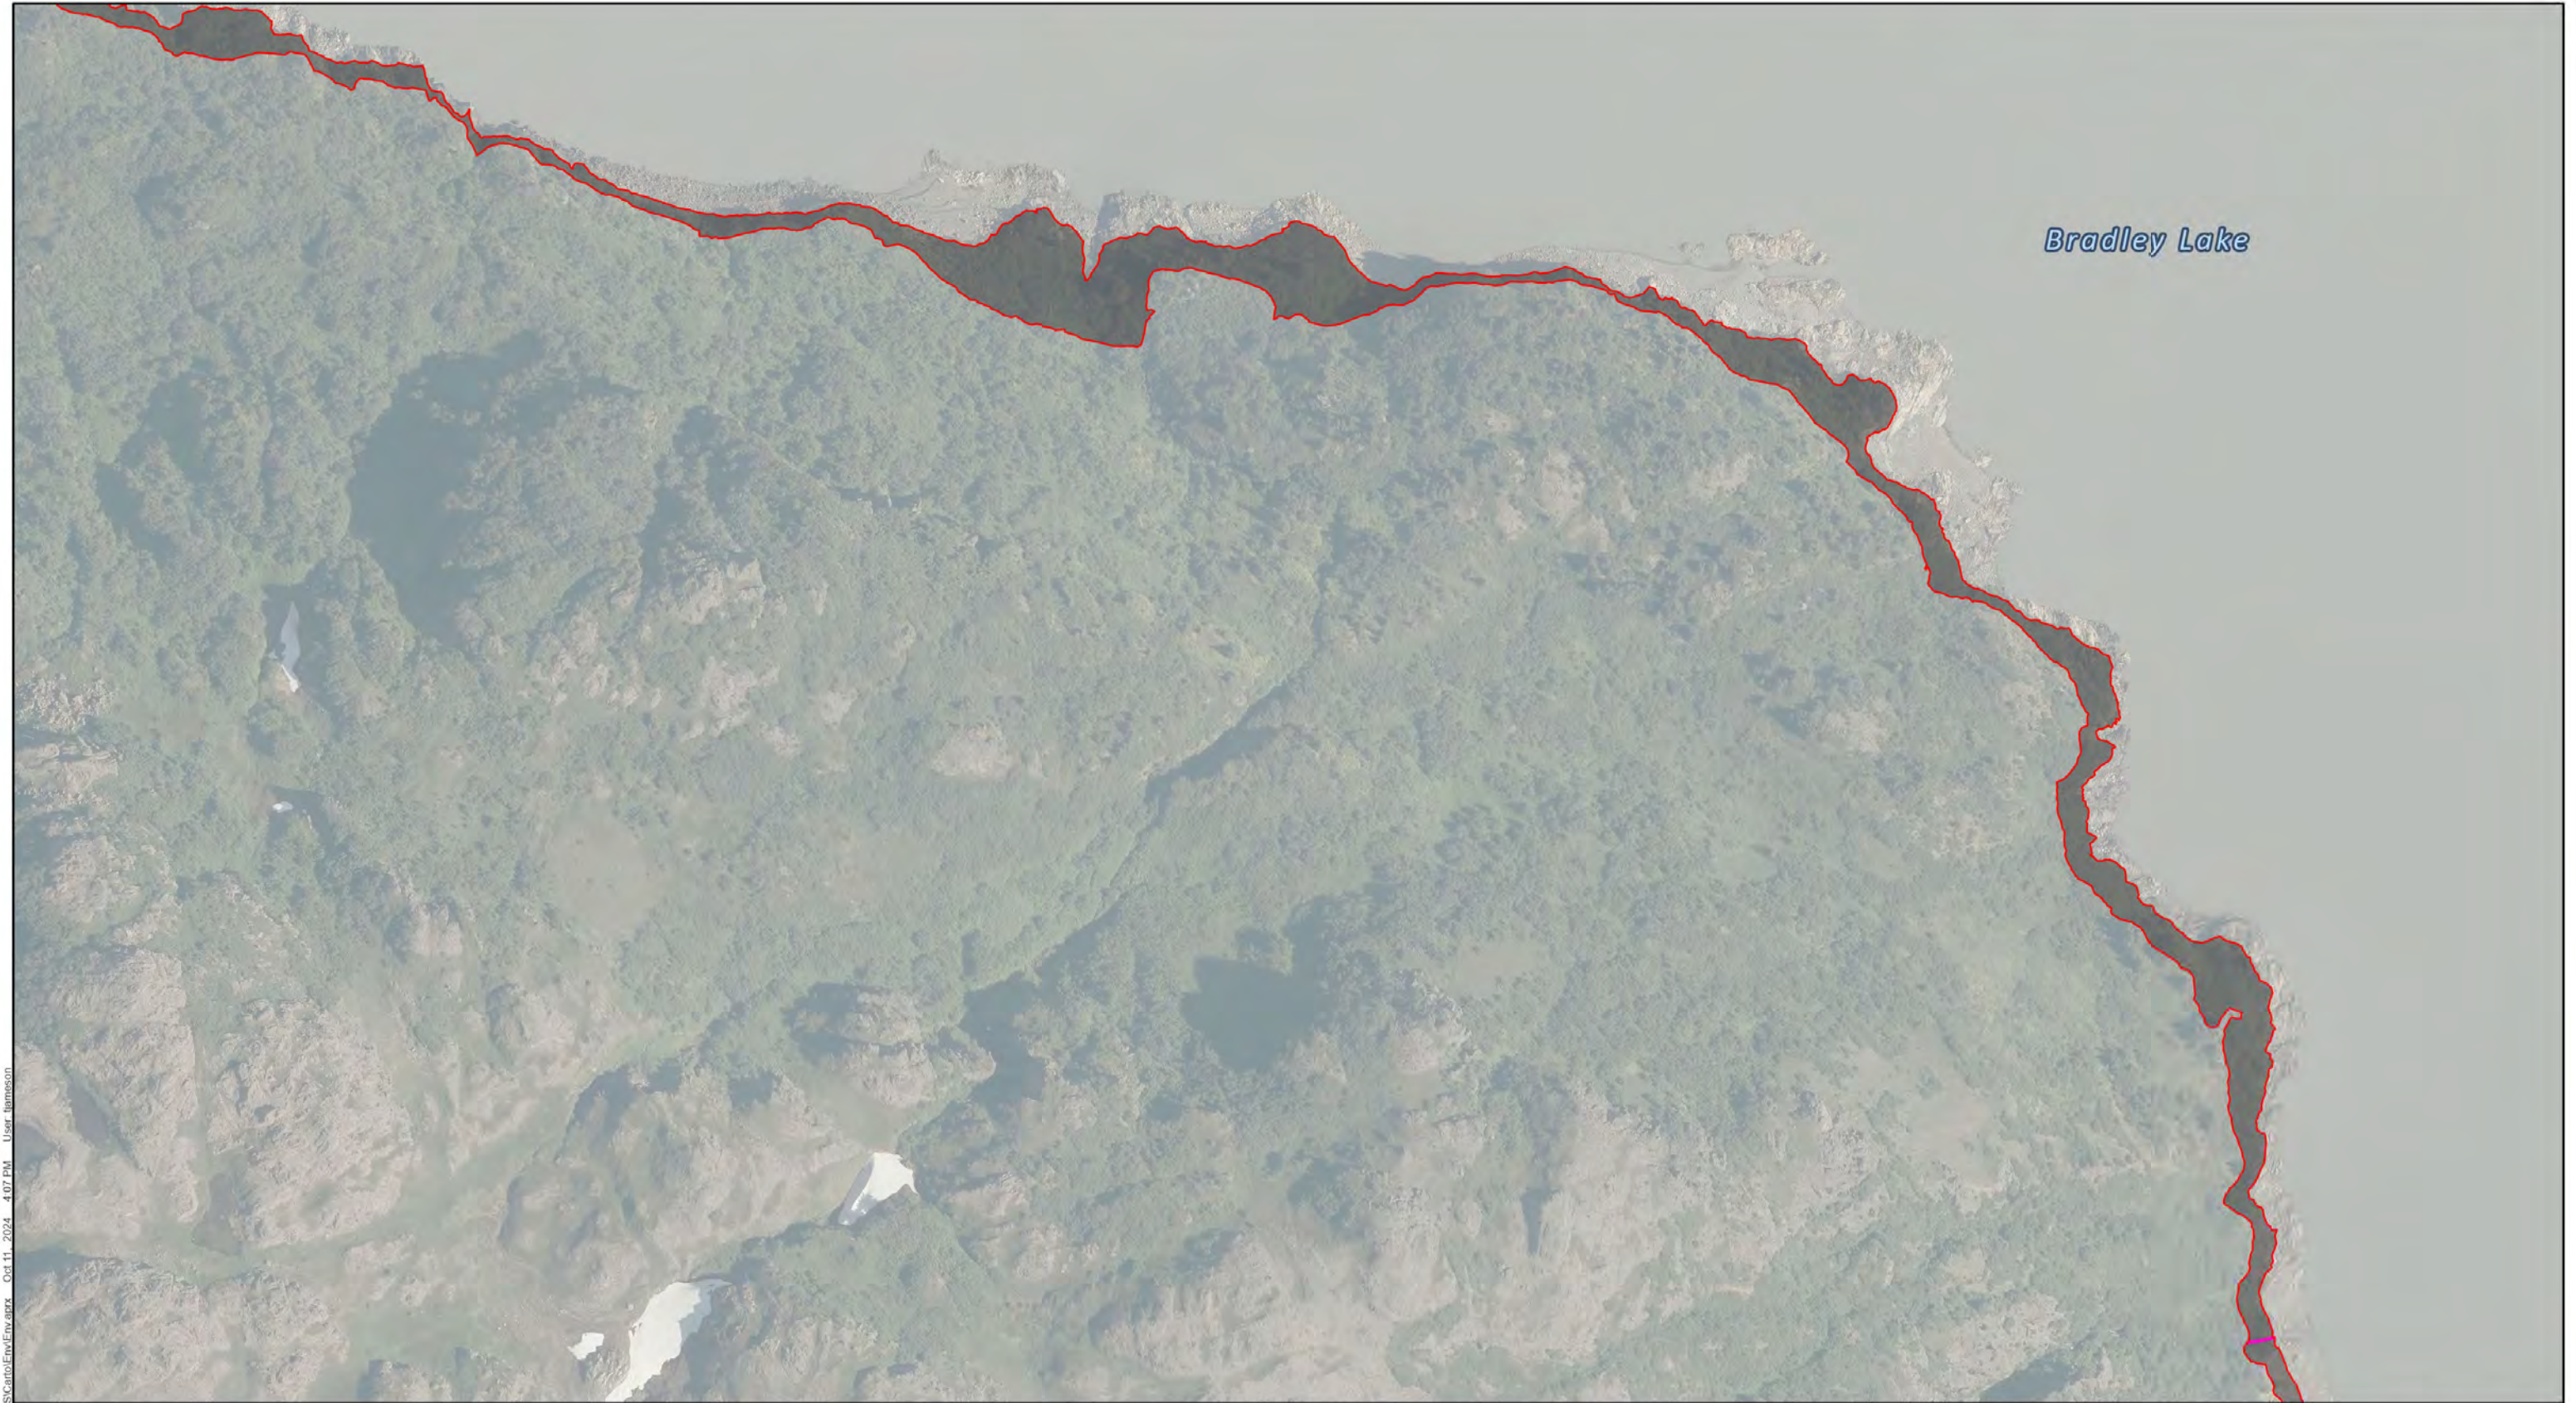
Study Area	<b>DOWL Mapped Stream (Cowardin)</b> R4SBC	<b>DOWL Mapped Wetland (Cowardin)</b> Upland	Riverine Slope		<b>Wetland Delineation</b>	
	<b>Wetland Mapping</b> <b>DOWL Mapped HGM</b> Depressional					Bradley Lake Wetland Delineation	
							Date: October 2024 Figure 4.26

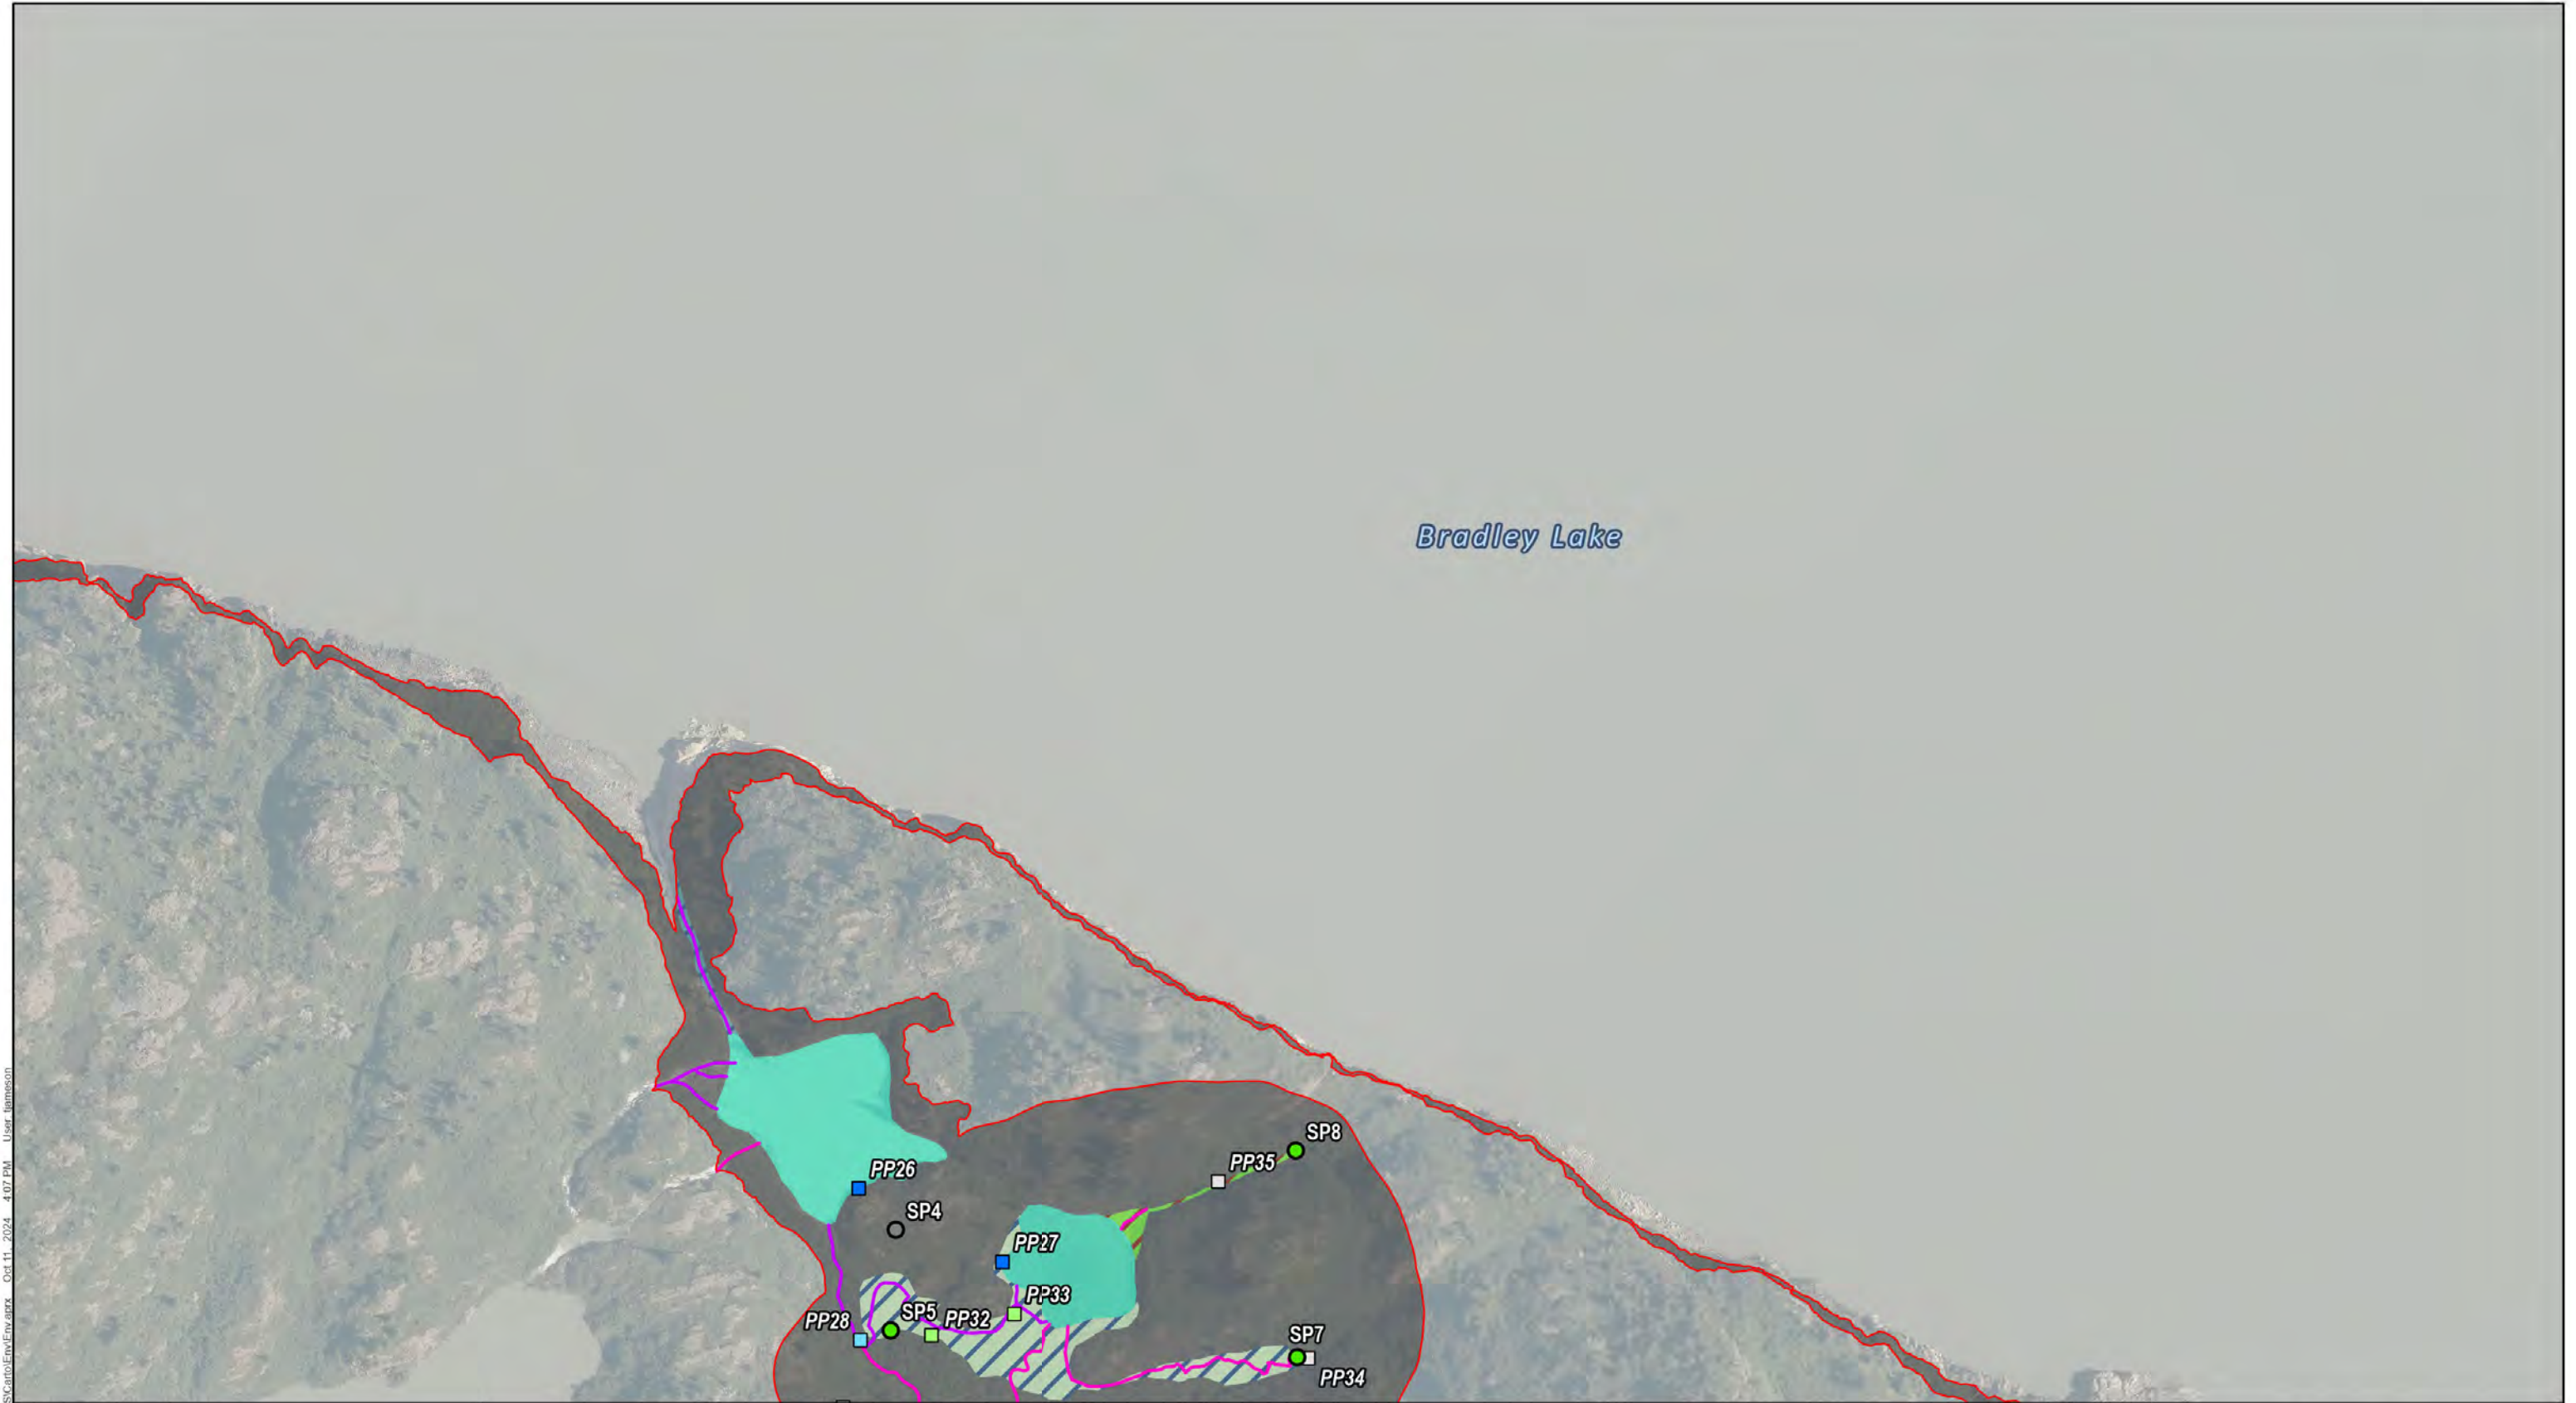
Study Area	<b>DOWL Mapped Stream (Cowardin)</b> R4SBC	<b>DOWL Mapped Wetland (Cowardin)</b> Upland	Riverine Slope	 	<b>Wetland Delineation</b>	
	<b>Wetland Mapping</b> <b>DOWL Mapped HGM</b> Depressional					Bradley Lake Wetland Delineation	
							Date: October 2024 Figure 4.27

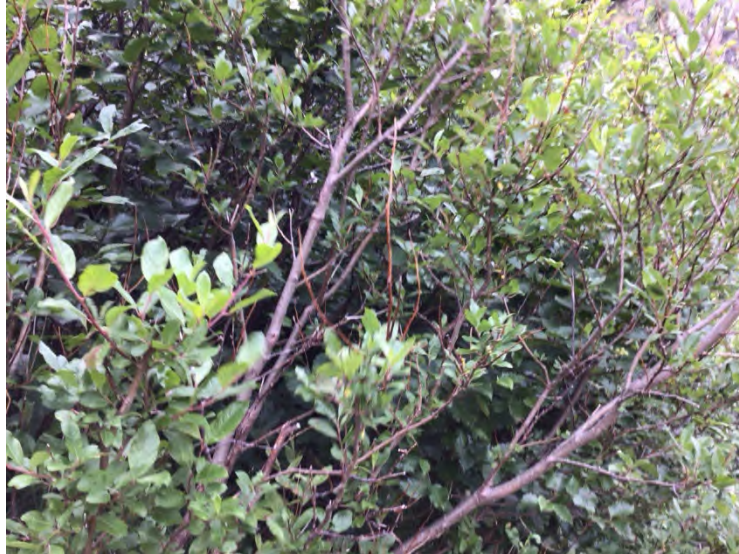
Landscape: FACING EAST

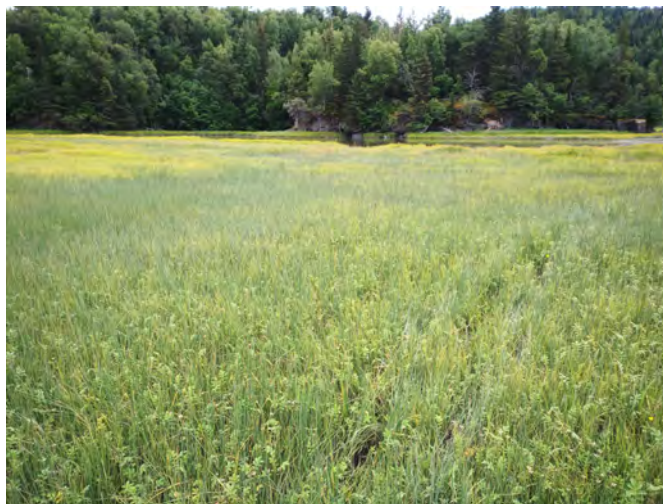
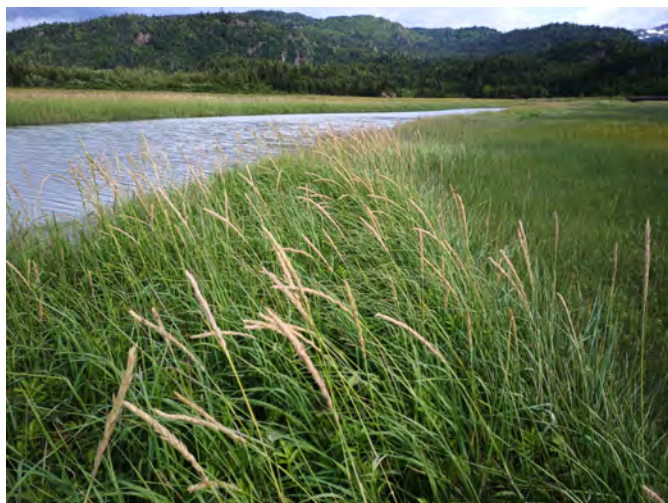
**Sampling Point:** dixon\_02

**Viereck code:** Halophytic Grass Wet Meadow

**Dominant Mineral:** Clayey

**Notes:** Shallow levee next to a tidal gut. Plot dominated by *Leymus mollis*, with a relatively deep rooting zone alternating clayey and sandy layers throughout.

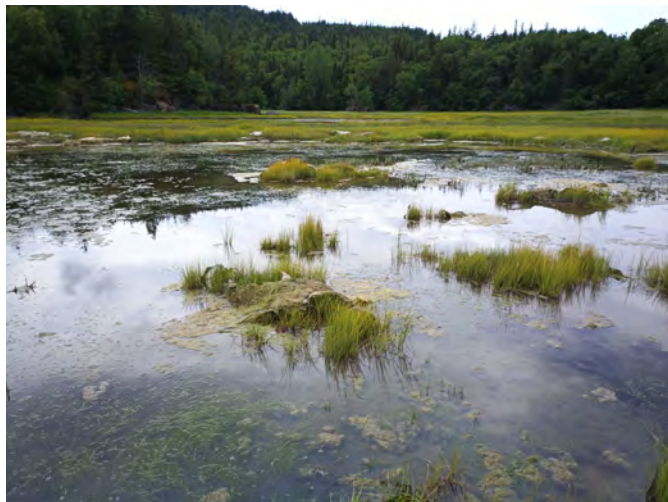
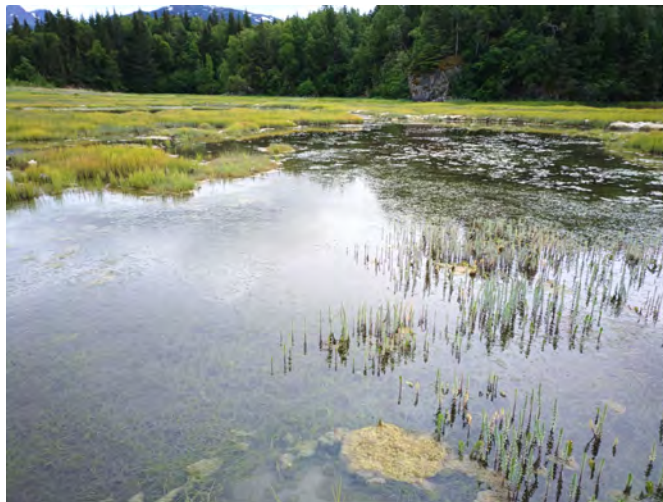
**Sampling Point:** dixon\_04

**Viereck code:** Aquatic Algae

**Notes:** Estuarine pond, with variable depth. Probably not flooded with salt water daily. Dried out algal mats on the edges that suggest the pond only dries out infrequently.

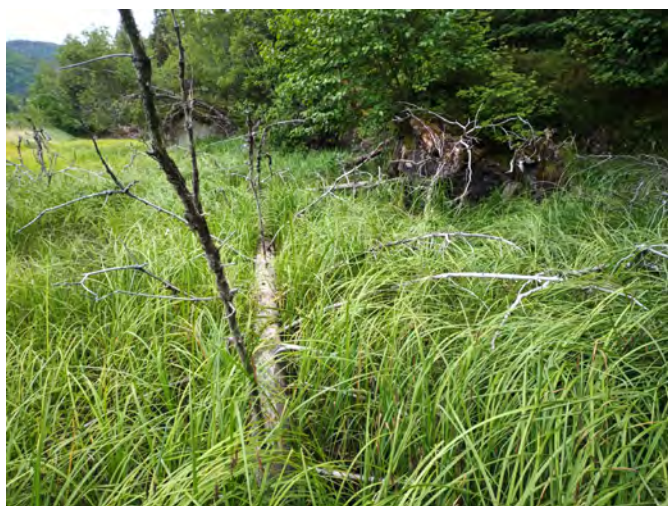
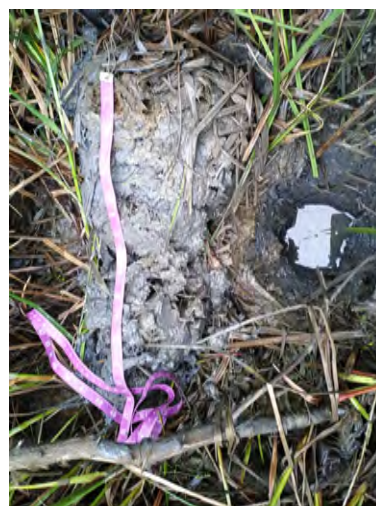
**Sampling Point:** dixon\_05

**Viereck code:** Halophytic Sedge Wet Meadow, brackish

**Dominant Mineral:** Clayey

**Notes:** Narrow band of *Carex lyngbyei* next to the forest. Soils with a relatively deep rooting zone and marine clays. Hydrogen sulfide odor and gleyed soil colors.

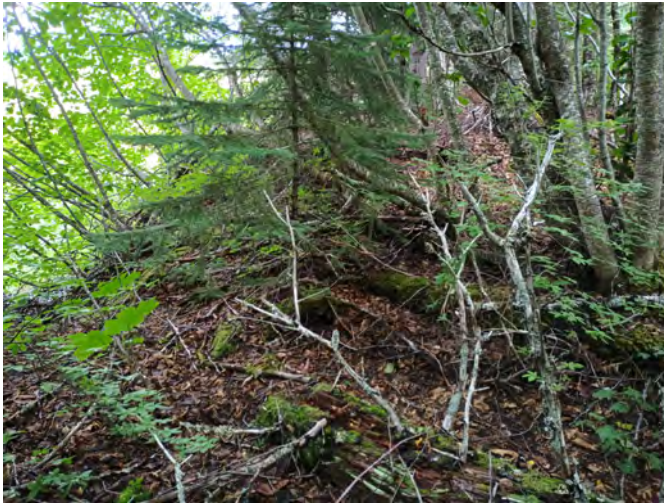
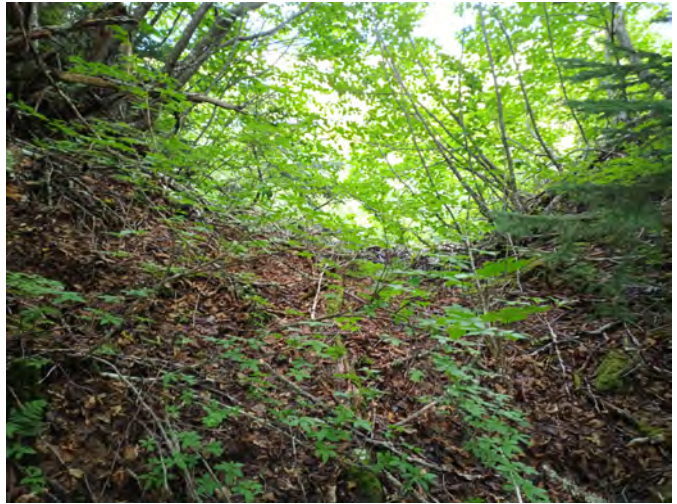
**Sampling Point:** dixon\_06

**Dominant Mineral:** Loamy

**Notes:** Plot located 5 feet into the forest from the salt marsh, up a steep little draw. Most of the "shoreline" in this area is a rocky cliff.

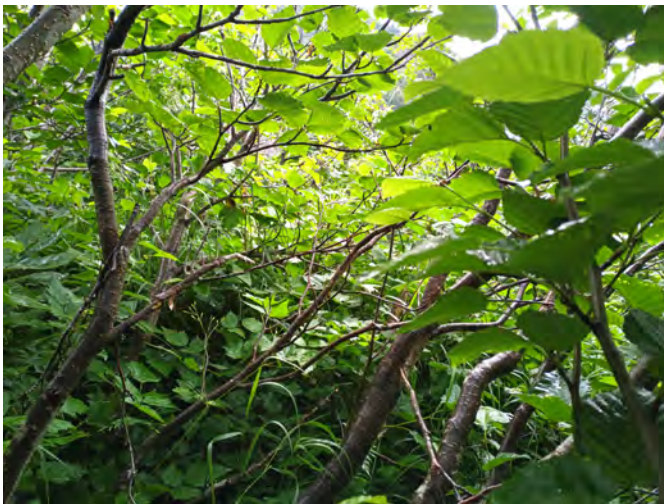
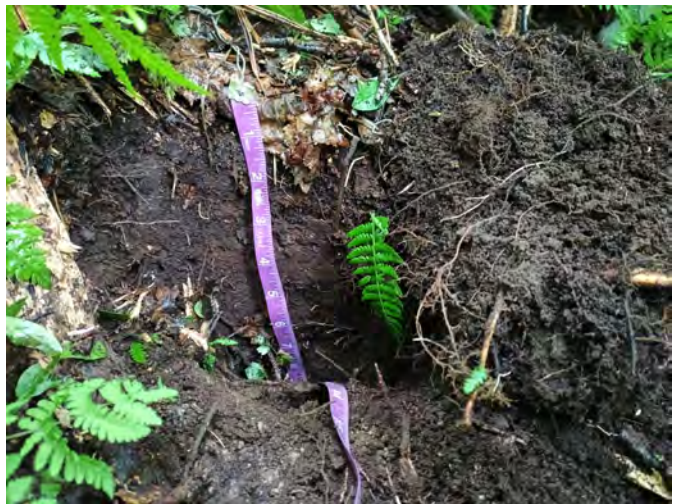
**Sampling Point:** dixon\_07

**Dominant Mineral:** Loamy

**Notes:** Closed alder community in a draw, located off the access road bordering a small stream. Soils consist of shallow surface organics over organic rich loam.

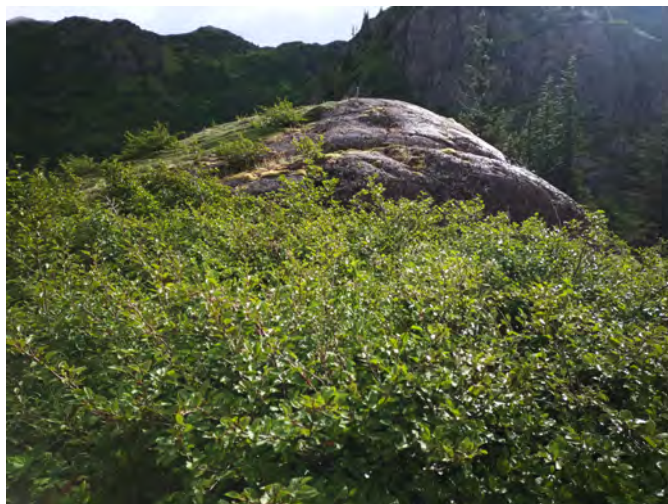
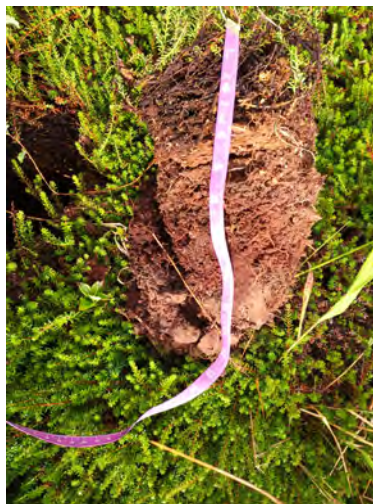
**Sampling Point:** dixon\_08

**Viereck code:** Open Low Alder

**Dominant Mineral:** Loamy

**Notes:** Plot located almost at the top of a rocky outcrop, representative of the habitat mosaic including bare rock, tundra, and tall shrub. Crustose lichen counted

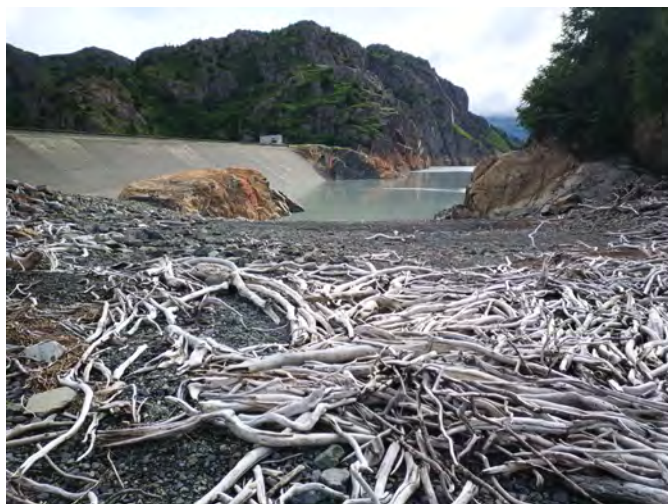
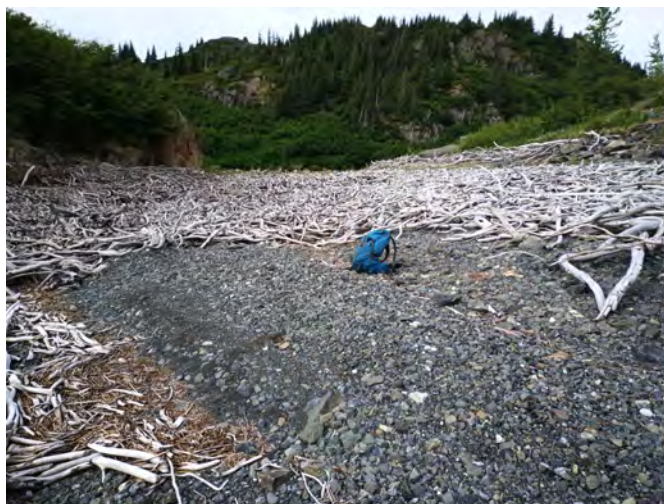
**Sampling Point:** dixon\_09

**Viereck code:** Barren

**Dominant Mineral:** Rubbly

**Notes:** Plot within the reservoir inundation zone. Plot is on a cobble beach with significant wrack deposits. Lake shoreline

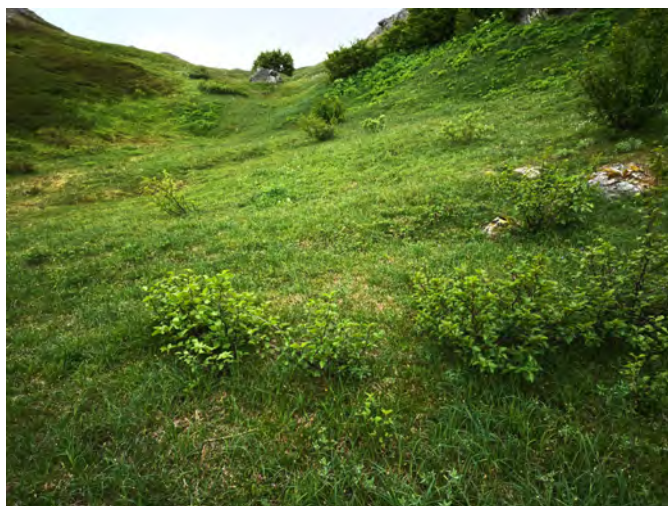
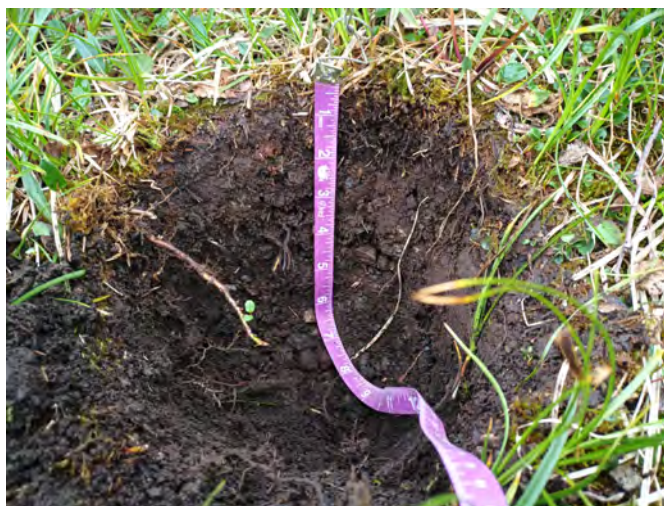
**Sampling Point:** dixon\_10

**Viereck code:** Moist Sedge Meadow Tundra

**Dominant Mineral:** Gravelly

**Notes:** An alpine forb meadow at the headwaters of a tiny stream. Soils have 4 inches of organic development above angular gravelly loam.

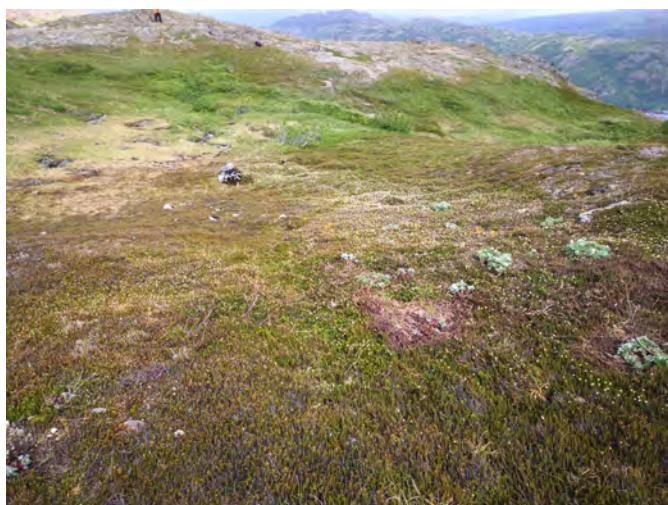
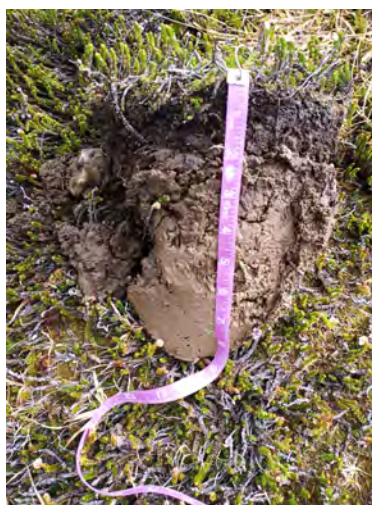
**Sampling Point:** dixon\_11

**Viereck code:** Cassiope Dwarf Shrub Tundra

**Dominant Mineral:** Loamy

**Notes:** Heather meadow adjacent to the forb meadow described at plot 10 on a convex ridge.

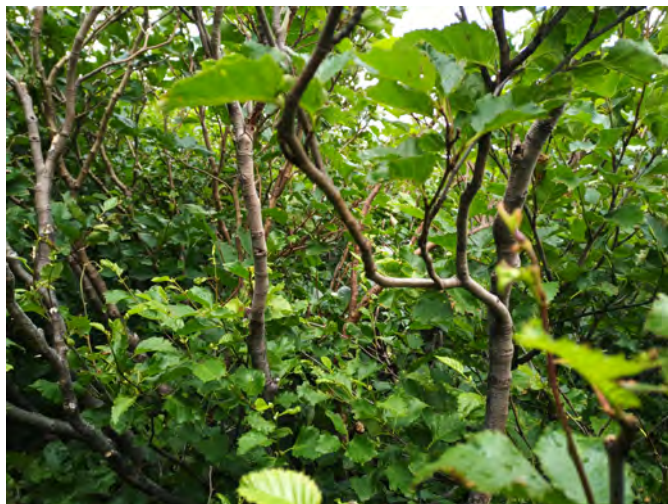
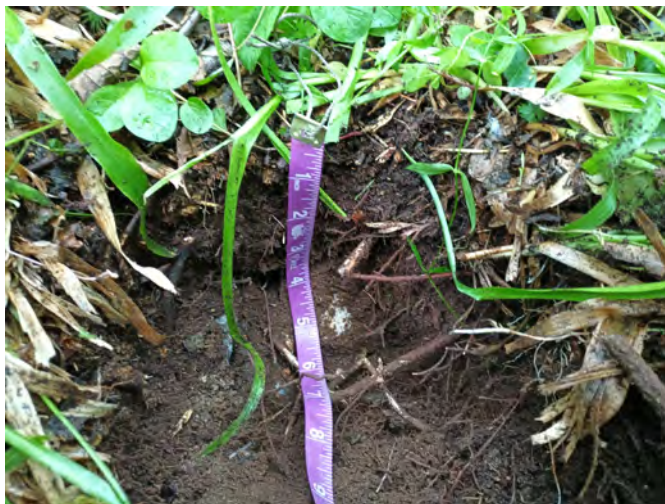
**Sampling Point:** dixon\_12

**Viereck code:** Closed Tall Alder

**Dominant Mineral:** Rubbly

**Notes:** Closed alder at the top of a draw. Plot in steep terrain extending to cliffs above the reservoir. Soils consist of a shallow rooting zone over weathered bedrock.

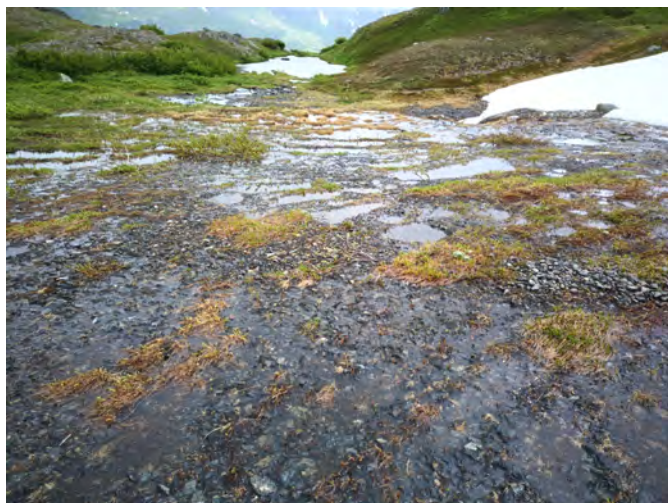
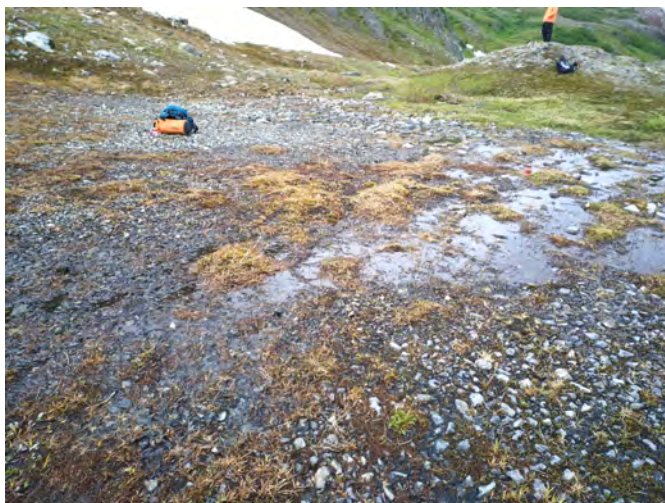
**Sampling Point:** dixon\_14

**Viereck code:** Subarctic Lowland Sedge Wet Meadow

**Dominant Mineral:** Rubbly

**Notes:** Hydrology source is a combination slope discharge and snowmelt in stream headwaters. Vegetation is patchy with exposed weathered bedrock and shallow surface water. Sheet flow present. Snowbed

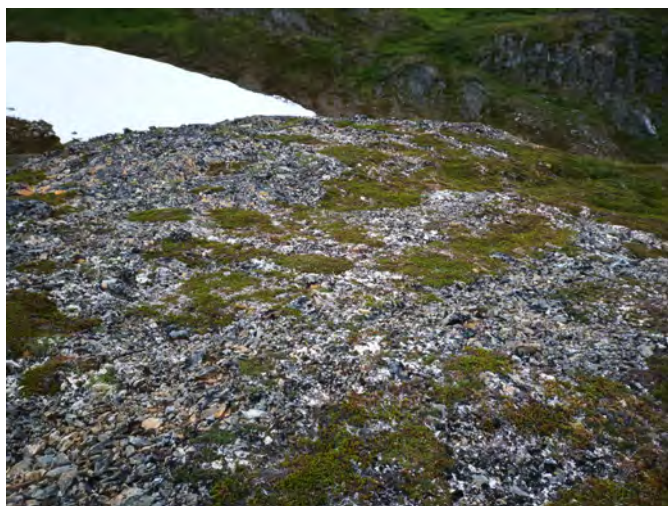
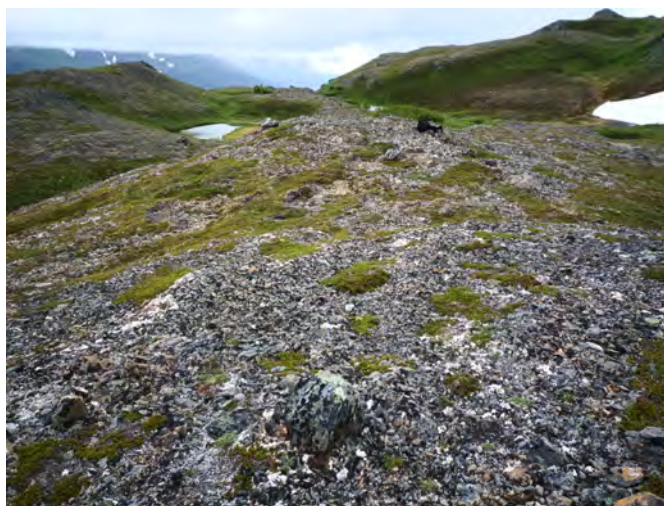
**Sampling Point:** dixon\_15

**Viereck code:** Ericaceous-Lichen Dwarf Shrub Tundra

**Dominant Mineral:** Gravelly

**Notes:** Plot is located on a ridge top, and is partially vegetated with exposed bedrock and gravel.

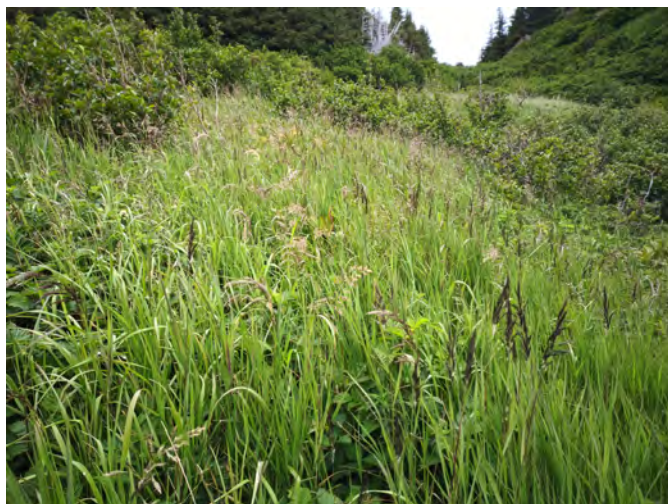
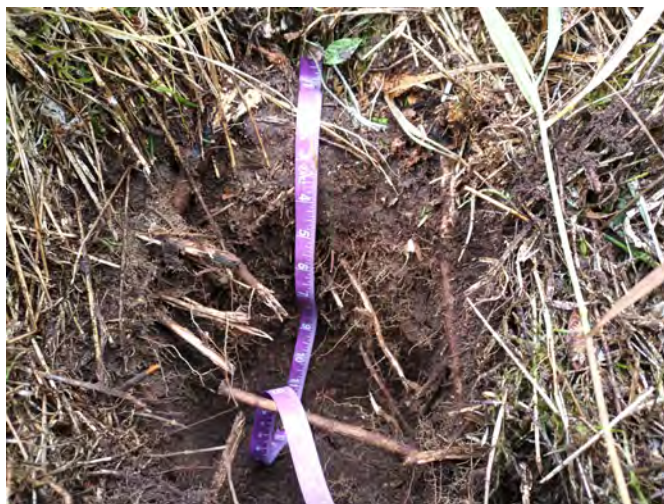
**Sampling Point:** dixon\_16

**Viereck code:** Open Low Shrub

**Dominant Mineral:** Sandy

**Notes:** Site is a steep forb/grass meadow, with soils consisting of 8 inches of rooting zone organics over sandy mineral soil with lots of organics.

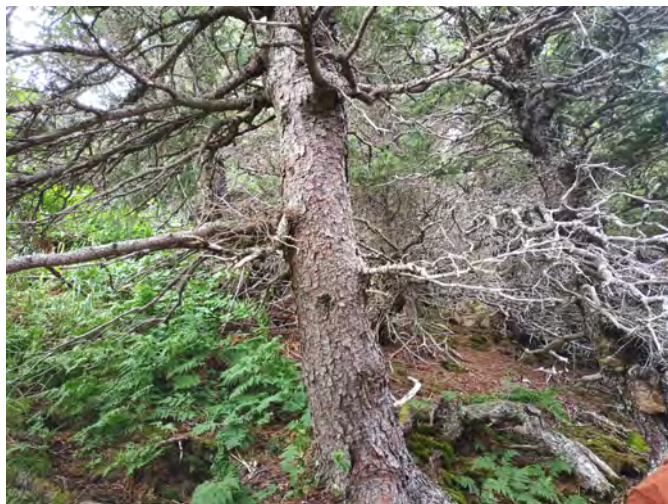
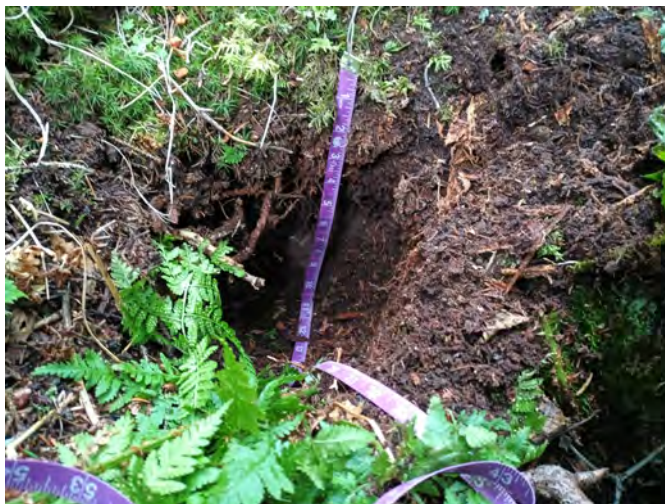
**Sampling Point:** dixon\_17

**Viereck code:** Open Lutz Spruce

**Dominant Mineral:** Loamy

**Notes:** Plot is located in a thin patch of Lutz spruce on a steep ridgeline, with thin organics over loam.

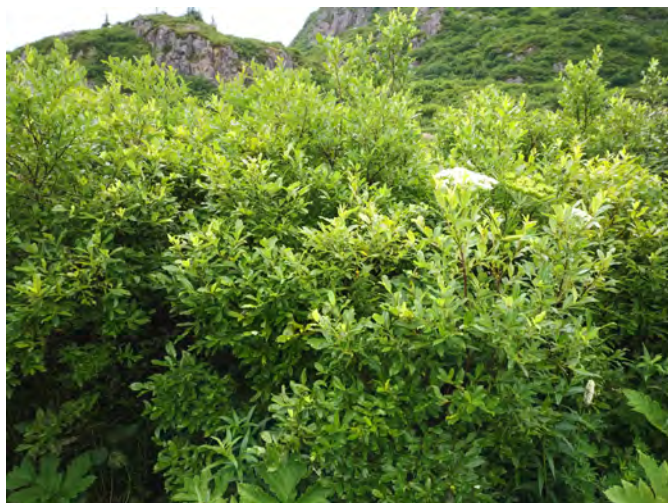
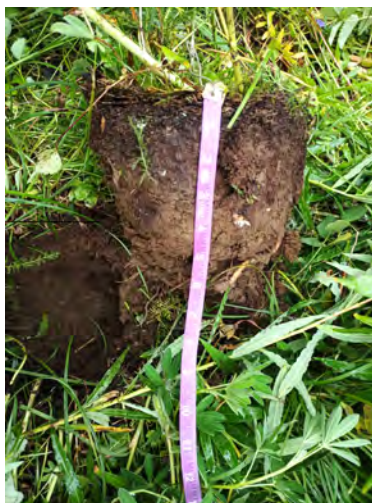
**Sampling Point:** dixon\_18

**Viereck code:** Closed Tall Willow

**Dominant Mineral:** Loamy

**Notes:** Site is in a willow margin to an inundated wetland, next to a laydown pad for the road construction. Soils are made up of shallow organics over loamy sand.

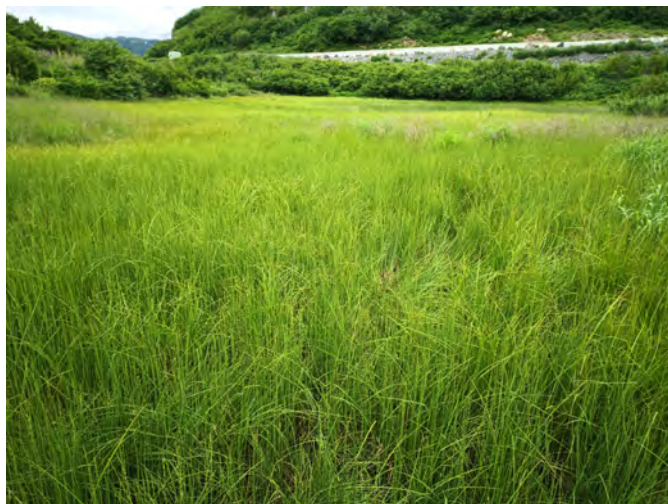
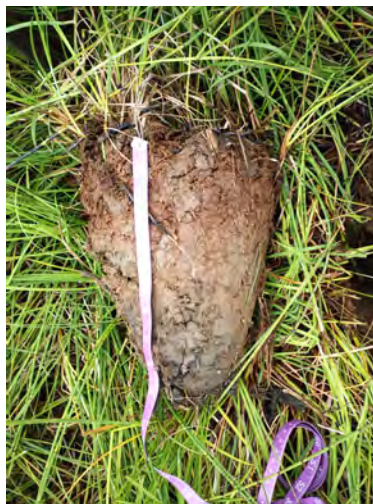
**Sampling Point:** dixon\_19

**Dominant Mineral:** Loamy

**Notes:** Plot located in a sedge/horsetail meadow that should be more or less flooded but there is no evidence of a shallow water table within the first 12 inches. No water in the pit and a relatively shallow organic layer.

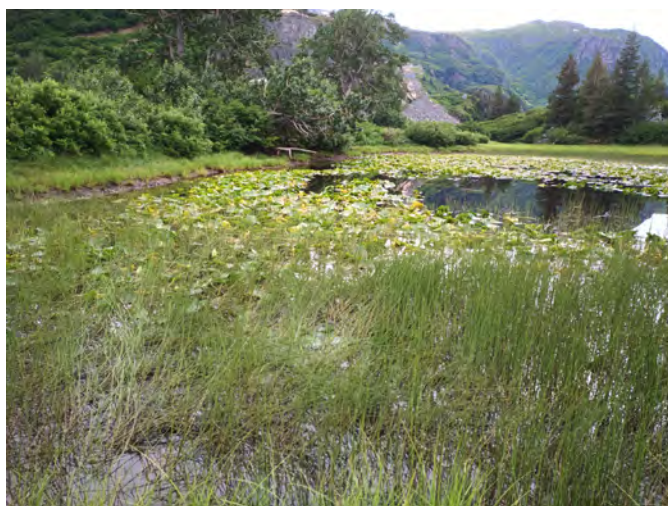
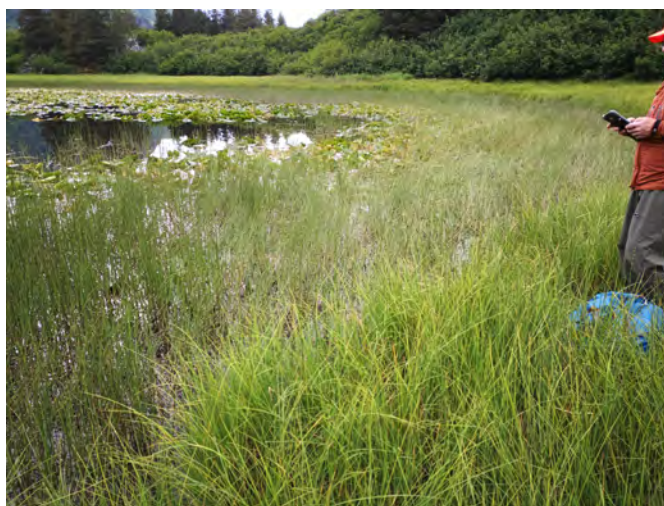
**Notes:** Nuphar (pond lily) pond adjacent to sedge meadow described by dixon\_19. The pond water level appears to be 6 inches lower than normal, perhaps related to the drier than normal sedge meadow. Pond with emergents

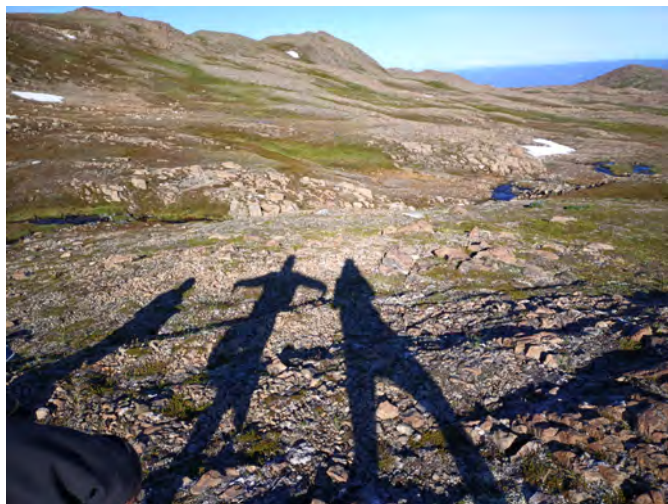
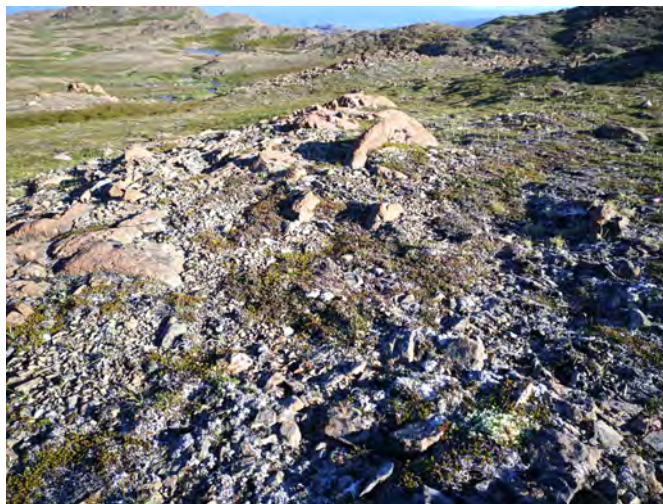
**Sampling Point:** dixon\_22

**Notes:** Site located on a partially vegetated outcrop\ridge. No soil pit as the site is mostly exposed bedrock with patchy vegetation.

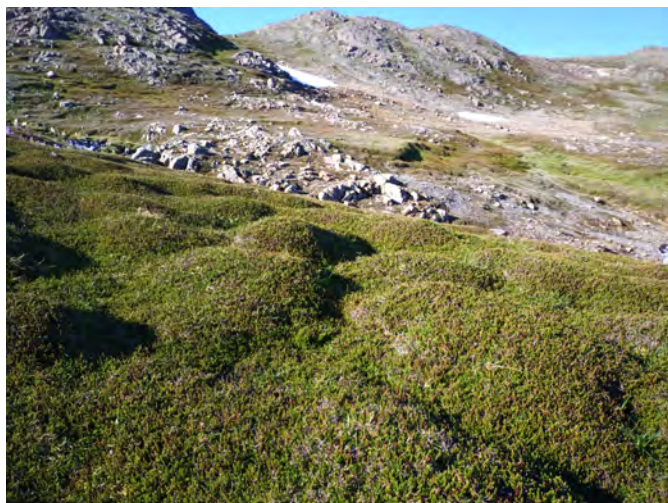
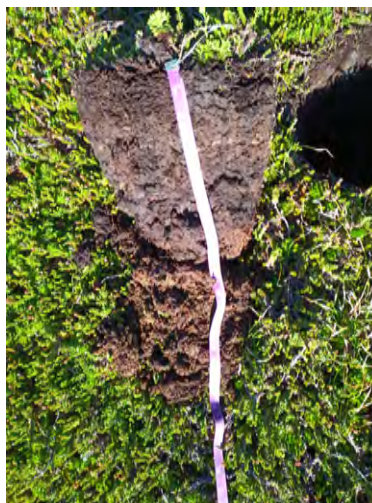
**Sampling Point:** dixon\_23

**Notes:** Plot in a small patch of hummocks supporting Cassiope. Soils are loamy with organics mixed in to 8 inches.

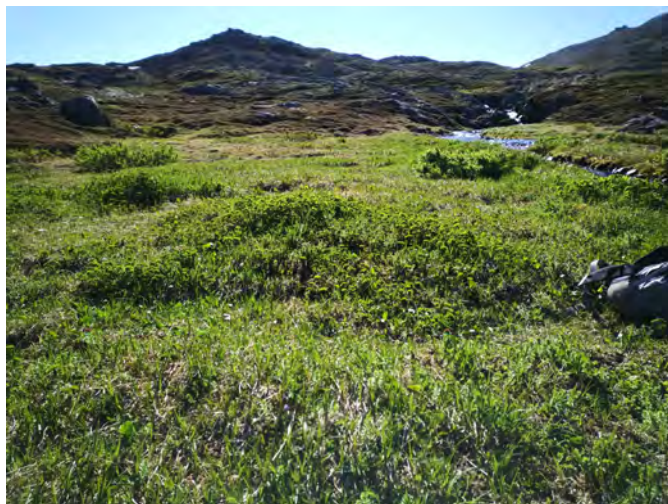
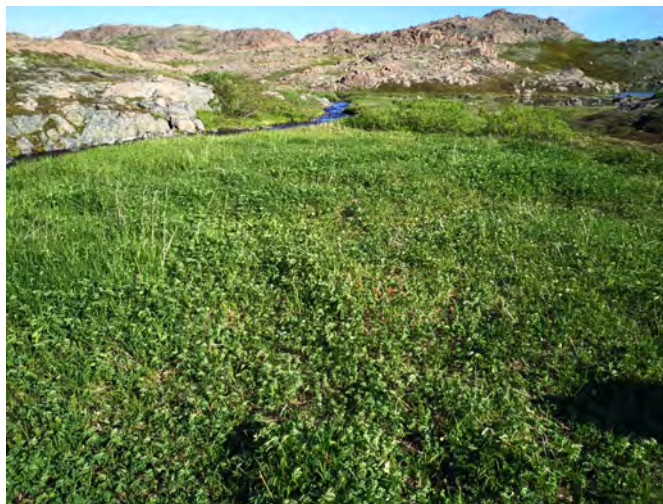
**Sampling Point:** dixon\_25

**Notes:** A riverbank supporting a forb community. Soils consist of an organic mat over sandy and gravels very high organic content.

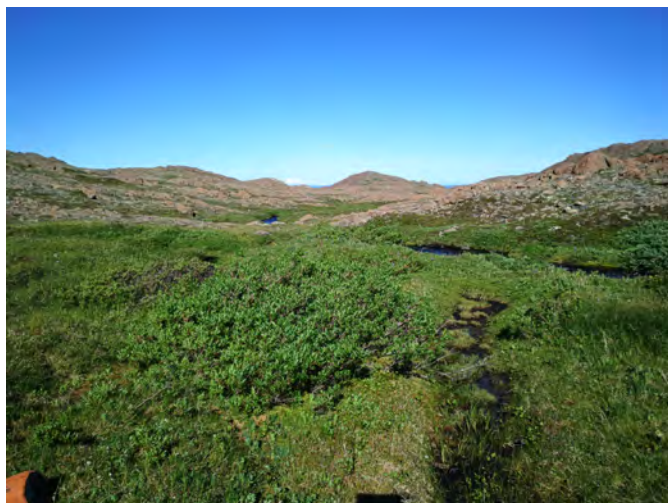
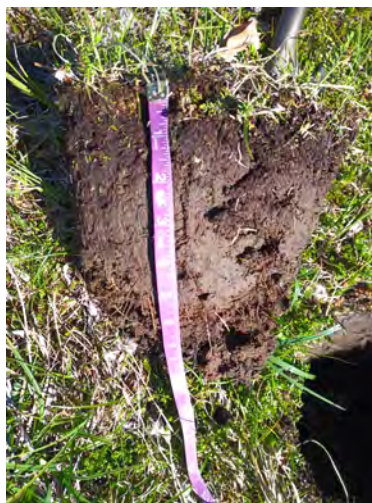
**Sampling Point:** dixon\_27

**Notes:** Streambank with forbs and low willow patches. Soils are shallow organics over loam with high organic content. The mineral layer is moist but not quite saturated. Water is a stream bisecting plot

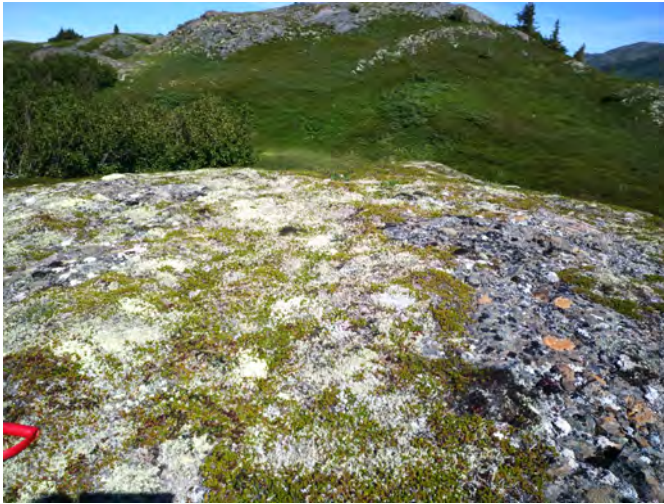
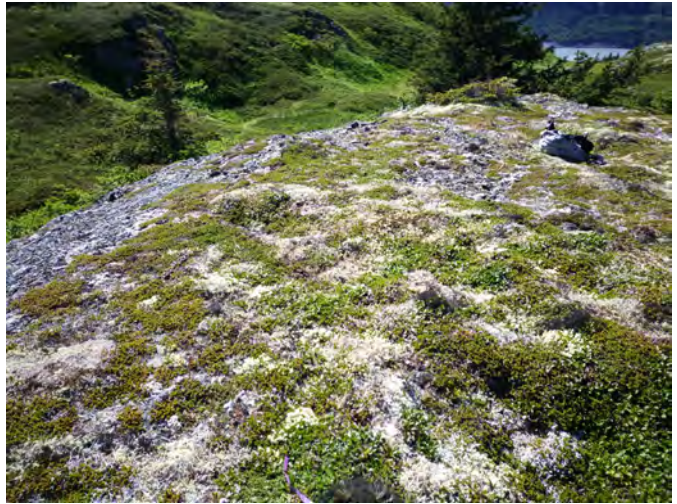
**Sampling Point:** dixon\_28

**Notes:** Plot located at the crest of a knoll within undulating terrain. A component of a subalpine mosaic with small patches of spruce, low shrub, dwarf shrub tundra, lichen tundra, and partially vegetated ground. Lichen covered stoney outcrop
