RE: Bradley Lake Project FERC Project No. 8221  
Dixon Diversion Amendment Terrestrial Study Reports

The Alaska Energy Authority (AEA) is pursuing a Federal Energy Regulatory Commission (FERC) license amendment associated with the existing 120-megawatt Bradley Lake Hydroelectric Project (Bradley Lake Project, FERC No. P-8221). The purpose of the amendment is to gain authorization to increase the Bradley Lake Dam height and divert meltwater from the Dixon Glacier to Bradley Lake to generate additional power. The Bradley Lake Project is located on the Bradley River in the Kenai Peninsula Borough northeast of the town of Homer in Southcentral Alaska. AEA is providing study reports related to terrestrial resources for the proposed license amendment.

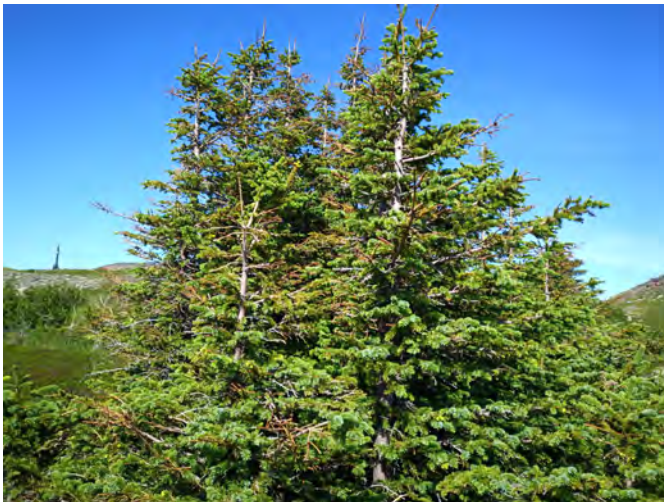
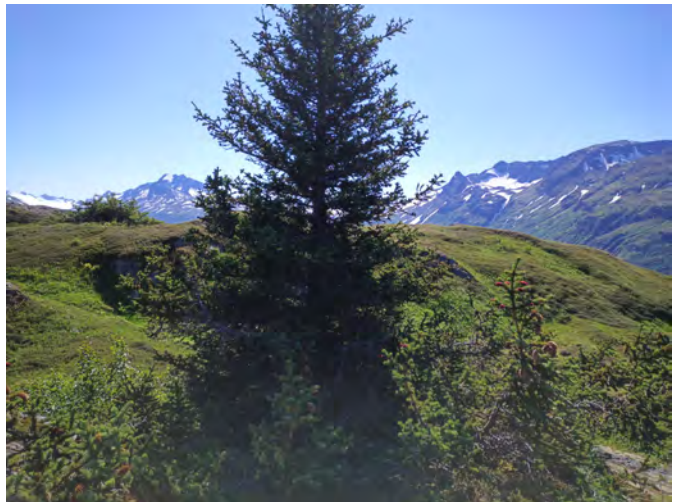
**Sampling Point:** dixon\_29

**Notes:** Plot is in a tiny band of Lutz spruce (slightly krumholtzed). Similar patches are present all throughout the undulating terrain in the subalpine south side of reservoir. Structure only. Mix of dwarf and full size Lutz spruce

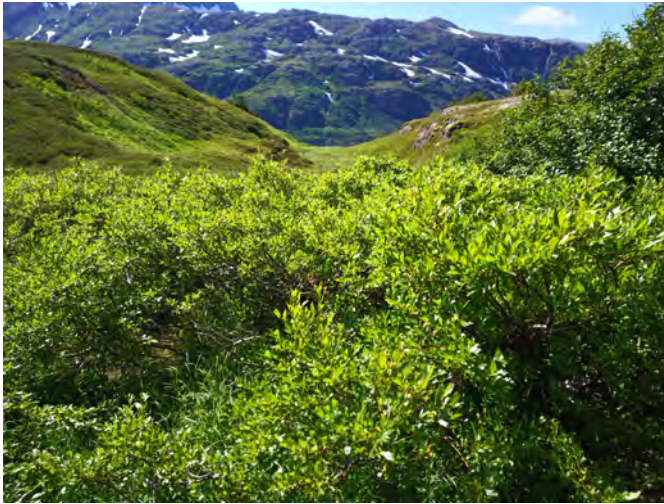
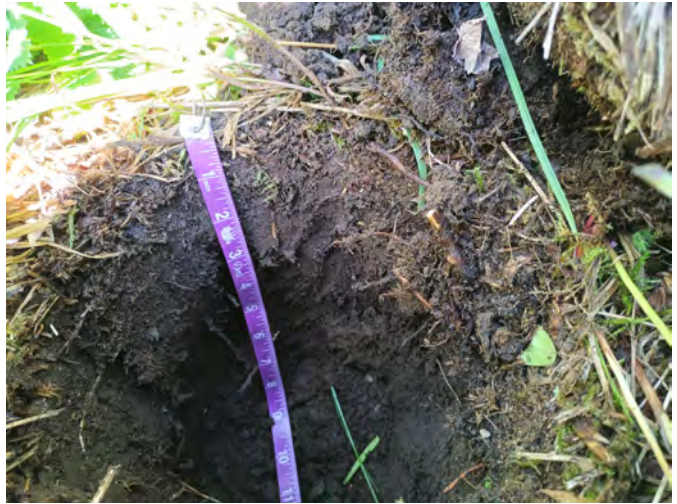
**Sampling Point:** dixon\_30

**Notes:** Site is a closed willow in a narrow draw. There is some exposed soil, indicating seasonal flooding, with no surface water at time of sampling. Willow drainage.

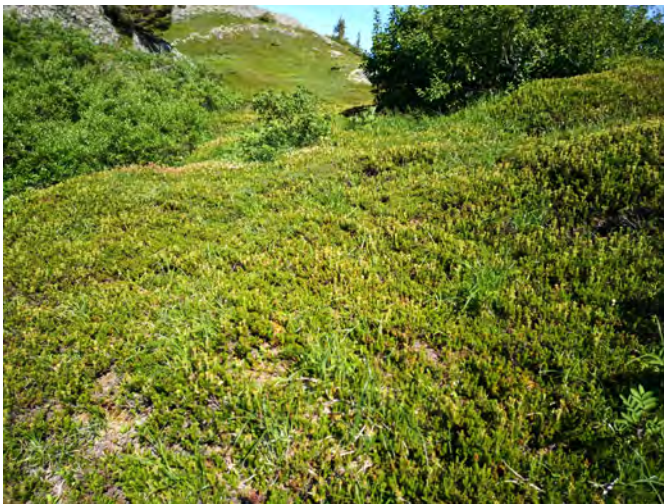
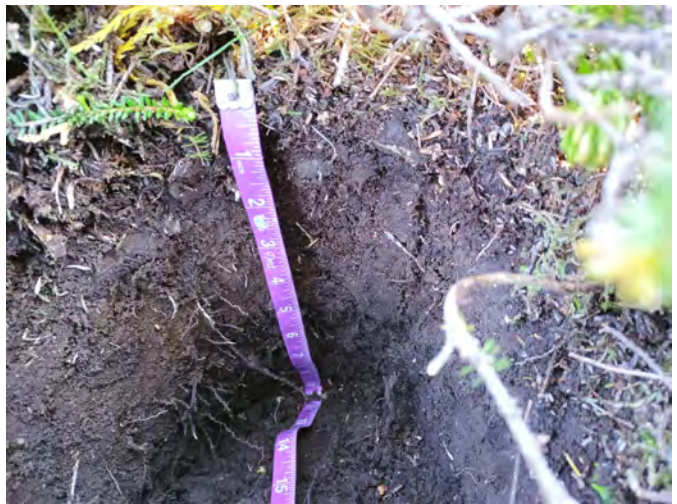
**Sampling Point:** dixon\_31

**Notes:** Plot is a Phylodoce meadow, within the subalpine mosaic in undulating terrain on the east side of the reservoir. The soils at this plot have a shallow rooting zone with organic rich loam.

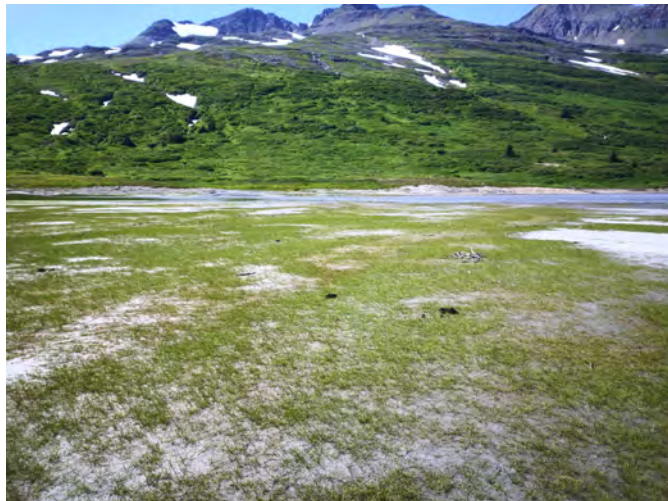
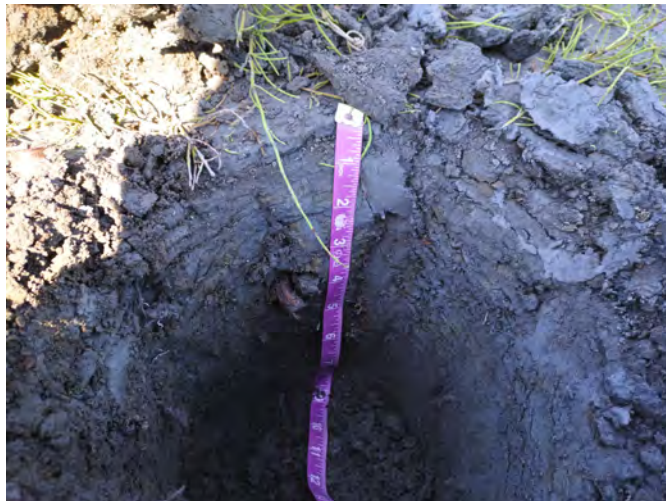
**Sampling Point:** dixon\_33

**Notes:** Site located on an exposed terrace. This site is intermittently exposed due to fluctuations in reservoir level. Partially vegetated with *Equisetum arvense* and many piles of bear scat. The top 4 inches of the soil profile are bedded lacustrine clay materials underlying by sand. Heavy bear scat on plot. 20 scat piles in 50 m radius

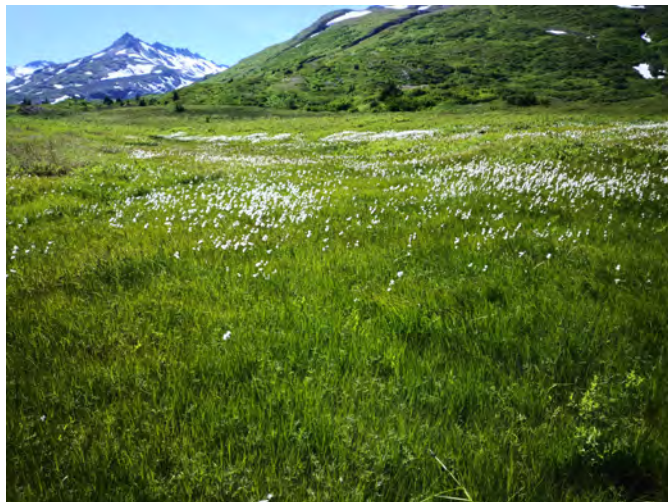
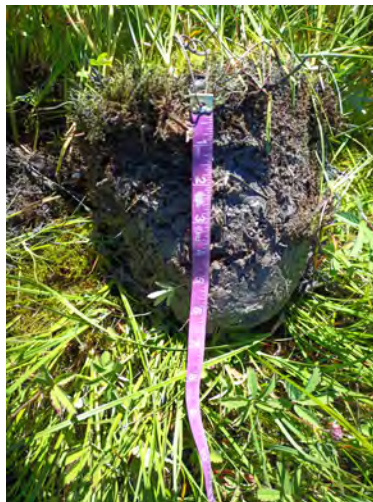
**Sampling Point:** dixon\_34

**Notes:** Wet sedge meadow on the bank of a tributary to Clearwater stream. Soils are saturated to the surface, with 4 inches of organic rooting zone over gleyed silts.

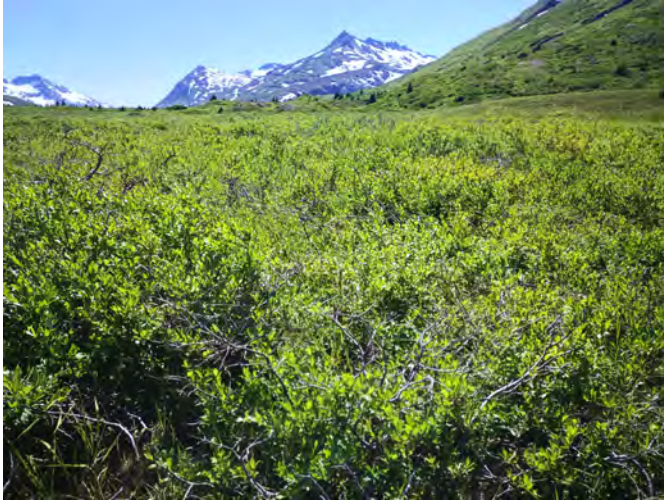
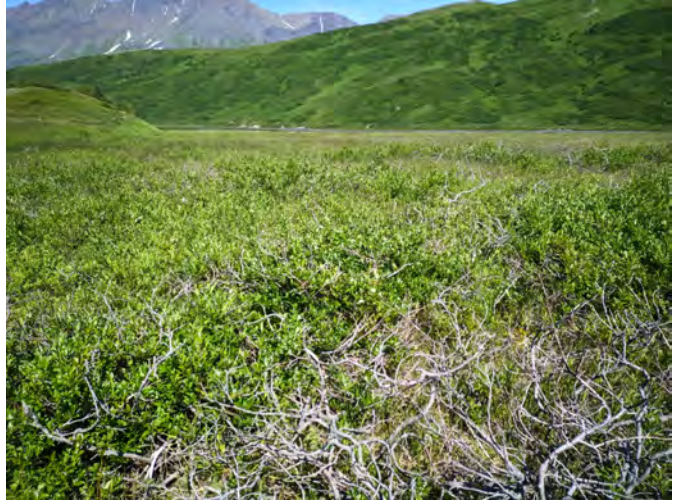
**Sampling Point:** dixon\_35

**Notes:** Closed low willow between the glacial river and the tributary to Clearwater stream. Flooded and abandoned channels are present throughout but the vegetated surfaces are still well above the water table. The soils consist of 4 inches of rootingzone organics over rounded riverine gravels and sand. Channels running through type

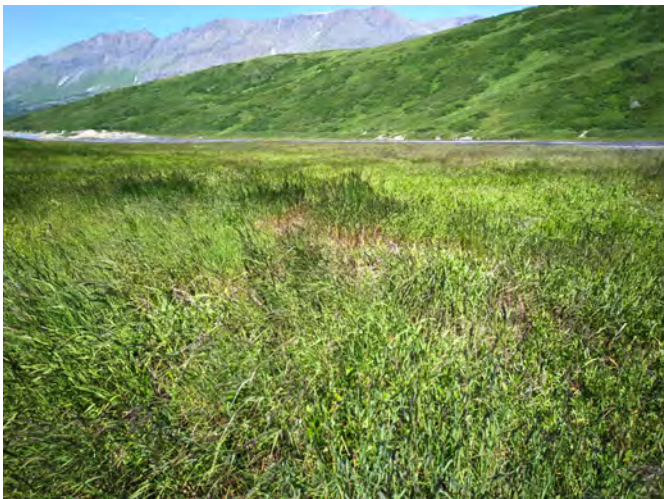
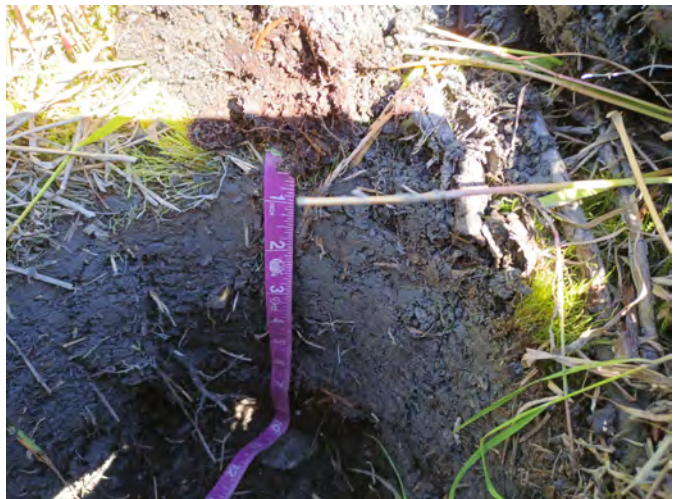
**Sampling Point:** dixon\_36

**Notes:** Vegetation is a graminoid meadow with an understory of low willow and some standing dead willow. Soil profile consists of 7 inches of silt deposits over buried organics. Disturbed vegetation community resulting from wildly fluctuating reservoir levels.

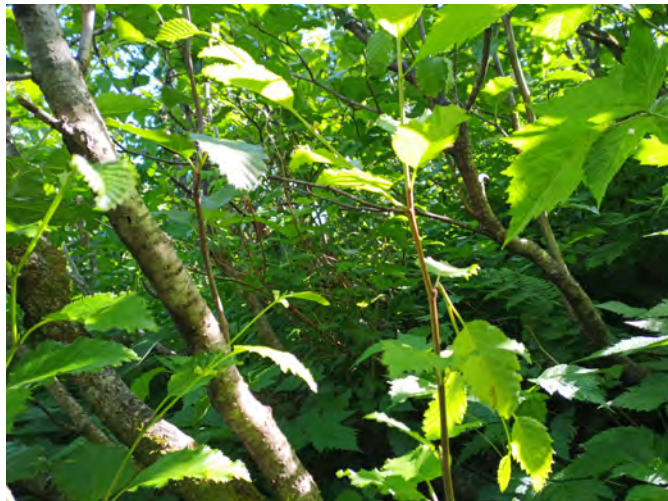
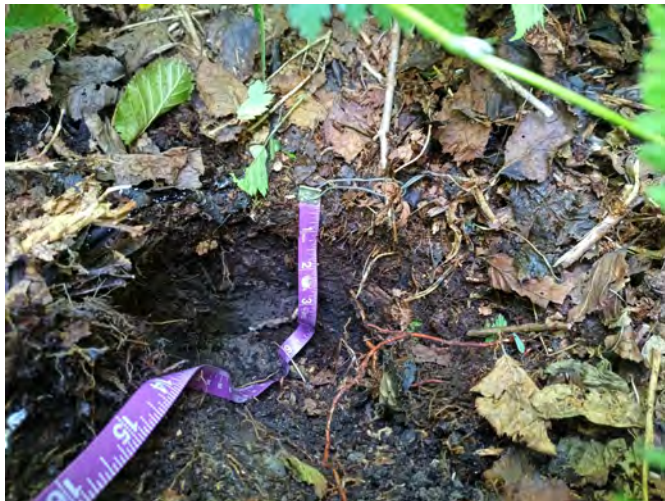
**Sampling Point:** dixon\_38

**Notes:** This plot is a tall closed alder stand, typical of lower slopes surrounding the lake.

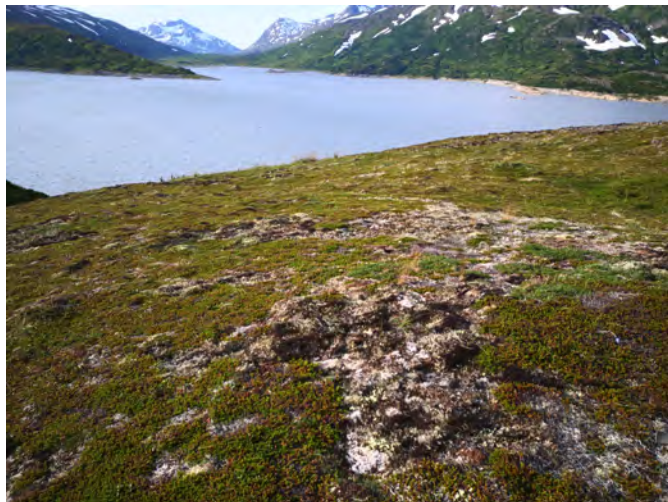
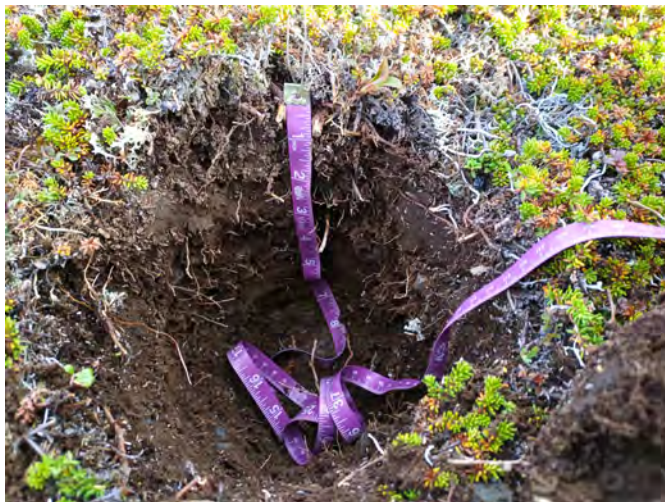
**Sampling Point:** dixon\_39

**Notes:** Empetrum tundra with higher cover of cladonia\cladina and stereocaulon. Soils have very little organic development over gravelly loam.

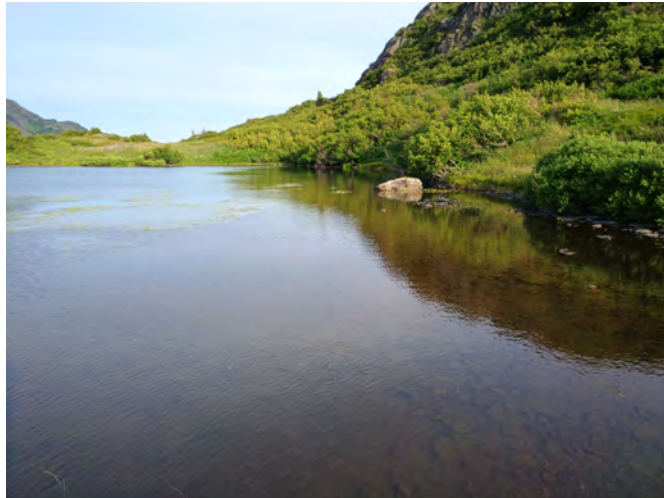
**Sampling Point:** dixon\_40

**Notes:** Small shallow subalpine pond with Potamogeton. Pond contains clear water with silty substrate.

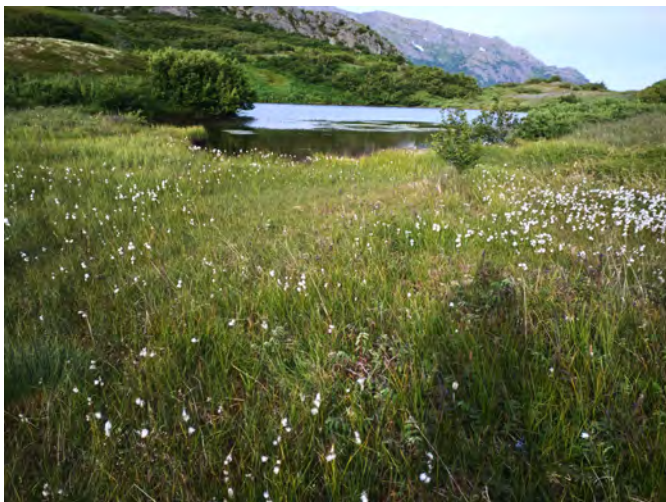
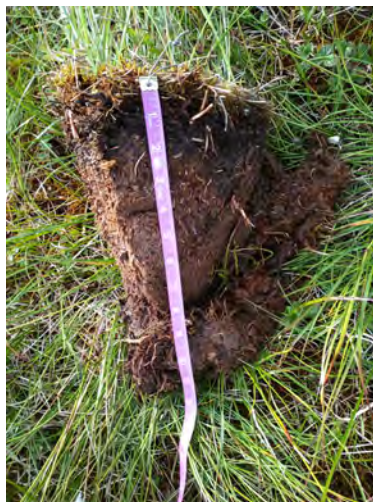
**Sampling Point:** dixon\_41

**Notes:** Wet sedge and moss bog meadow next to a small stream flowing into shallow pond. Soils are a histosol but are dryer than typical. Water table is not present within the top 12 inches.

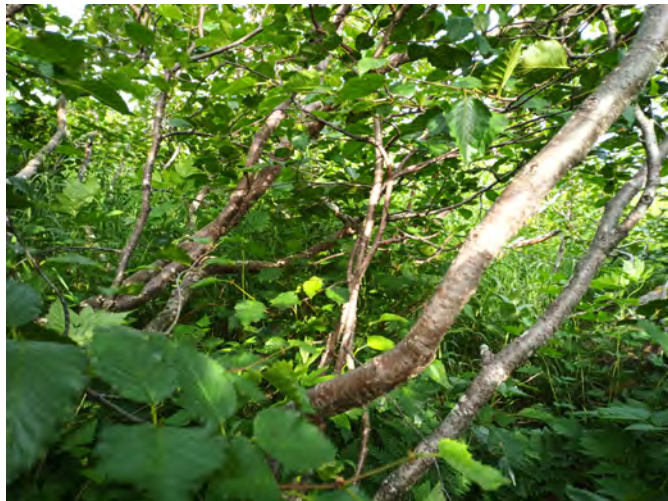
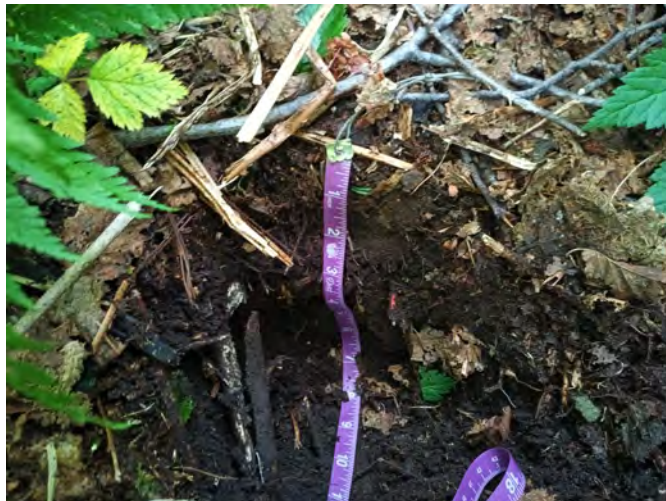
**Sampling Point:** dixon\_42

**Notes:** Tall closed alder shrub, with shallow leaf litter duff over black loam.

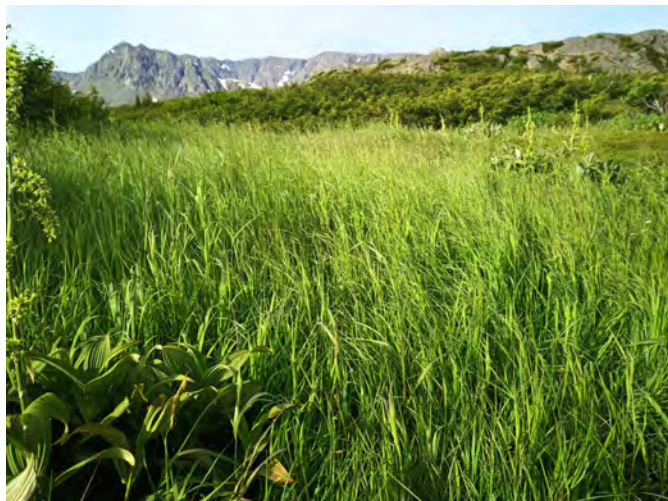
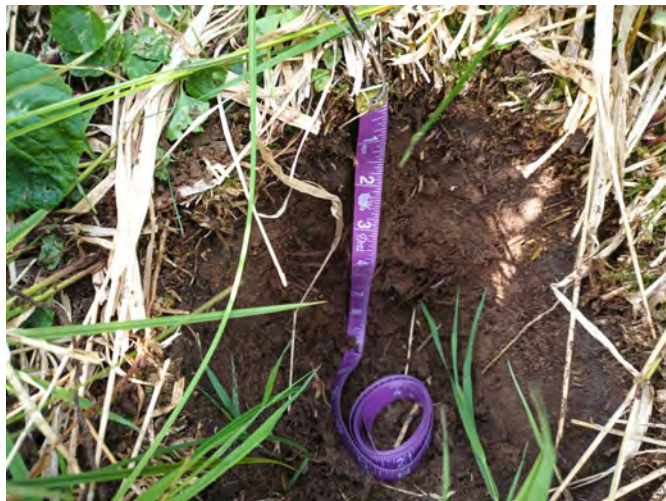
**Sampling Point:** dixon\_43

**Notes:** Plot is a grass forb meadow on a steep north facing slope. Soils are a shallow organic layer over a layer of loam with a high organic content, over mineral soil composed of sands and angular gravel. This type is a bright green photo signature . Steep sloped.

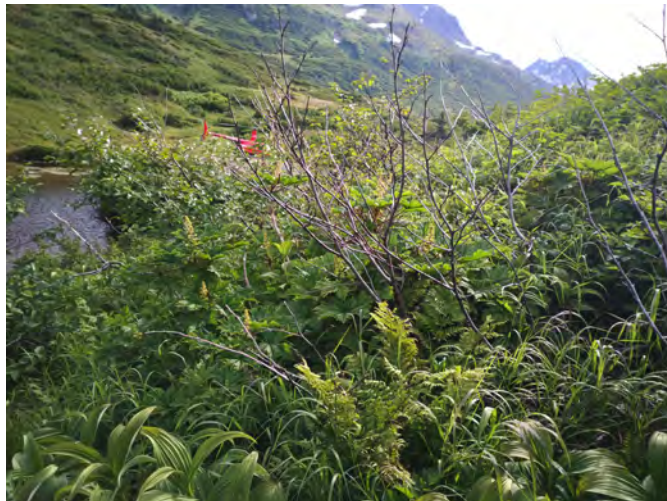
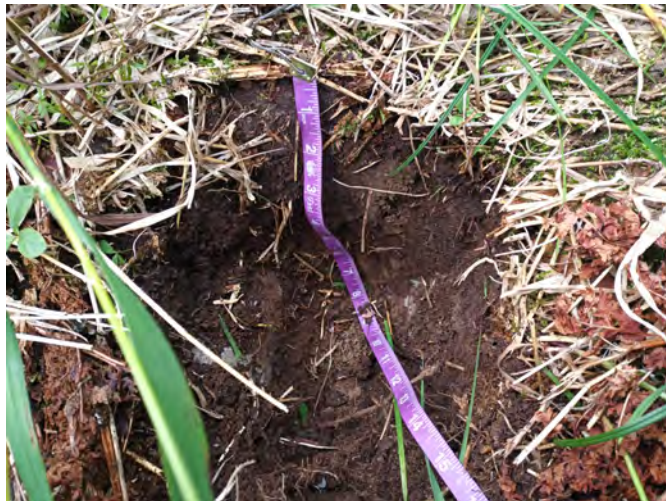
**Sampling Point:** dixon\_44

**Notes:** Mixed forb and tall shrub meadow. Open canopy at the transition from forb meadow to alder patch,. Soils with shallow organics over loam with cobbles.

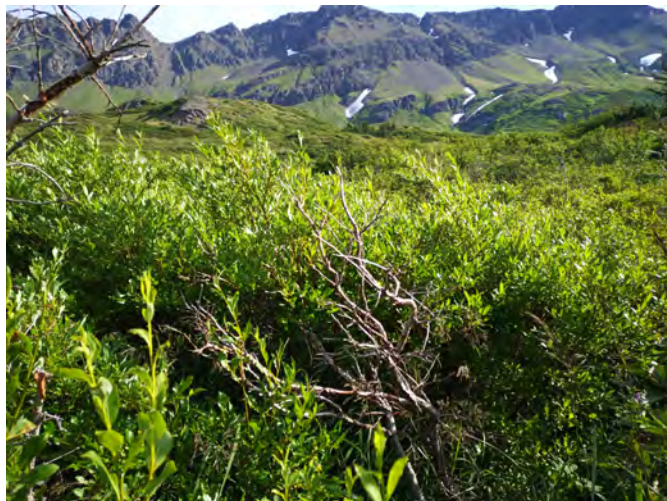
**Sampling Point:** dixon\_45

**Notes:** Plot describes closed tall willow stand in a drainage way. Soils consist of a shallow organic layer over high organic content loam. Deep pits throughout the closed willows, lacking surface water at the time of sampling but may be seasonally flooded. Dense willow in old drainage feature

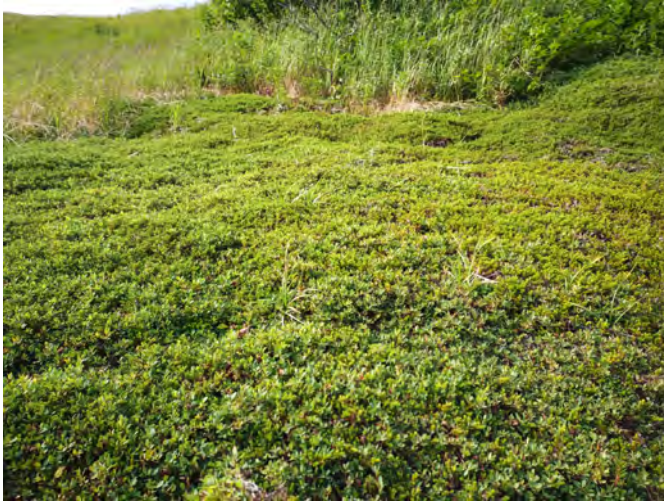
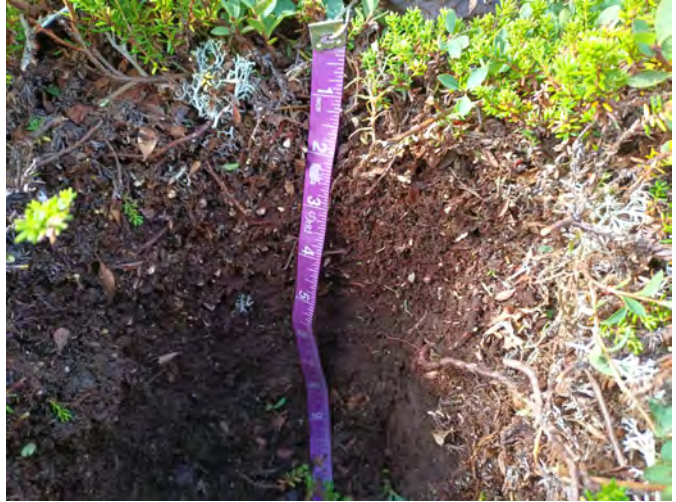
**Sampling Point:** dixon\_46

**Notes:** Dwarf shrub Empetrum tundra with very low lichen percent cover. Site is on a north facing slope. Soils with 4 inches of organic soils over dark colored loam over gravel. This type typically occurs in small distinct patches but is possibly too small to map.

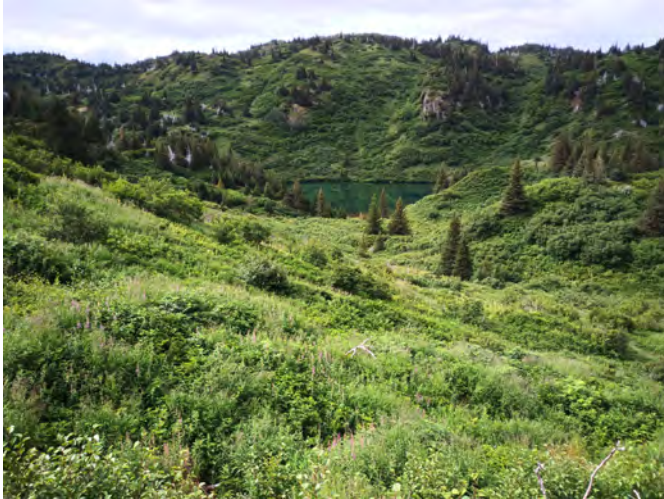
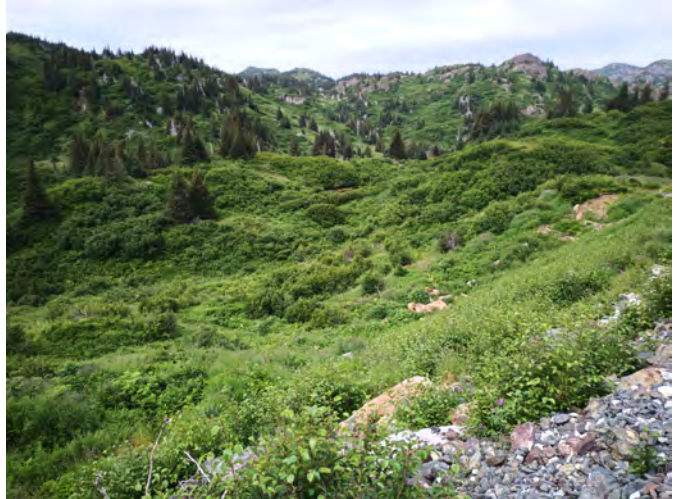
**Notes:** Plot is a verification point describing the mid-elevation forested landscape. Steep sided hills, forested summits with a meadow\tall shrub mosaic.
