TO: Ryan McLaughlin, PE
 FROM: Mya Sawyer, EI; Andrew Johnson, PE
 DATE: 12/8/2025
 PROJECT: Bradley Lake Expansion Project
 SUBJECT: 2025 Dixon Operations Model Update

DOWL again collected discharge measurements on the Martin River and its major tributaries. This memorandum describes the updates to the Dixon Diversion operations model with 2025 streamflow measurements.

MARTIN RIVER STREAMGAGING DATA ACQUISITION AND ANALYSIS REPORT

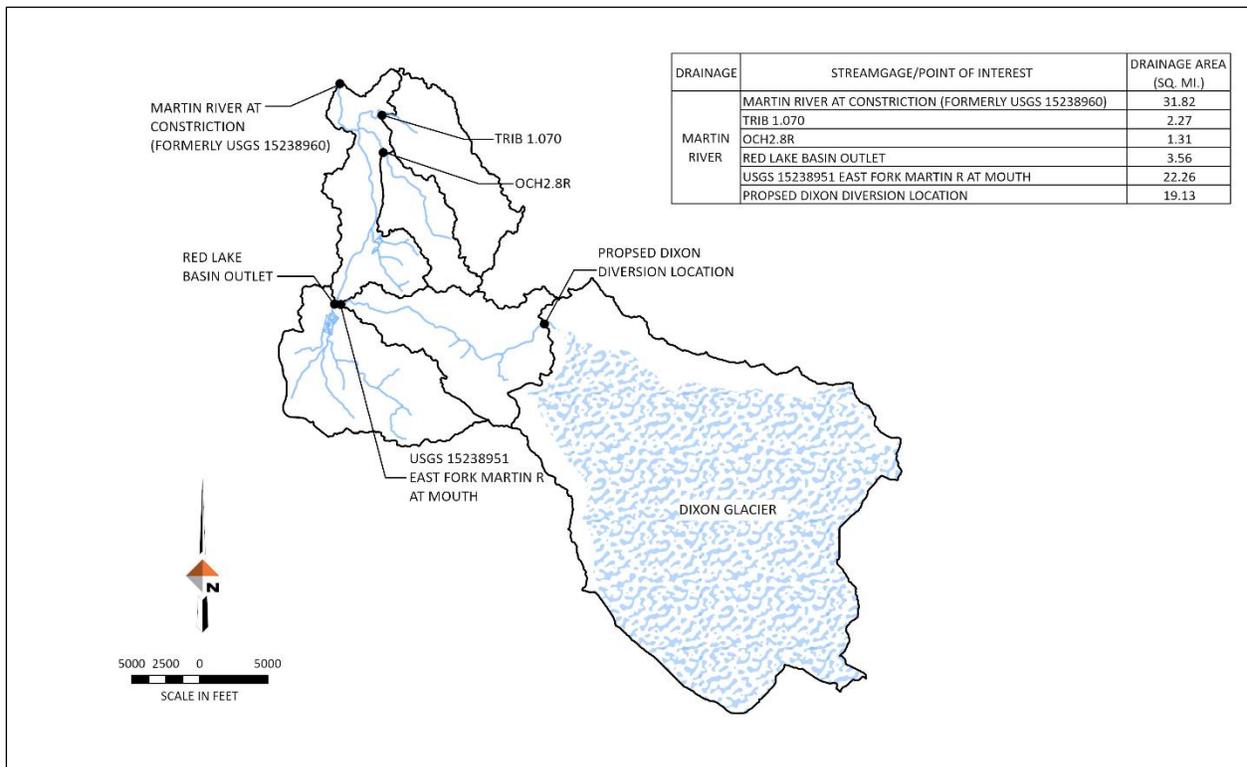
Figure 1: Streamgages along the Martin River Watercourse

DOWL has collected streamflow measurements on the Martin River for the past three consecutive years (i.e., 2023-2025). The Martin River Streamgaging Data Acquisition and Analysis Report (Attachment 1) describes the methodology, details of the discharge measurements, development of the rating curves, and rating shifts. Figure 1 presents locations and drainages of the streamgaging stations. Streamflow was measured at the following locations:

- Martin River at the Constriction
- Red Lake Basin Outlet
- OCH2.8R
- Trib 1.070
- East Fork Martin River at the Mouth (not continuous)

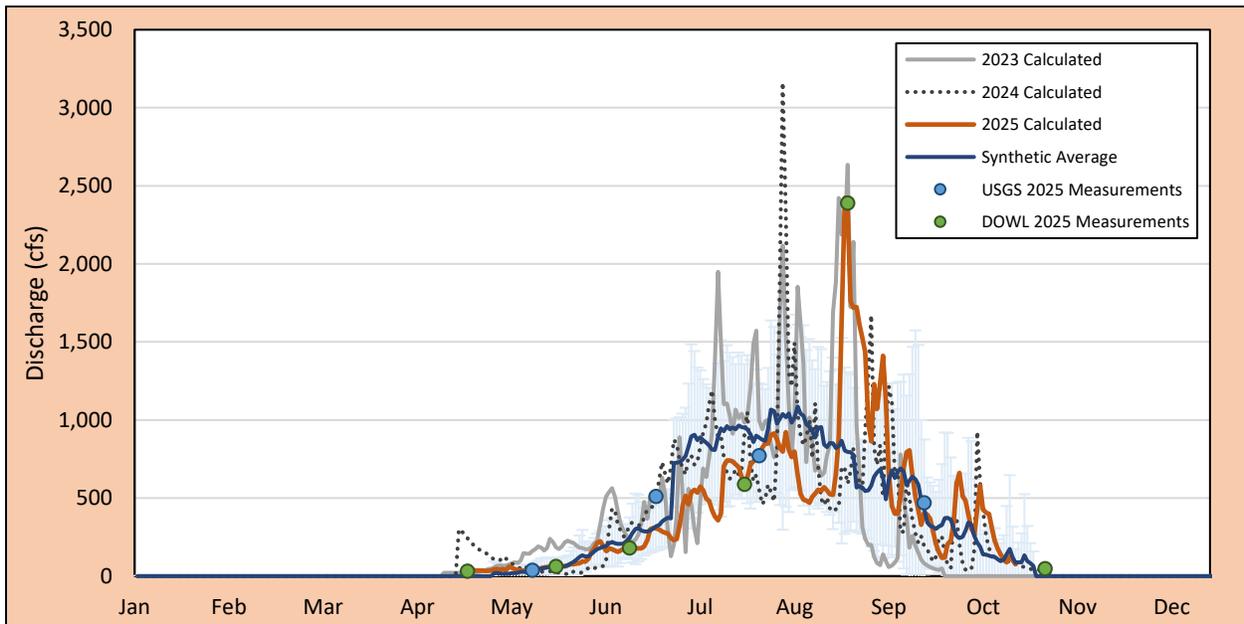
Figure 2: East Fork Martin River Discharge at the Mouth

Continuous streamflow measurements are not available at the East Fork Martin River at the Mouth (USGS 15238951), although discharge is occasionally measured by the USGS and DOWL; therefore, DOWL created an approximate discharge hydrograph for the Dixon Basin. The discharge at the East Fork Martin River was calculated by subtracting the discharge at Red Lake, OCH2.8R, and Trib 1.070 from the discharge of the Martin River at the Constriction. The calculated discharge at the Mouth was validated using point discharge measurements by DOWL and the USGS (USGS 15238951). Note that there is an unaccounted-for area between the proposed diversion and the Mouth, which is about 3.13 mi² (~16% of the drainage area to the Dixon Diversion), but is believed to not significantly affect the discharge estimates at the diversion because the runoff would only be from early season snowmelt (as opposed to glacier melt throughout the summer) and precipitation. Figure 2 presents the 2025 average daily East Fork Martin River Hydrograph at the Mouth and Attachment 2 summarizes the discharge calculations.

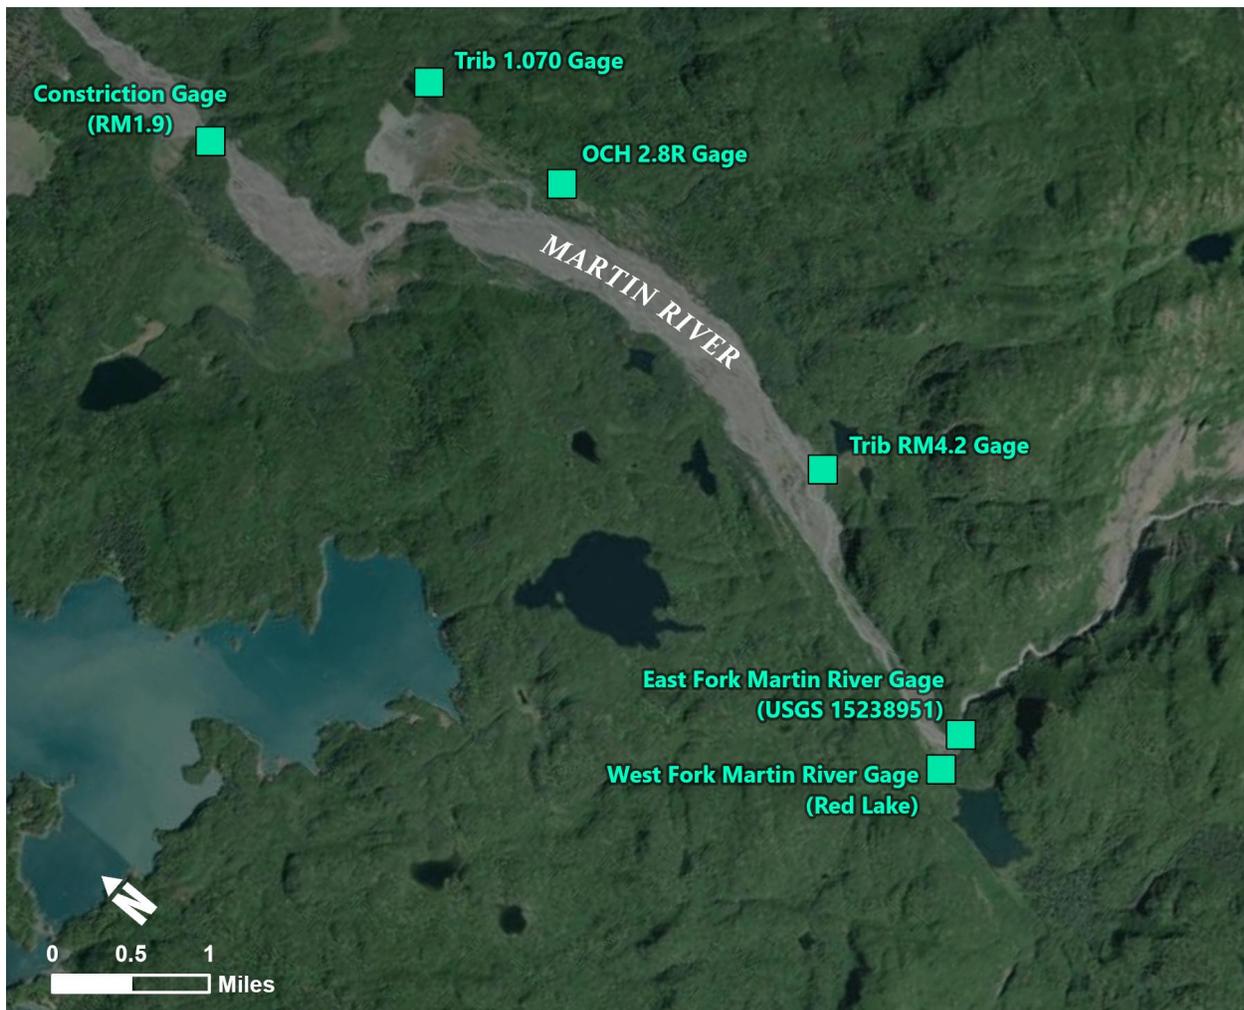
Figure 2: Locations of Water Level Loggers

Figure 2 depicts the approximate locations of the water level loggers.

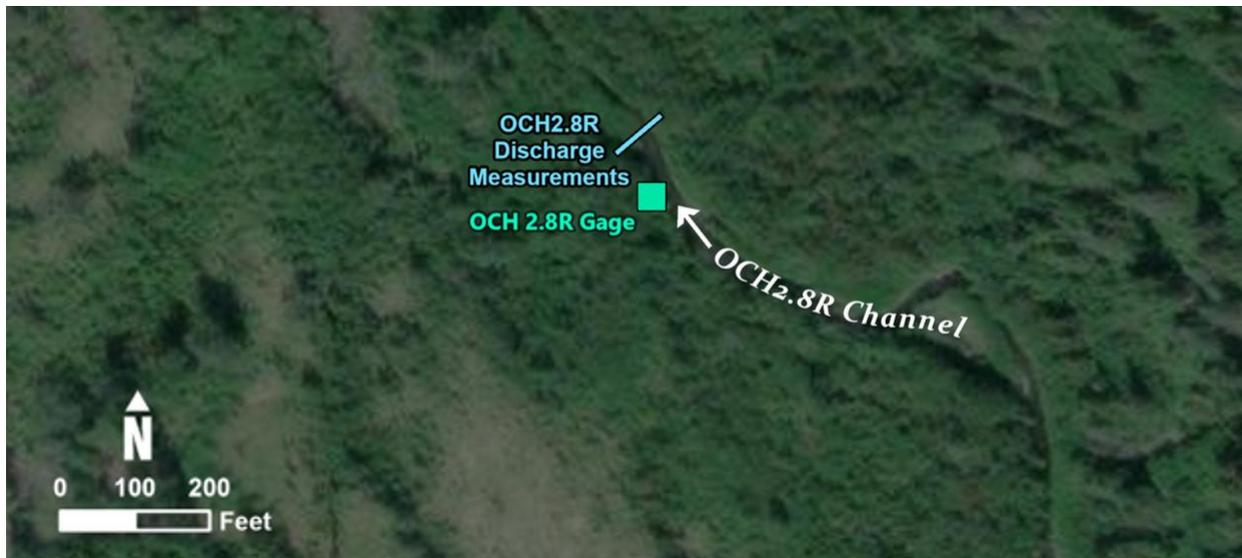
Figure 3: OCH2.8R Discharge Measurement Location

Discharge measurements were collected 15 feet downstream of the OCH2.8R gage at a stable riffle control (Figure 3). It was selected based on USGS recommendations for its uniform flow, with consistent depth and velocity distribution, and suitable hydraulic conditions for accurate discharge measurements.

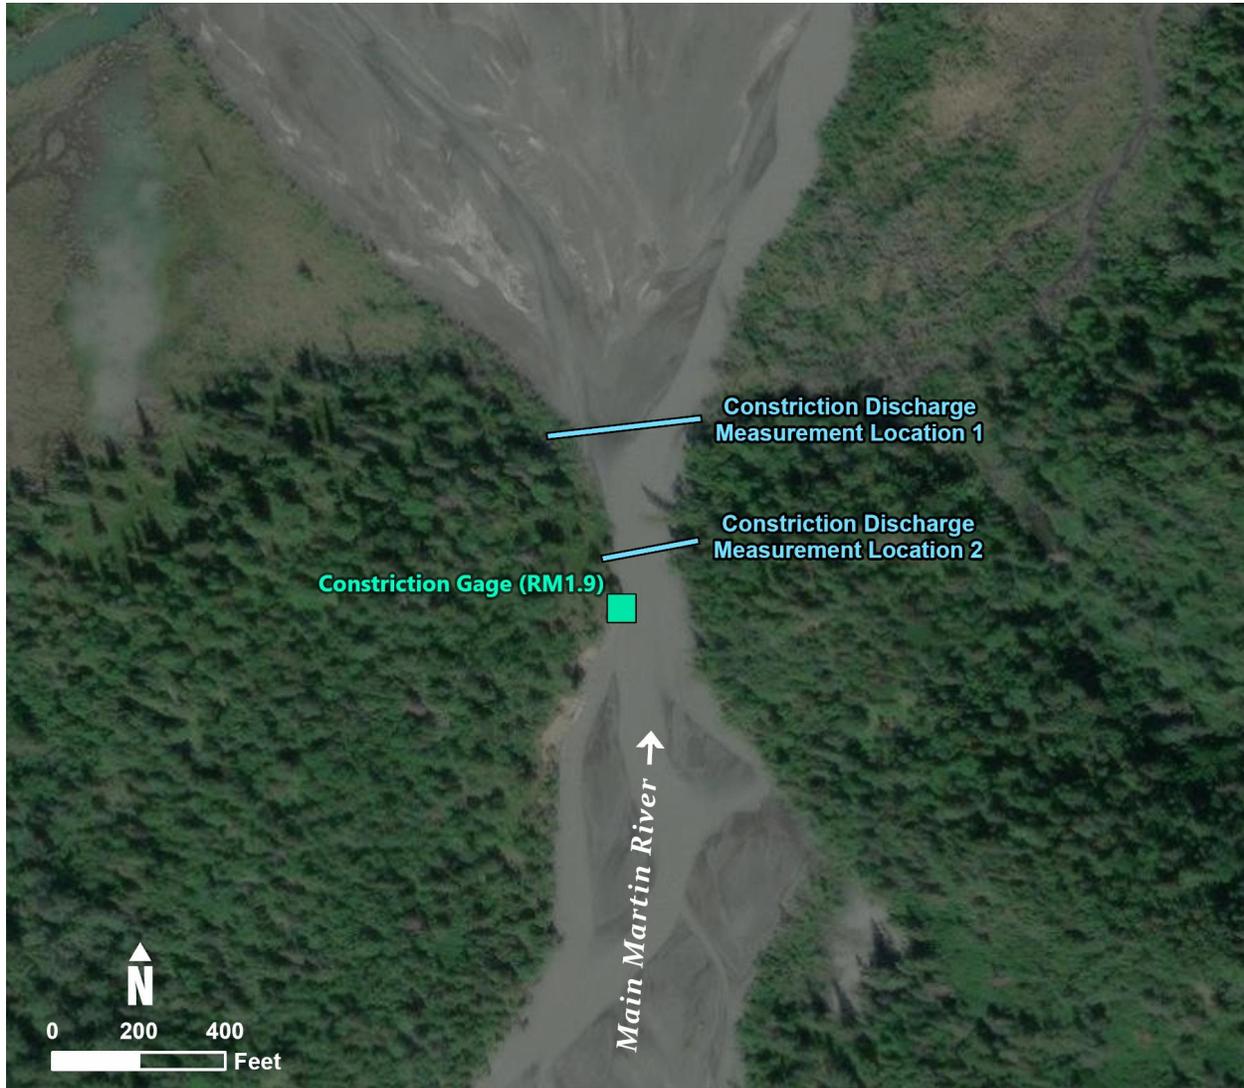
Figure 4: Constriction Discharge Measurement Location

At the Constriction gage (RM 1.9), discharge measurements were collected at two downstream cross-sections selected in accordance with USGS recommendations for identifying sites with uniform, steady, and representative hydraulic conditions. For flows between approximately 20 and 1,000 cubic feet per second (cfs), measurements were taken about 200 feet downstream of the gage at a straight, well-defined cross-section (Discharge Measurement Location 1 in Figure 4) that provided adequate depth, minimal turbulence, and stable banks for ADCP and current meter measurements. Under high-flow conditions

exceeding 1,000 cfs, measurements were conducted approximately 40 feet downstream at Discharge Measurement Location 2, where a steel cable could be deployed to allowed secure attachment of the trimaran and provided a safer, more controlled environment for operating equipment during elevated, high-velocity conditions. Together, these locations offered hydraulically appropriate and safe measurement conditions across the full range of observed discharges.

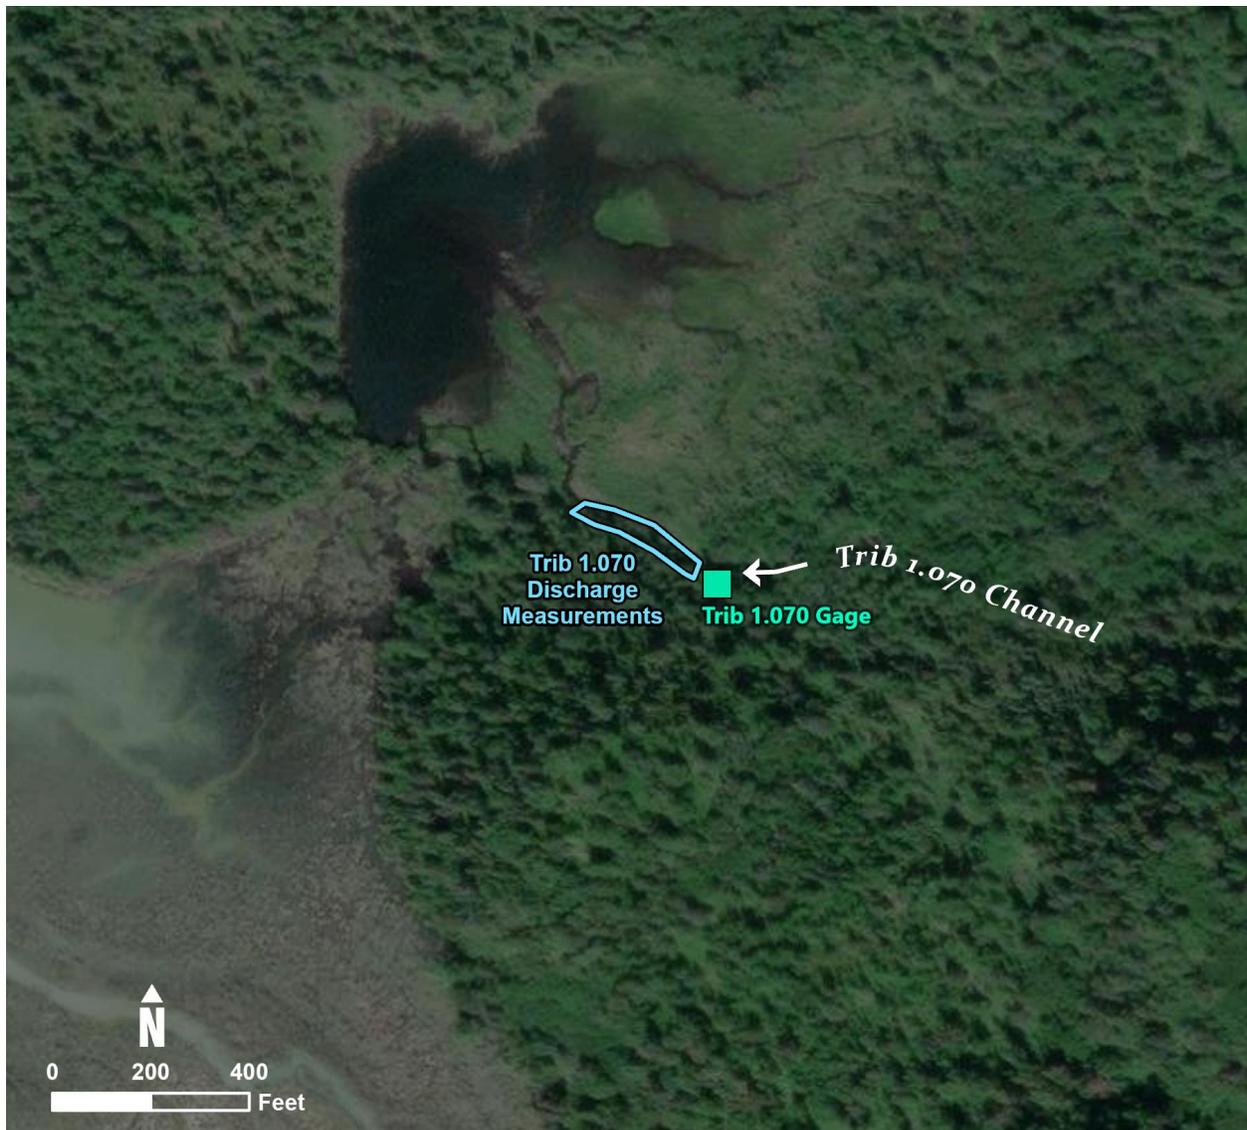
Figure 5: Trib 1.070 Discharge Measurement Location

Discharge measurements at Trib 1.070 were collected within a reach extending approximately 5 to 150 feet downstream of the gage (Figure 5). The measurement location varied seasonally and was selected in accordance with USGS recommendations. Within this short, low-gradient channel, the optimal measurement location shifted with water levels and vegetation growth. Cross-sections were chosen where the channel exhibited a well-defined shape, consistent depth and velocity distribution, minimal bankside vegetation interference, and stable bed conditions suitable for wading measurements.

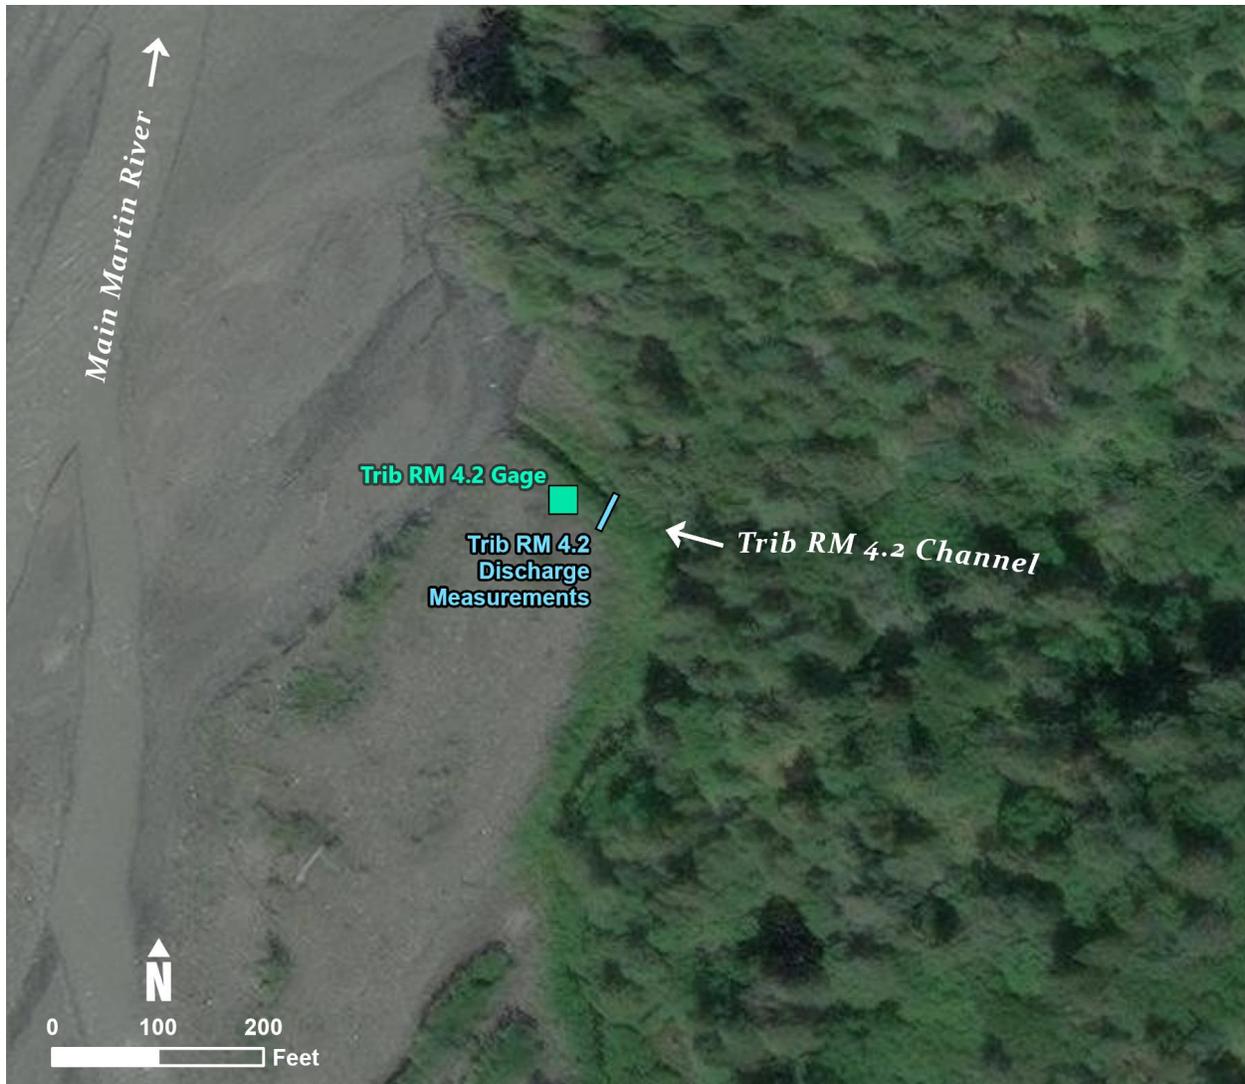
Figure 6: Trib RM4.2 Discharge Measurement Location

At Trib RM 4.2, discharge measurements were typically collected approximately 15 feet upstream of the gage at a straight, well defined section of the tributary channel (Figure 6). This location provides a stable hydraulic section where flow is confined between vegetated banks and passes over a shallow sandy gravel bed, producing uniform depth and velocity profiles suitable for wading measurements. The upstream cross-section was selected in accordance with USGS recommendations.

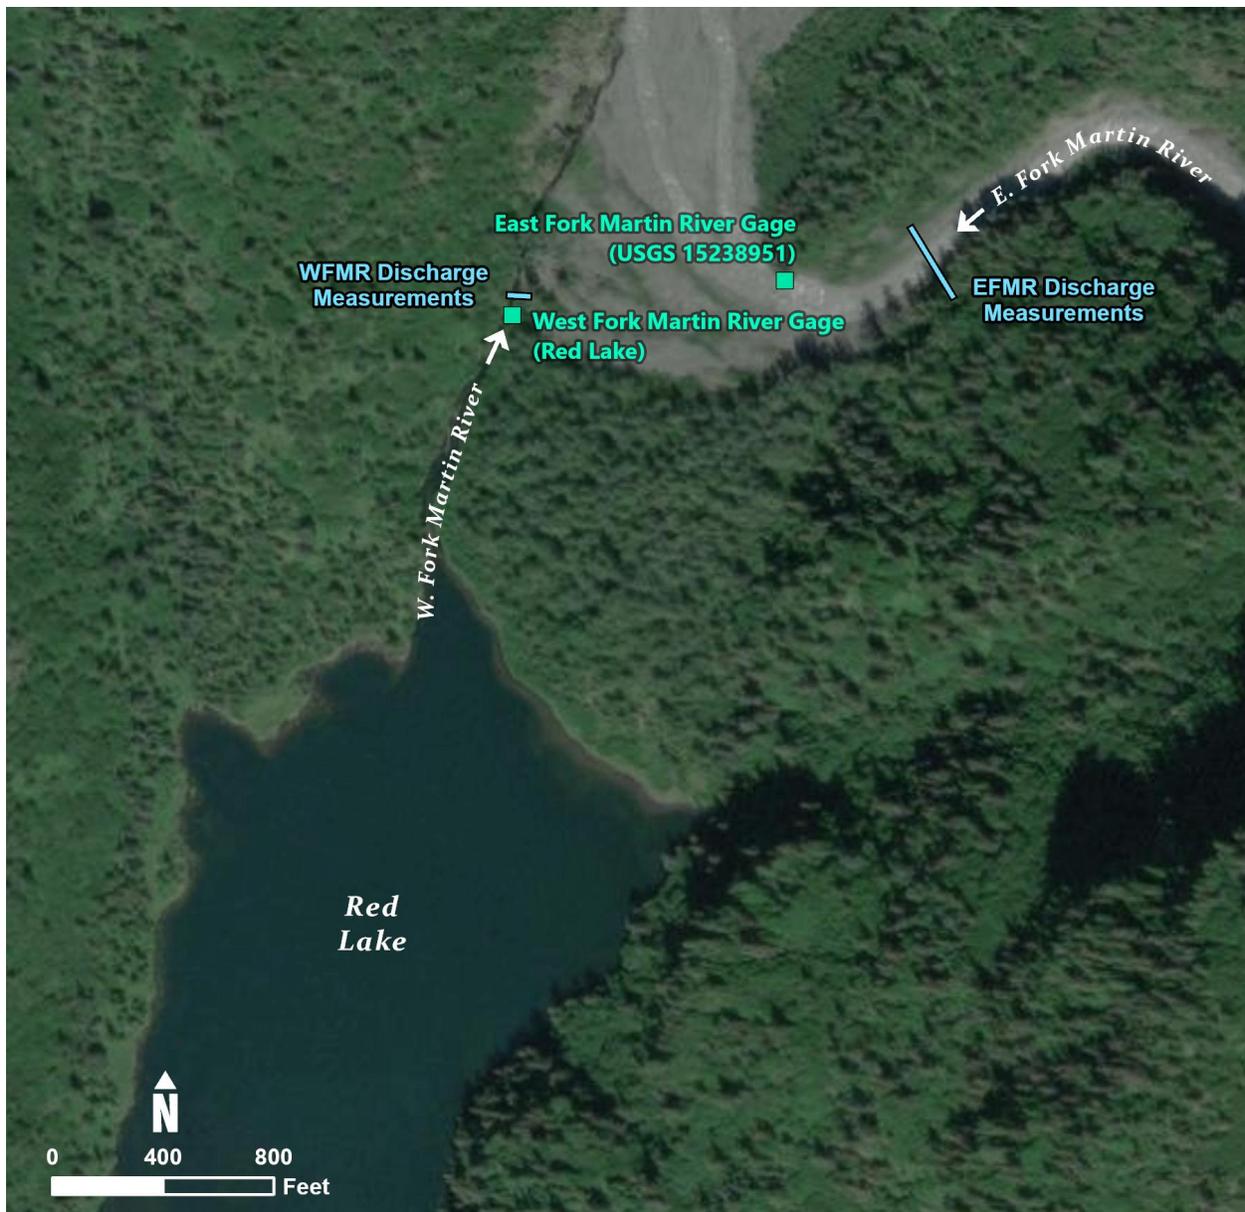
Figure 7: EFMR and WFMR Discharge Measurement Location

At the WFMR gage, discharge measurements were typically collected approximately 10 to 15 feet downstream of the gage at a straight, confined section of the channel, upstream of the confluence with the EFMR (Figure 7). This location provides a well-defined measurement cross-section with uniform flow, moderate depths suitable for wading or low-flow ADCP deployment, and a relatively stable sandy cobble bed that minimizes lateral variability in velocity. The proximity to the gage ensures that no tributary inflows, channel bifurcations, or backwater influences occur between the gage and the measurement site. The cross-section was selected in accordance with USGS recommendations.

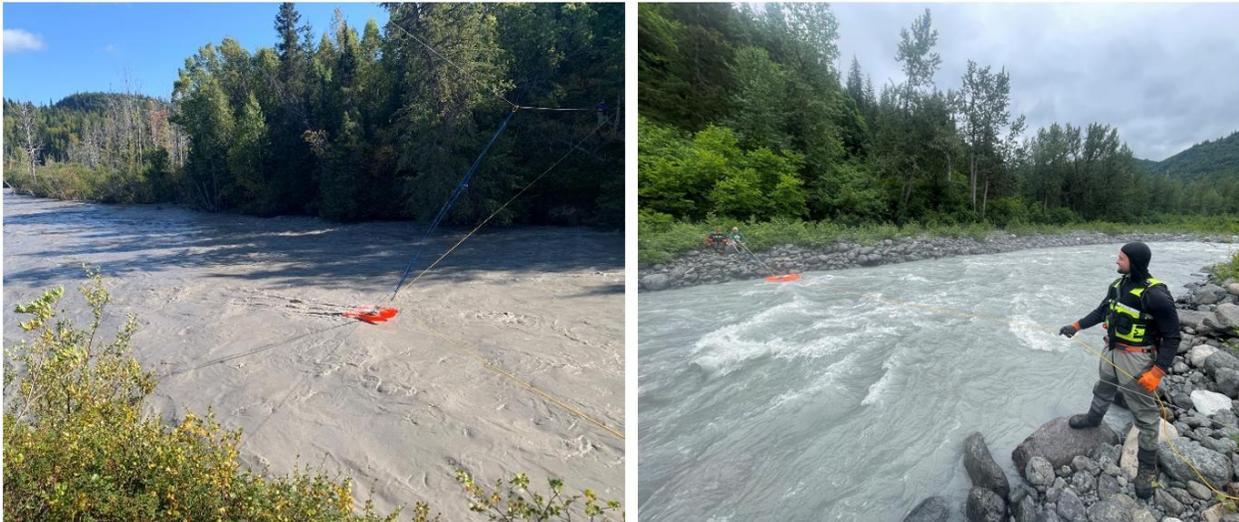
ADCP measurements were conducted using either a remote-controlled HR Wallingford ARCboat, a 4-foot trimaran platform or Sontek Hydroboard, attached to a tethered rope. When using the Hydroboard or trimaran, the ADCP was guided across the channel along controlled transects to collect velocity, depth, and boat-track data. The operator maintained consistent cross-section coverage by manually pulling the rope attached to the trimaran while monitoring real-time quality indicators to ensure valid bottom tracking and signal performance. Figure 8 shows ADCP measurements conducted at the Constriction and EFMR.

Figure 8: RiverPro ADCP on Trimaran, Right Photo - 8/29/25 | Constriction | 2,490 cfs Left Photo - 7/23/24 EFMR | 614 cfs

A Teledyne RDI RiverPro ADCP, operating with WinRiver II software, was used to measure discharge during high summer flows. The RiverPro 1200 kilohertz beams enable accurate discharge profiling in water depths up to 80 feet, with adaptive sampling to maintain high-quality velocity and depth data despite variations in turbidity, bed formation, and flow conditions.

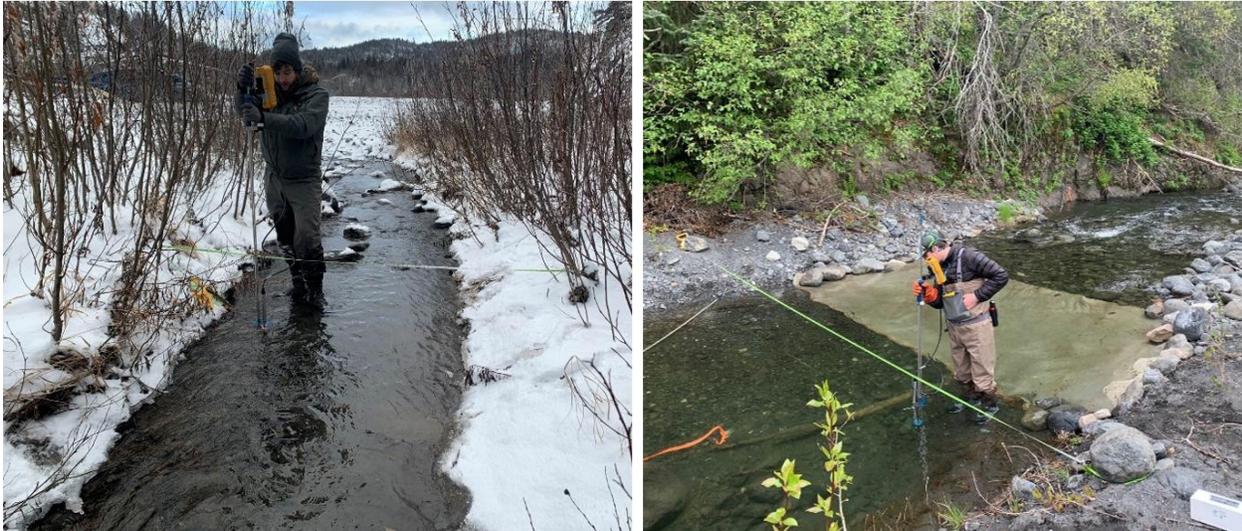
A SonTek FlowTracker2 ADV was used to obtain discharge measurements during shallow wading conditions. The FlowTracker2 is a current meter that utilizes acoustic doppler technology to measure two-dimensional water velocity with high precision, making it well-suited for shallow, low-velocity, or complex flow environments where larger instruments cannot be deployed. The system features built-in quality assurance checks, real-time signal diagnostics, and onboard data processing to support consistent, defensible velocity measurements in accordance with standard hydrometric practices. Figure 9 shows the ADV measurements being conducted at Trib RM4.2 and WFMR.

**Figure 9: FlowTracker2 Measurements: Left Photo - 11/17/23 | Trib RM4.2 | 0.5 cfs
Right Photo - 5/22/25 | WFMR | 16.0 cfs**

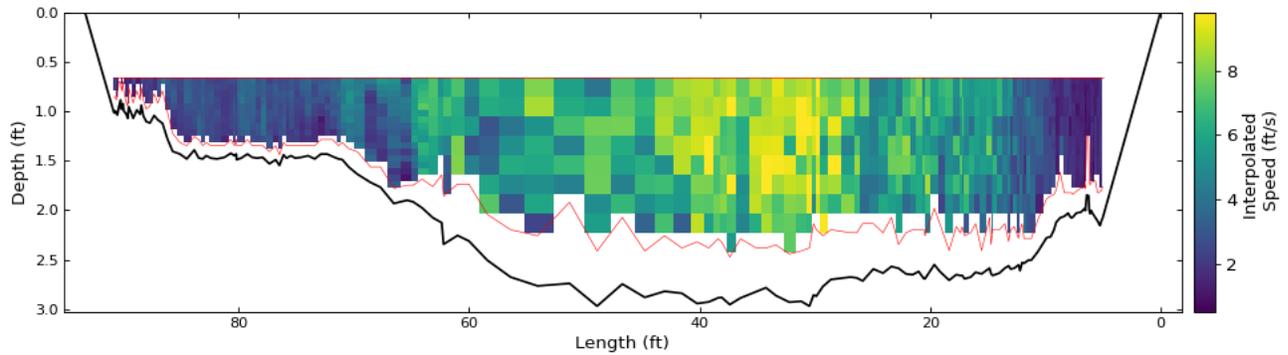
Post-processing quality control was completed using QRev, a USGS software for evaluating and documenting ADCP discharge measurements. Each measurement was assessed for transect path consistency, proper edge discharge estimation, moving-bed corrections, and extrapolation methods. Additional diagnostics included a review of ensemble validity, beam correlation and amplitude, velocity profile shape, depth consistency, discharge variability between transects, and calculation of measurement uncertainty. Final discharge values were accepted only after all QRev checks were satisfied and the measurement met USGS criteria. Figure 10 depicts the Qrev output of a discharge transect, in terms of velocity and depth, for a measurement at the constriction. The white areas at the water surface, channel bed, and along the banks represent zones where direct velocity data could not be collected. QRev automatically estimates velocities in these unmeasured regions using USGS-approved extrapolation methods.

Figure 10: QRev ADCP Discharge Profile, Constriction, 7/3/24 at 15:30, 722 cfs

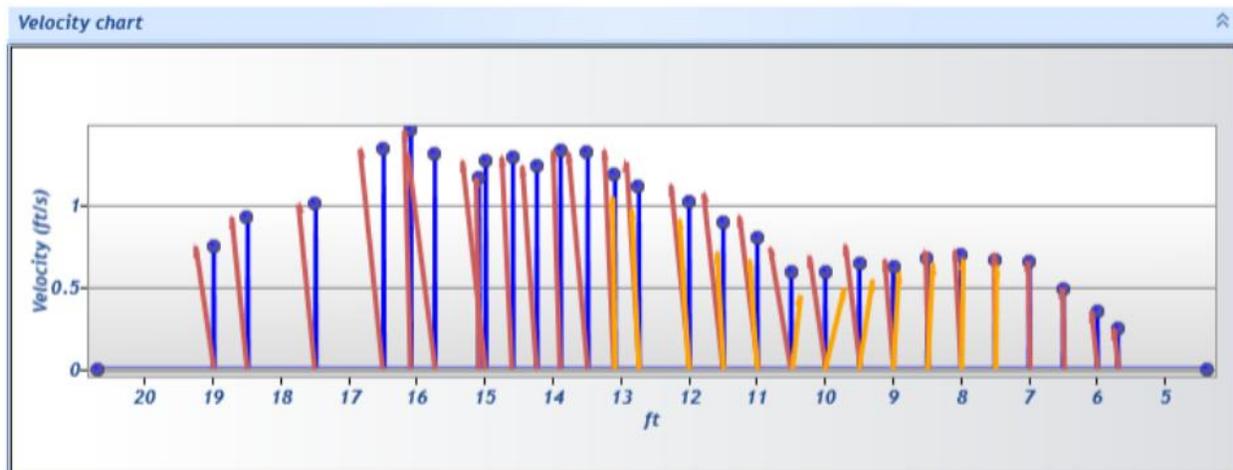
Post-processing QC included exporting and reviewing measurement results in Flowtracker2 software, ensuring that subsection widths, mean velocities, and discharge calculations were consistent and free of anomalous values. The final discharge result was accepted only after a comprehensive review of both field diagnostics and processed data confirmed compliance with USGS current-meter measurement standards. Figure 11 depicts the velocity profile from an ADV measurement at the WFMR. Within the FlowTracker2 software, velocity data can be examined for both magnitude and direction at each vertical where measurements were collected, allowing detailed assessment of flow structure across the cross-section.

Figure 11:Flowtracker2 Velocity Profile, WFMR 5/22/25 at 9:30, 17.0 cfs

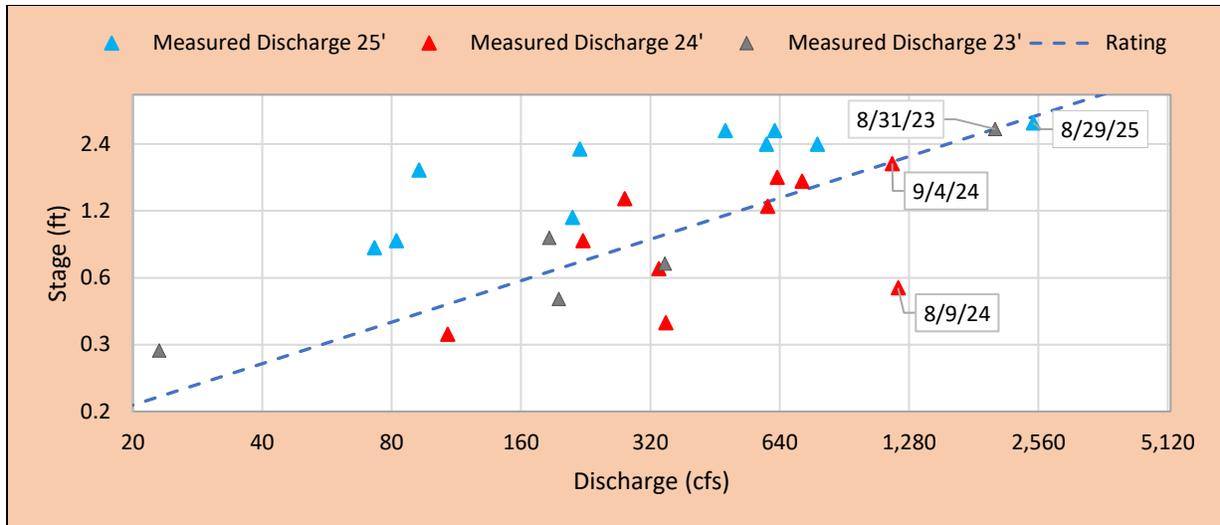
Figure 12: Constriction Rating Curve

Figure 12 illustrates the Constriction stage-discharge relationship, based on 27 recorded measurements, compared to the computed rating curve equation.

The Constriction gage on the Martin River is situated within a braided gravel-bed system at an abrupt narrow reach, where the channel transitions from a broad 550- to 950-foot active width to a confined section approximately 120 feet wide between 15-foot-tall, vertically stable banks. The constriction as a gage location exhibits highly unstable hydraulic controls, with repeated cycles of scour, deposition, and hydraulic-forcing conditions that elevate the water surface, and low water channel migration, typical of wide gravel-bed channels. Summer measurements (July to August) display the most significant variability, forming both scour clusters tied to mid-summer storm events that mobilize bed material and aggradational clusters reflecting deposition during receding flows.

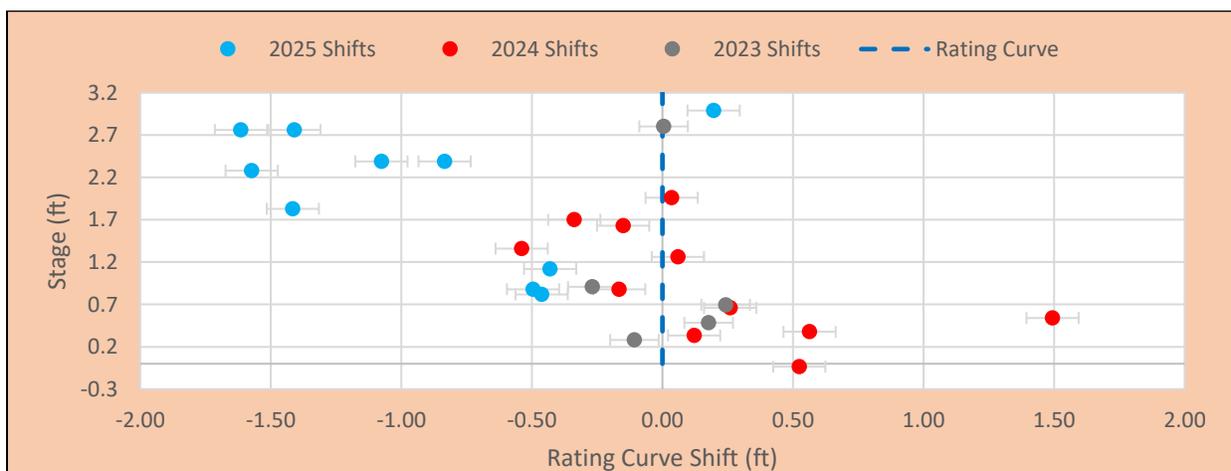
Figure 13: Constriction Shift Diagram

Rating stability is poor, with shifts ranging from +1.49 to -1.61 (Figure 13), far exceeding the typically acceptable range for a stable USGS rating. Several large shifts in 2025 indicate a significant change in bed elevation or channel migration toward the river's left gage location. The magnitude and variability suggest that a single rating curve is inappropriate, and that frequently updated shifts to the rating curve, along with gage height-based control switching, may be necessary.

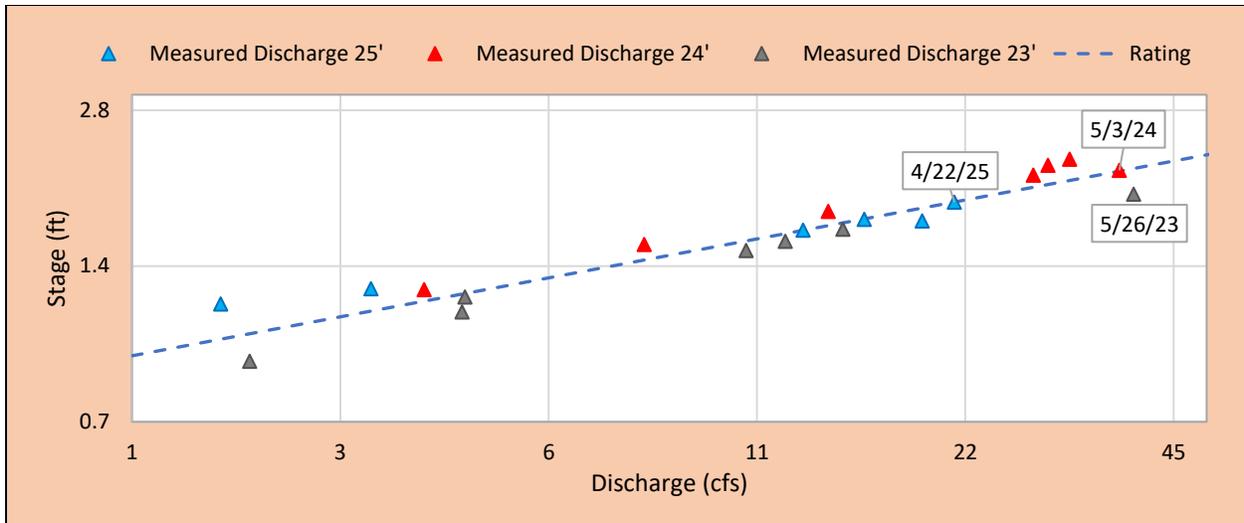
Figure 14: WFMR Rating Curve

Figure 14 illustrates the WFMR stage-discharge relationship, based on 25 recorded measurements, in comparison to the computed rating curve equation.

The rating-curve data for this gravel/cobble stream with a boulder-dominated section control exhibits relatively small and stable shifts throughout the 2023 to 2025 period, indicating a largely stable hydraulic control. Most shifts fall within a narrow range of approximately -0.20 to +0.23 (Figure 15), suggesting minimal bed elevation changes or channel morphology adjustments affecting the stage-discharge relationship.

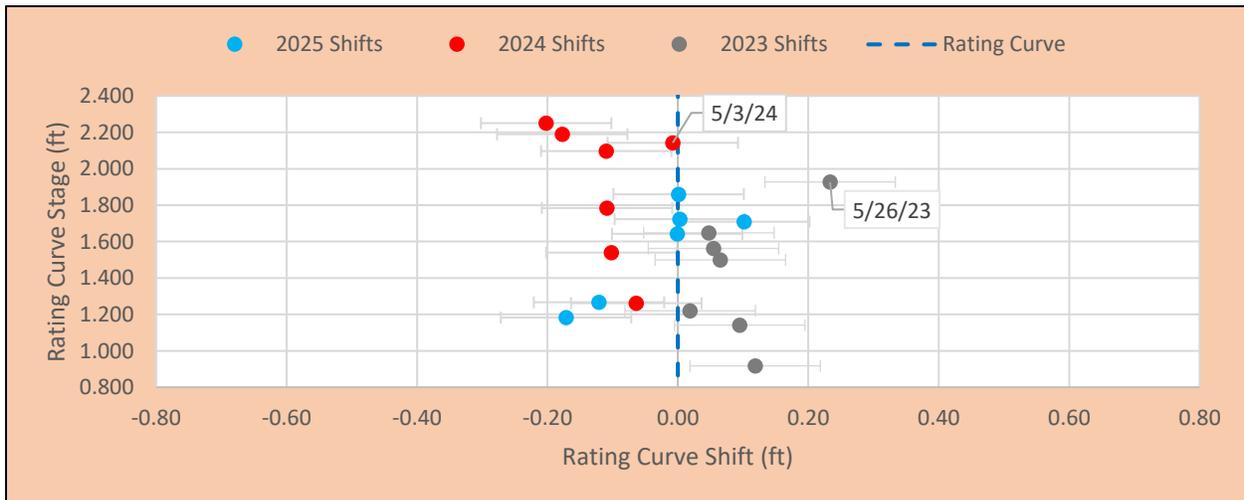
Figure 15: WFMR Shift Diagram

Early data from spring to fall 2023 show small shifts (0.02 to 0.23), which likely reflect minor adjustments in bed material around the boulder control. In 2024, a moderate shift of -0.20 was observed in April, possibly indicating minor aggradation; however, this shift quickly returned toward zero after the spring high flows in subsequent measurements. Most 2024 and 2025 measurements cluster close to zero shift, with only minor changes (up to -0.18) observed during summer and fall months, indicating generally stable control conditions with occasional minor scour and aggradation events. Martin River overbank flooding conditions in late summer and early fall 2024 do not indicate significant changes in control. The small magnitude and limited variability of rating-curve shifts suggest the boulder control provides a relatively stable hydraulic reference, reducing the need for frequent rating adjustments or major re-surveys.

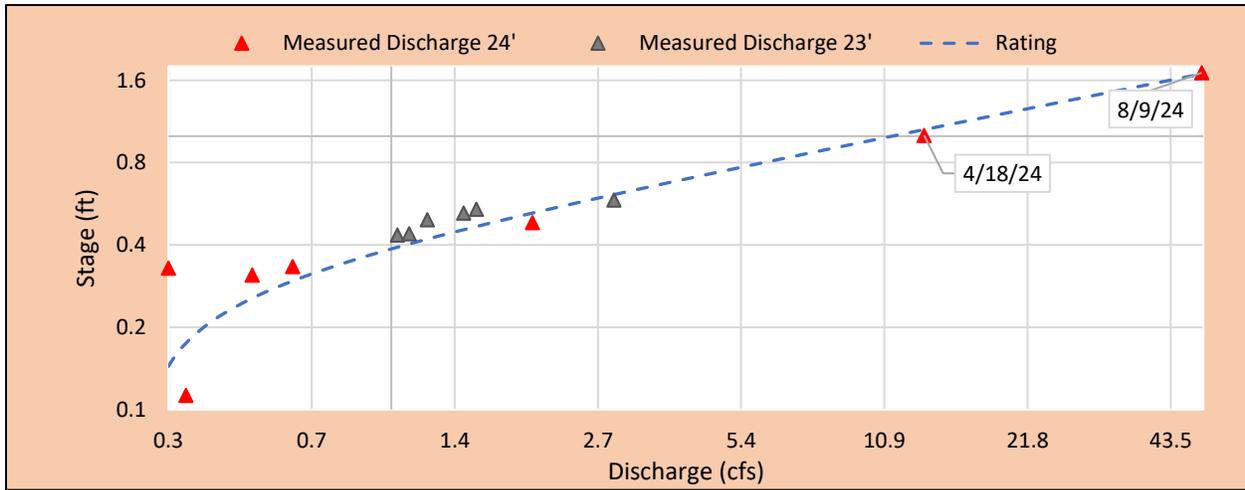
Figure 16: Trib RM4.2 Rating Curve

Figure 16 illustrates the Trib RM4.2 stage-discharge relationship, based on 14 recorded measurements, compared to the computed rating curve equation.

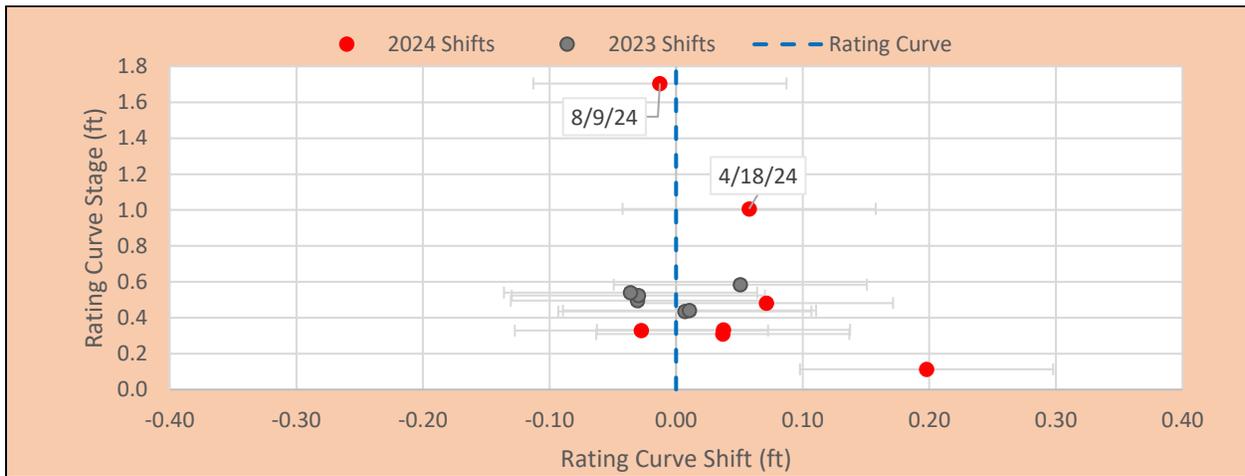
Figure 17: Trib RM4.2 Shift Diagram

This small, 5-foot-wide stream with a boulder section control appears stable over the 2023 to 2024 monitoring period, with shifts mostly between -0.04 and +0.07 (Figure 17), indicating a relatively stable hydraulic control and minimal bed elevation changes under typical flow conditions. The small magnitude of shifts through spring to mid-summer 2024 suggests consistent channel geometry and control integrity, with the boulder section providing a reliable reference for discharge estimation. Discharge values for the small stream range mostly between 0.3 and 2.9 cfs, reflecting low-flow conditions.

A notable outlier is on 8/9/24, when a significant flooding event from Martin River caused a sudden spike in discharge to over 50 cfs. This gage location was lost during the event, and the sensor was removed. Overall, the stable, low-amplitude rating-curve shifts suggest a resilient section control through the monitoring period. The boulder control and sandy gravel substrate likely contribute to limited channel mobility under typical flows. This stability supports reliable use of the established rating curve for continuous discharge estimation outside of extreme events.

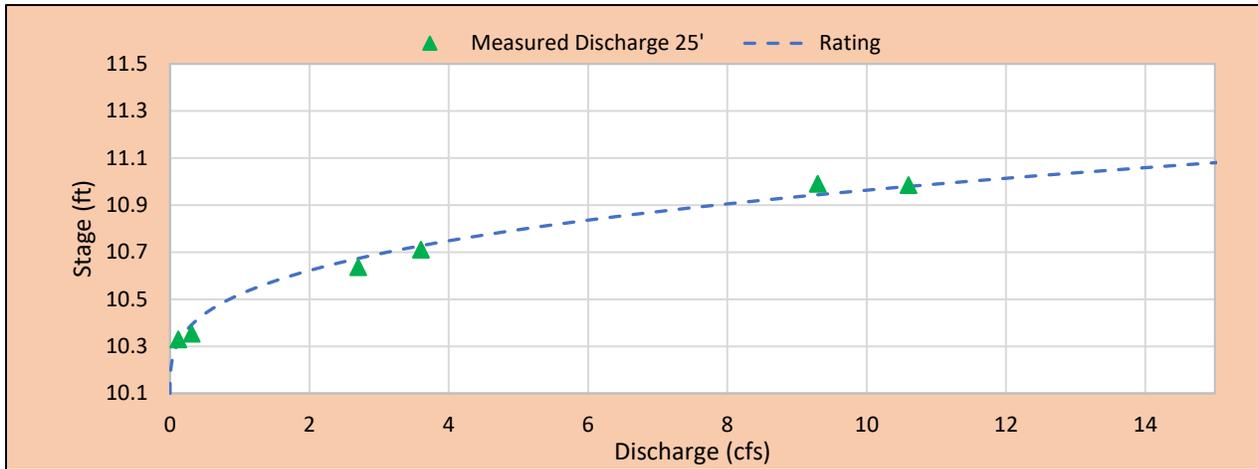
Figure 18: MR Tributary 1.070 Rating Curve

Figure 18 illustrates the Martin River Tributary 1.070 stage-discharge relationship, based on six recorded measurements, compared to the computed rating curve equation.

This approximately 10-foot-wide sandy gravel bed stream with a gravel riffle section control appears stable over the 2025 monitoring period. The dataset includes six discrete discharge measurements, ranging from 0.12 to 10.6 cfs, with associated rating-curve shifts between -0.05 and $+0.04$ (Figure 19).

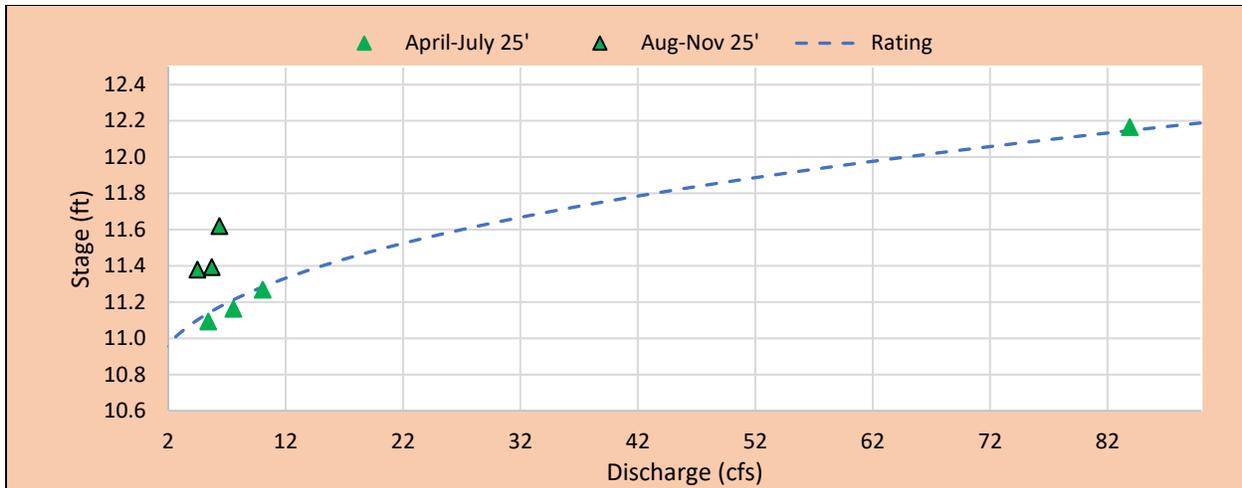
Figure 20: OCH2.8R Rating Curve

Figure 20 depicts the Martin River tributary OCH2.8R stage-discharge relationship, with seven recorded measurements, relative to the computed rating curve equation.

This approximately 20-foot-wide tributary, characterized by a sandy-gravel bed with stable 3-foot banks and a well-defined cobble riffle control, displayed stable hydraulic behavior early in the 2025 season. Rating curve shifts before mid-June were minor (+0.01 to +0.05 ft) (Figure 21), indicating that the riffle control and reach maintained a relatively stable bed configuration. During this period, the channel retained its typical coarse controlling roughness, and the stage-discharge relationship showed minimal deviation across low to moderate flows. The largest discharge measurement recorded on July 25 (83.9 cfs) exhibited a negligible shift (-0.02 ft), without evidence of immediate geomorphic alteration at the control.

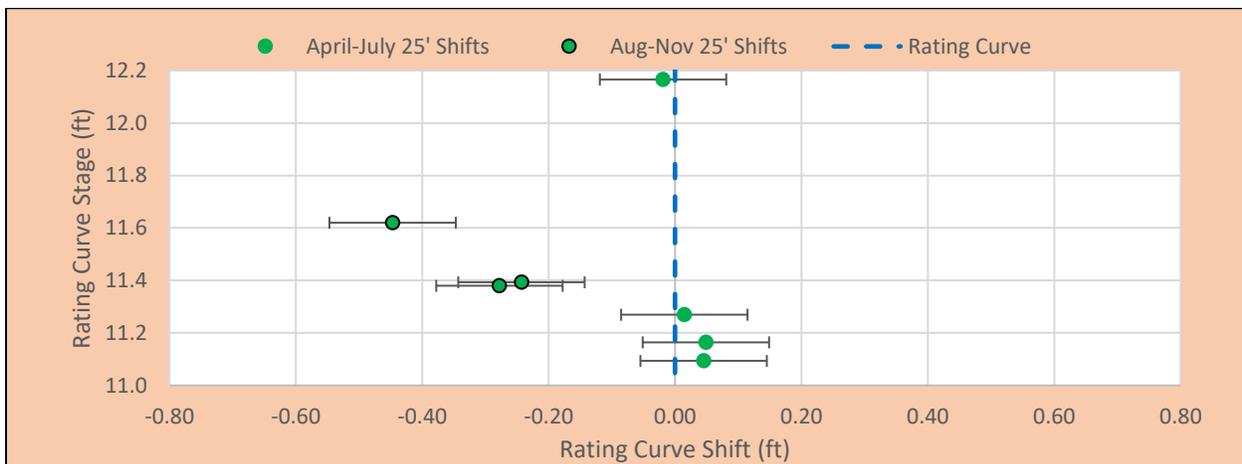
Figure 21: OCH2.8R Shift Diagram

Conditions changed sharply following the prolonged overbank input upstream from Martin River between June and September. The flood introduced sand and fine sediment into the tributary, and post-flood measurements show progressively larger rating-curve shifts (from -0.24 to -0.45 ft) from September to November. These increasing offsets are consistent with net aggradation noted at the gage, where burial of the channel bed surface reduced hydraulic conveyance and increased stage for a given discharge. The trend indicates that deposition continued into the fall, altering the control geometry. As a result, the stream should be considered in a transitional, sediment-impacted state; the pre-flood rating is no longer valid without adjustments to the rating curve for fall flows.

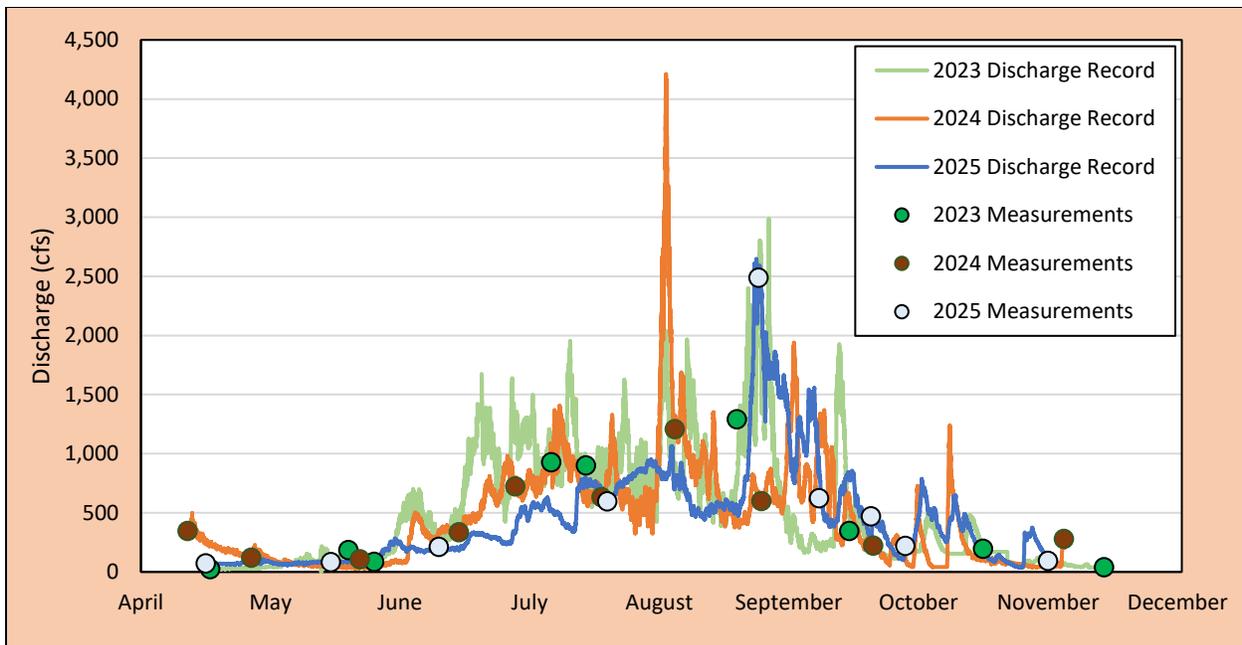
Figure 22: Constriction Discharge Record

The three-year hydrograph illustrates a coherent, continuous-discharge record with consistent measurement coverage and identifiable hydrologic patterns that align with seasonal drivers (Figure 22). Across the record, discharge measurements align well with the computed continuous discharge record, indicating that rating-curve shifts were appropriately applied. These adjustments, applied between measurements, effectively maintain continuity without introducing artificial bias in the hydrograph. Measurement density is appropriate, particularly around rising and falling limbs, providing multiple independent checks for rating stability during highly dynamic hydraulic conditions. High-flow measurements collected during peaks confirm the upper-end performance of the rating, while low-flow measurements collected during spring and late autumn constrain the lower limb.
