TO: Ryan McLaughlin, PE
 FROM: Mya Sawyer, EI; Andrew Johnson, PE
 DATE: 12/8/2025
 PROJECT: Bradley Lake Expansion Project
 SUBJECT: 2025 Dixon Operations Model Update

DOWL again collected discharge measurements on the Martin River and its major tributaries. This memorandum describes the updates to the Dixon Diversion operations model with 2025 streamflow measurements.

MARTIN RIVER STREAMGAGING DATA ACQUISITION AND ANALYSIS REPORT

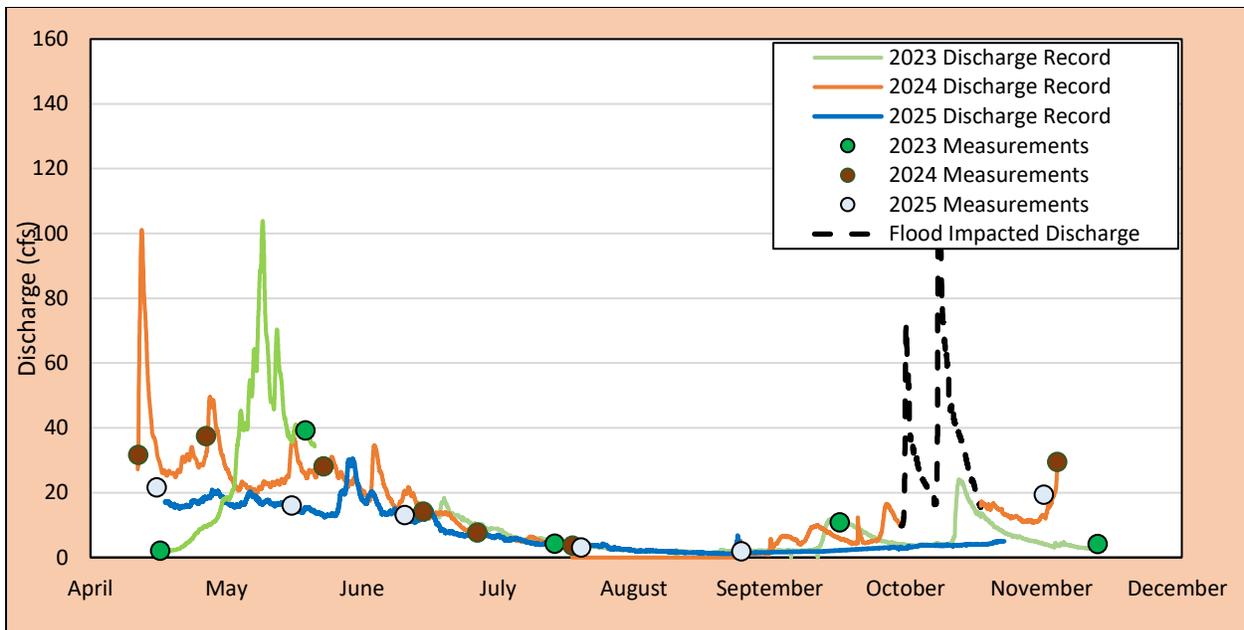
Figure 23: West Fork Martin River Discharge Record

The computed three-year hydrograph of the West Fork Martin River, shown in Figure 23, exhibits a consistent snowmelt-dominated regime with some annual variability in peak magnitude and summer baseflow. Spring runoff in 2023 and 2024 produced high flows (over 50 cfs) followed by a smooth recession to late summer baseflows generally between <1 and 3 cfs. The 2025 season experienced higher summer baseflows, and the spring peak likely occurred before sensor deployment. Overall, the hydrographs exhibit a characteristic transition from snowmelt to groundwater-dominated baseflow, with some responses to fall storms.

Beginning in late August 2024, the record was periodically affected by overflows from the East Fork Martin River, indicated by a black dashed line, after its channel migrated and began flooding the WFMR gage reach. These events caused abrupt and unrepresentative increases in stage and computed discharge, and the affected data were flagged and excluded from hydrologic analysis. In 2025, woody debris accumulated at the downstream control, periodically raising the local water surface, invalidating the standard rating. Daily discharges were estimated during periods of debris-impacted stage data. Periods of flood-impacted discharge and debris-related control changes in 2024 and 2025 were validated using time-lapse camera data.

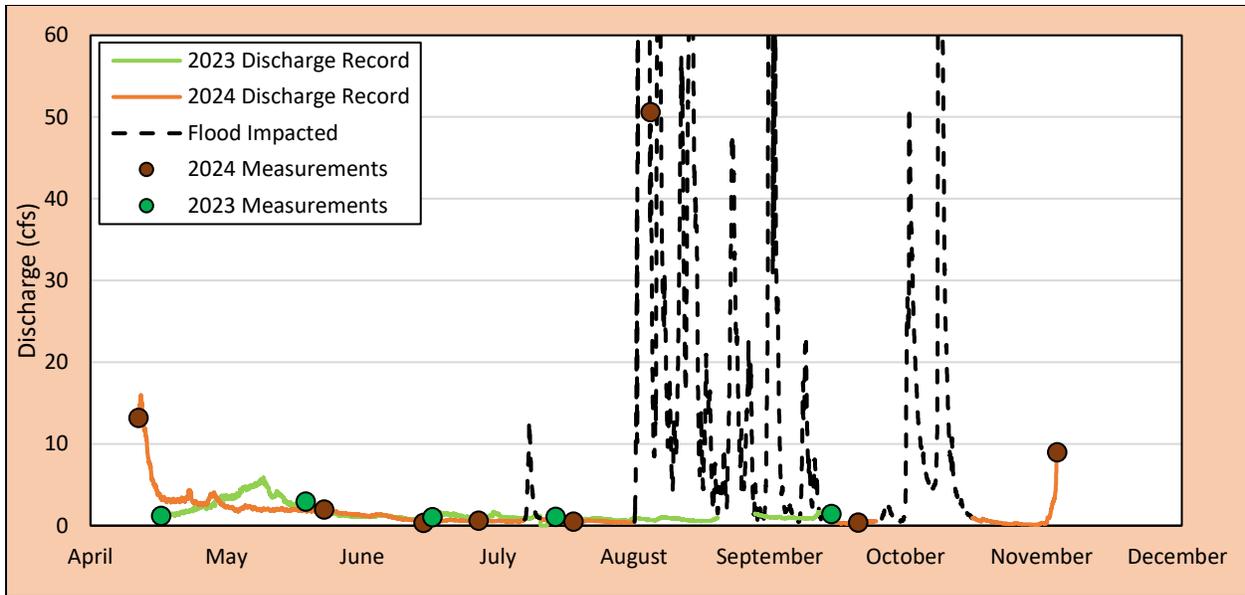
Figure 24: Trib RM4.2 Discharge Record

The two-year hydrograph for Trib RM4.2 (Figure 24), exhibits a consistent pattern of spring snowmelt peaks, followed by smooth seasonal recessions to low summer baseflows. In both 2023 and 2024, tributary discharge remains predominantly below 3 to 5 cfs after early May, with only brief melt-driven pulses. This low and stable hydrograph shape is characteristic of a short, groundwater-moderated drainage with limited storage. During periods of valid hydraulic control, the continuous record aligns well with expected watershed behavior, indicating that the rating curve application was appropriate.

The periods of extreme variability beginning in mid-August 2024 and late August 2025, shown as black dashed lines, "Flood Impacted" discharge values, do not represent actual Trib RM4.2 flows. These abrupt and repeated spikes coincide with overbank flooding from the Martin River, which inundated or backwatered the Trib RM4.2 channel. The overbank peaks are not shown on Figure 24 for clarity. The Trib RM4.2 basin is too small to generate flows of this magnitude or frequency; the elevated stage recorded and associated discharge during these intervals cannot be interpreted as natural flow from the Trib RM4.2 watershed. Periods of 2024 flood-impacted discharge were validated with time-lapse camera data. The discharge record with overbank flooding removed is shown on Figure 25.

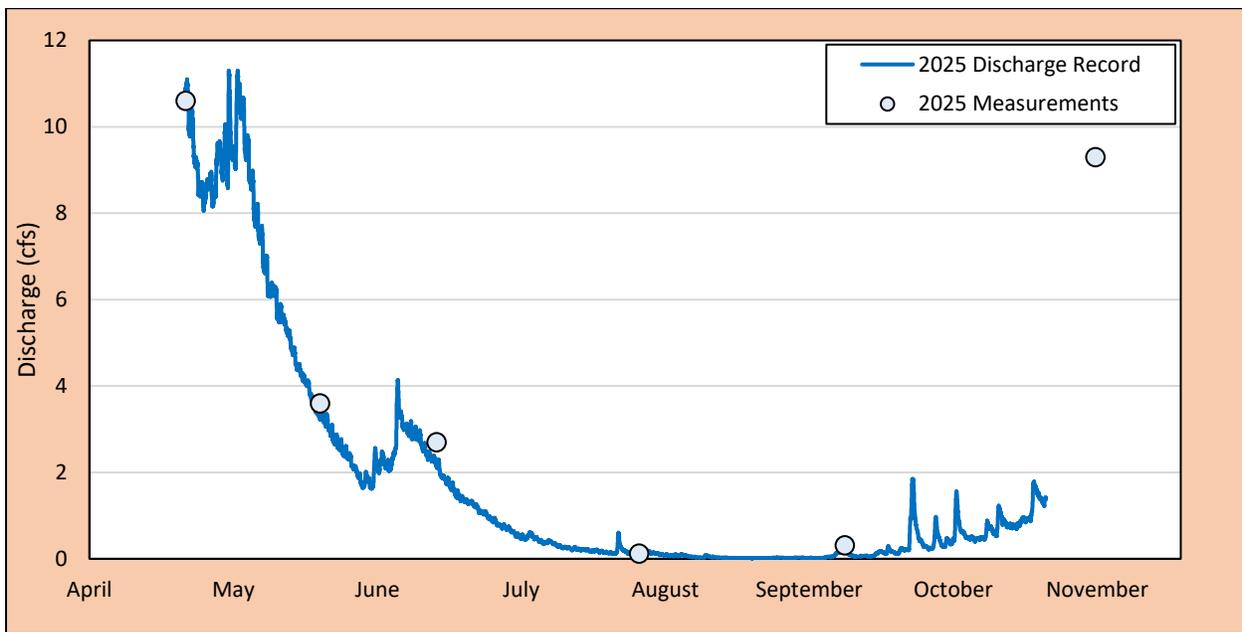
Figure 26: MR Trib 1.070 Discharge Record

The 2025 hydrograph for Trib 1.070, shown in Figure 26, exhibits a clear early-season snowmelt pulse followed by a long, smooth summer recession and a late-season rise expected with rainfall. Discharge increases rapidly in April to early May, peaking around 10 to 11 cfs before declining steadily through June as snowmelt contributions diminish. By July and August, flows stabilize at very low baseflow conditions (<0.1 cfs), reflecting minimal remaining snowmelt and a predominantly groundwater-controlled hydrologic regime. Beginning in September and continuing into October, discharge begins to rise again, responding to periodic fall storm events with small but distinct peaks.

The discrete discharge measurements show strong agreement with the computed continuous discharge record, indicating a stable rating curve with no evidence of significant shifts. The early season April measurement aligns well with the stage-derived peak flows, while the May and June measurements fall along the seasonal recession, following the transition into summer baseflow conditions. No measurements suggest bias or deviation, and the continuous record behaves as expected for the watershed's hydrologic regime.

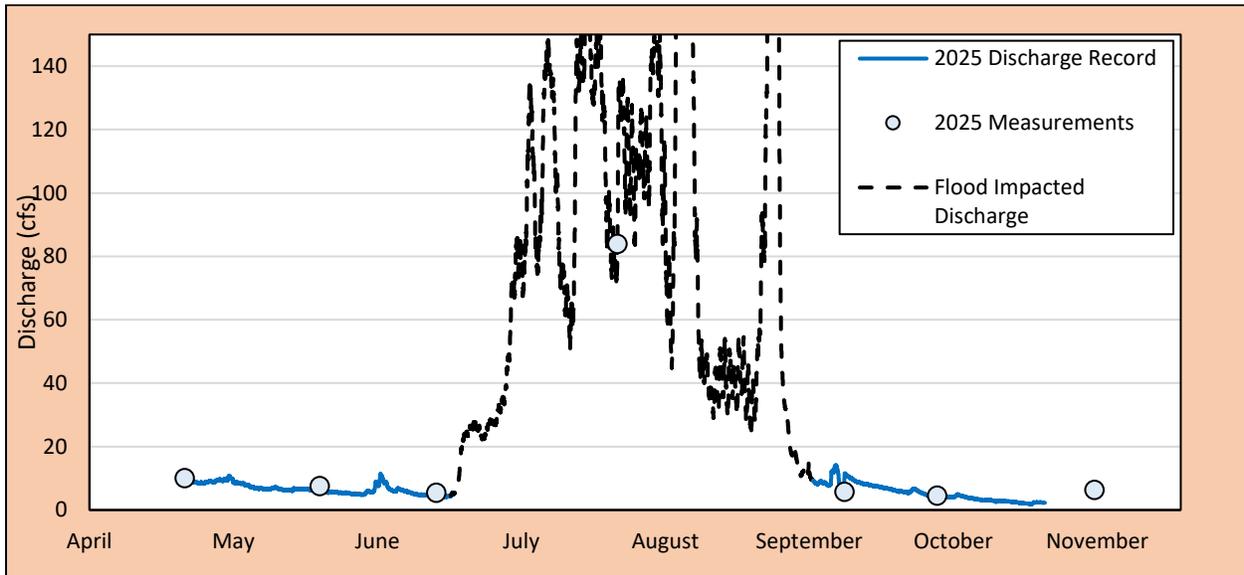
Figure 27: OCH2.8R Discharge Record

27 for clarity. These periods are not representative of the tributary discharge but instead reflect the flooding effects of the much larger Martin River.

During these overflow periods, computed discharge above 85 cfs is a rough estimate based on Manning's calculations and the recorded stage. Calculated values from June 19 to September 4 correspond to flooding from the Martin River and should be excluded from hydrologic interpretation. This period of flood-impacted discharge was validated with time-lapse camera and water temperature data. The discharge record with overbank flooding removed is shown on Figure 28.

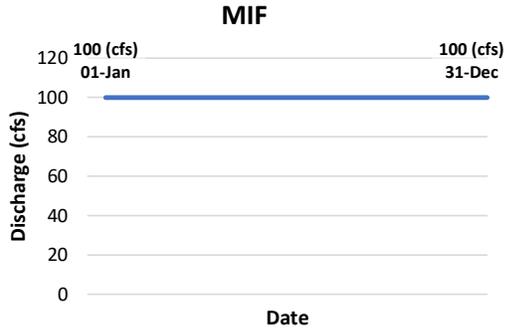
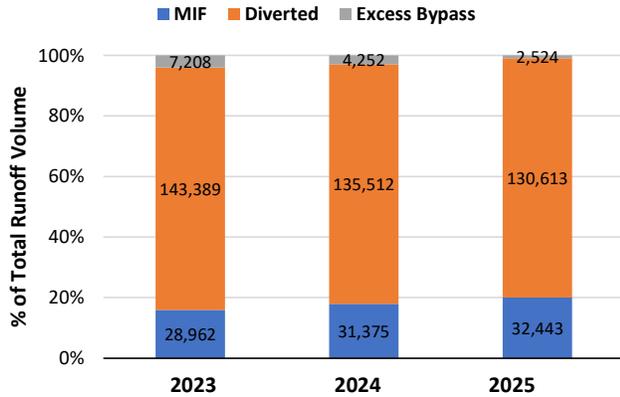
Note: Tunnel capacity of 1,650 cfs

Since the 2024 Dixon operations model update, the design and layout of the diversion have undergone significant refinement. Most notable is the diversion tunnel size and capacity, which is set at 1,650 cfs. Hence, the 2025 operations model update uses a tunnel capacity of 1,650 cfs. Attachment 3 presents the updated model results.
