AMENDMENT TO BRADLEY LAKE HYDROELECTRIC PROJECT (FERC No. 8221), DIXON DIVERSION PROJECT

Geomorphology and Sediment Transport Study Report

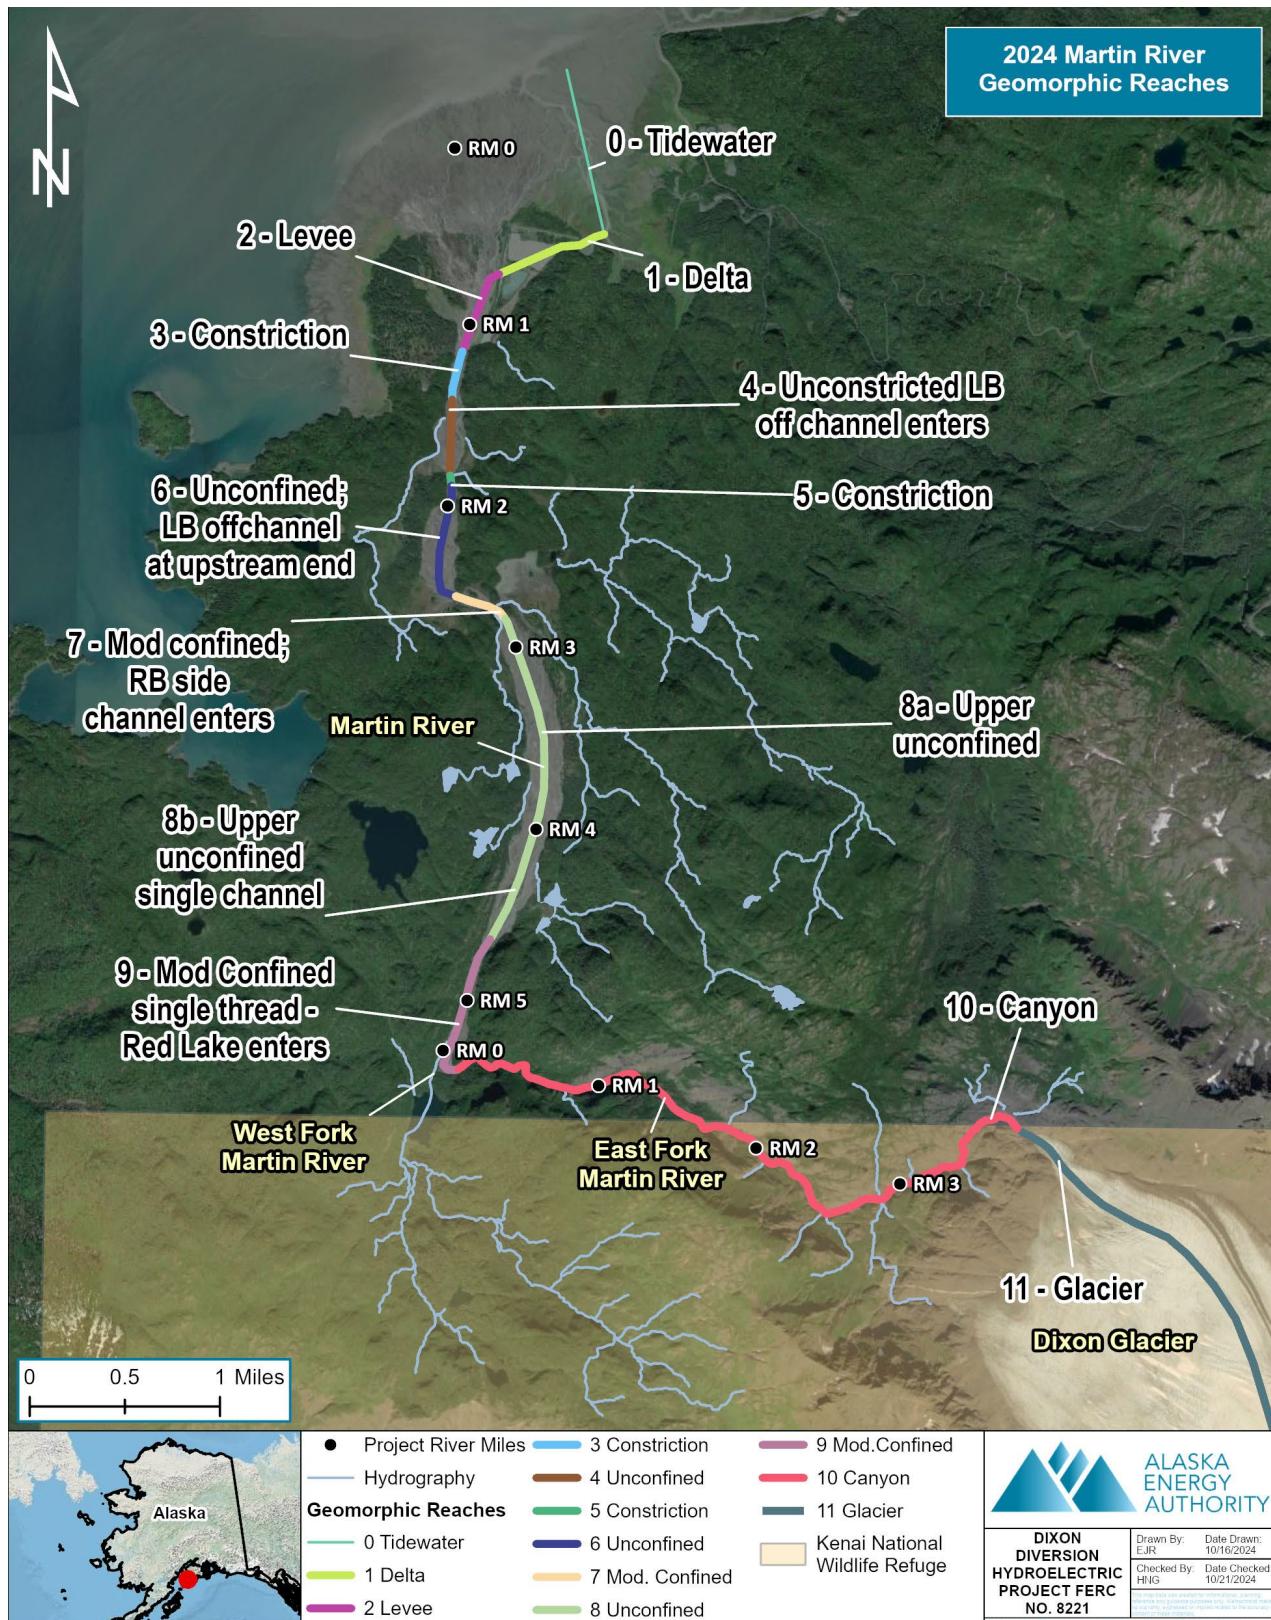
Figure 5-3 Martin River 2024 geomorphic reaches.

Twelve different geomorphic reaches were delineated along the Martin River and EFMR from tidewater to the Dixon Glacier in both 2022 and 2024 (Table 5-1, Figure 5-1, Figure 5-3). Reaches that are constricted/confined by bedrock or steep valley walls generally have one or two channels; unconfined areas generally have multiple channels (Figure 5-2). The number of wetted channels in each unconfined reach varies depending on flow conditions; at higher flows, more channels are wetted while at lower flows only one or two channels may be wetted. Note that Geomorphic Reach 8, while unconfined by valley walls, was subdivided into two distinct sub-reaches; a downstream unconfined sub-reach with multiple channels and an upstream sub-reach that is currently confined by a high terrace. The upstream reach (8b) is currently incising into past deposits to create the confining terrace; this section of the river was not confined to a single channel on historical aerial photographs (see discussion in Section 5.1.3).

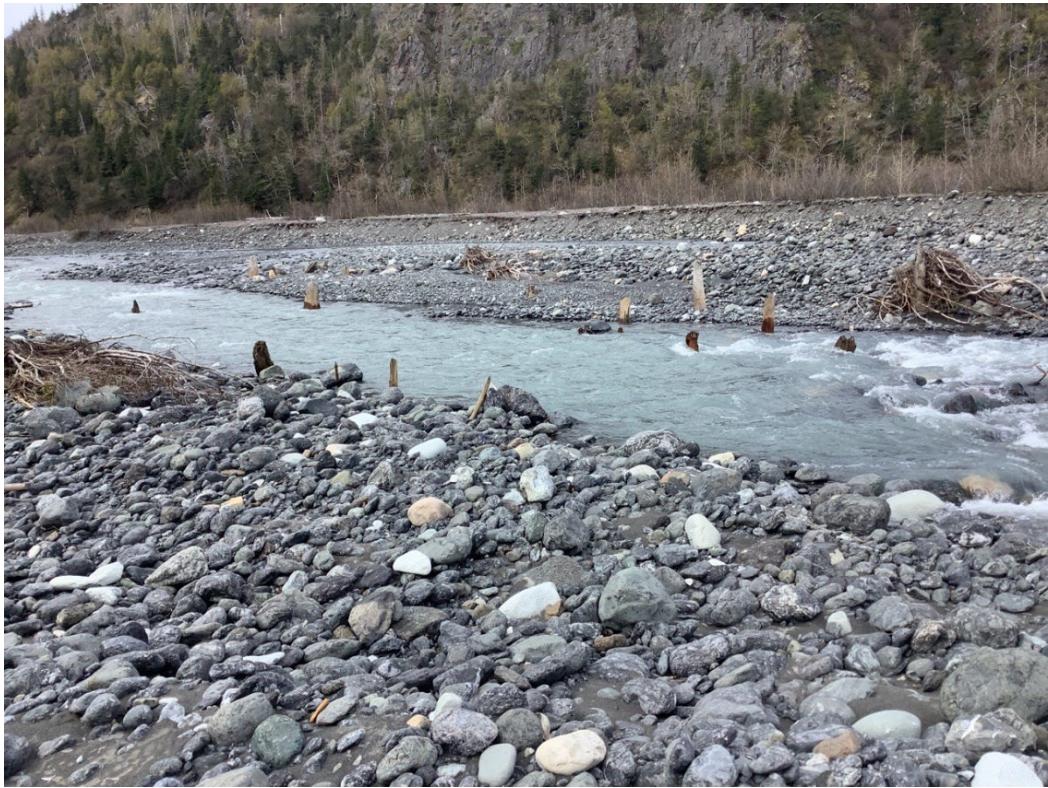
Photo 5-1 Buried trees in growth position near Martin River RM 4.4, photo taken looking upstream, May 22, 2023.

Field observations of indicators of rapid aggradation in the Martin River valley include large buried trees in growth position in the middle of the Martin River valley, particularly in geomorphic reaches 8a and 8b (between RM 3 and 4.5; see Photo 5-1) and near the mouth of the river suggest periods of rapid aggradation in the past. The buried trees near RM 4.4 are particularly interesting because they show that a mature forest existed in the middle of the Martin River valley in the past, relatively rapid aggradation of at least 7-8 feet that buried the trees and protected the stumps from erosion, and subsequent incision of a similar amount exposed them. Field observations of river valley margins in 2023 and 2024 also showed indicators of aggradation, with valley-margin vegetation buried in recent gravel resulting in tree death, new channels into the left bank off-channel areas at RM 2.5 and RM 1.2, and overtopping of the right bank levee near the mouth of the river in late 2023 (see Section 5.1.3.3 for detailed discussion of August 2023 levee breach).

Interestingly, this forest band is in the same location as the exposed stumps shown in Photo 5-1), suggesting that at least 7-8 feet of aggradation occurred between 1952-1982. The 1996-2022 aerial photographs show that the main channel no longer connected to the OCH RM4.3R ponds, and riparian vegetation was beginning to grow on the former fan. By 2022 the river had incised, and is likely still a few feet above the pre-1952 elevation forest in this area based on the buried tree stump elevations.

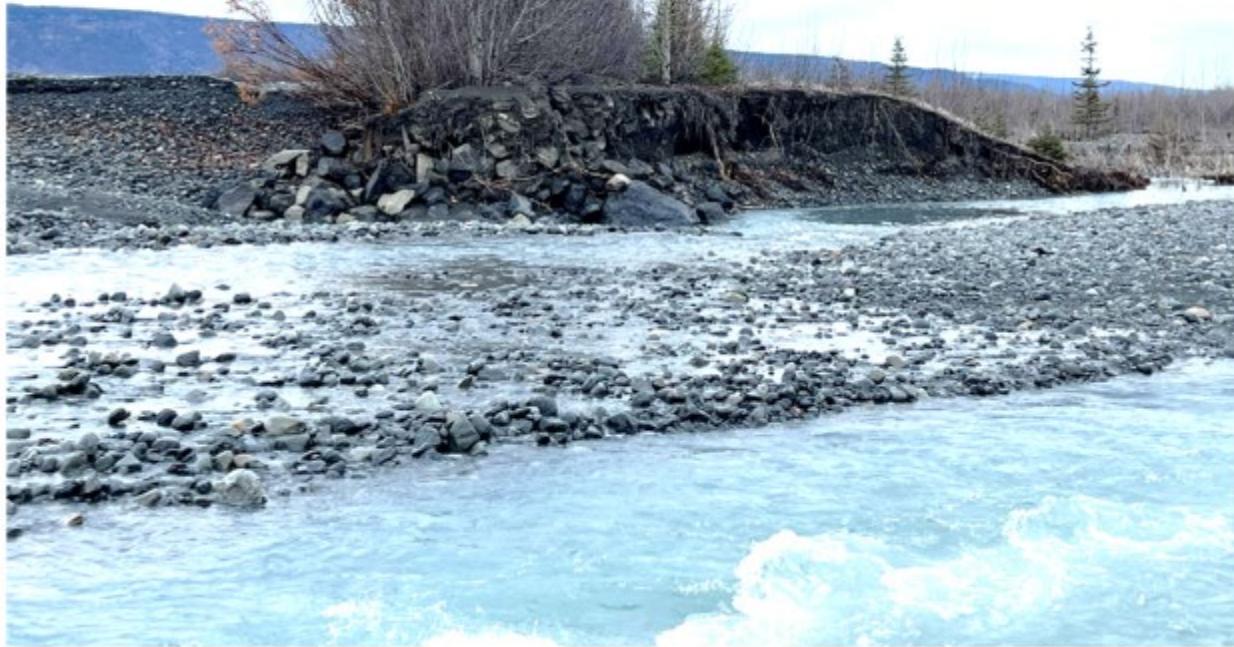
Photo 5-2 Cross-section of levee at breach location, November 2, 2023.

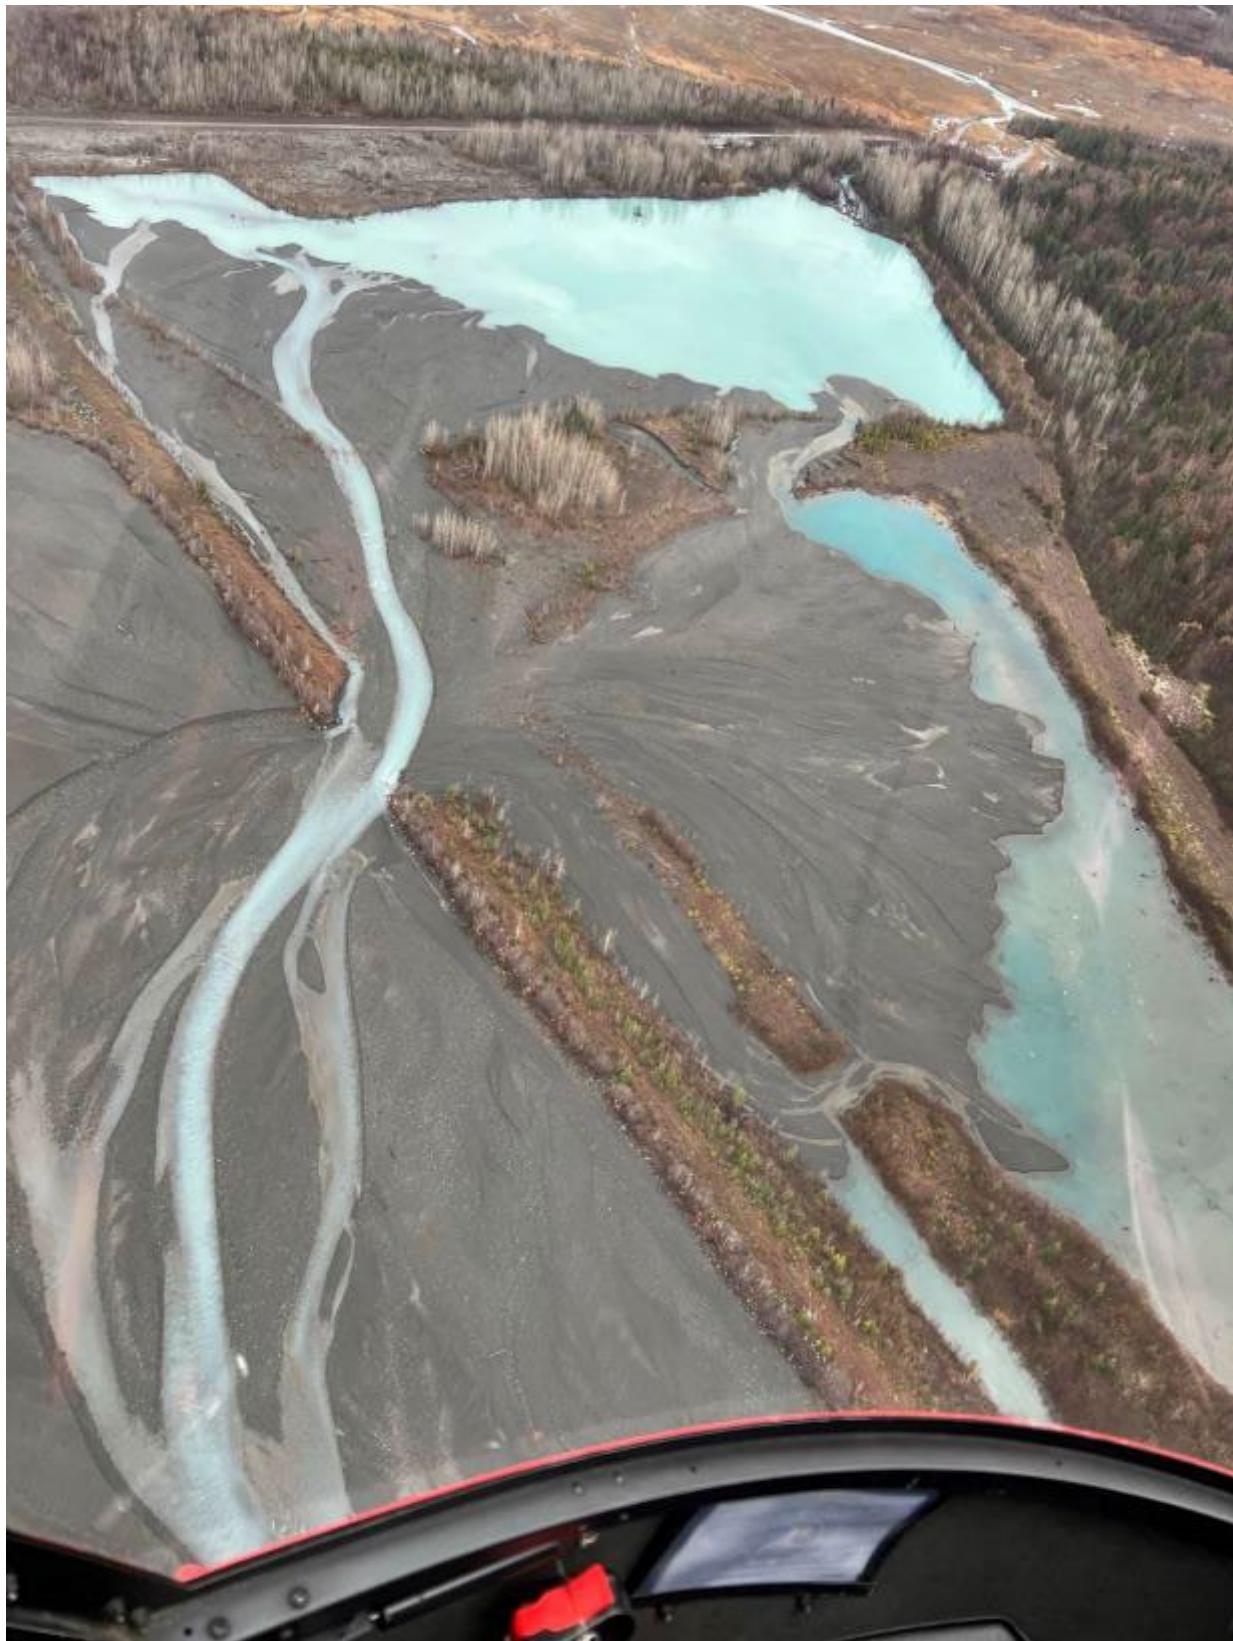
Photo 5-3 Extent of deposition in mitigation ponds; new Martin River outlet to tidewater (top right), November 2, 2023.

Since August 2, 2023, all flow from the Martin River flows through the levee breach, into the mitigation ponds, and out a low point at the northeast corner of the largest (northern) pond into Kachemak Bay (Photo 5-3, Photo 5-4, and Photo 5-5). The river has been building a delta into the ponds, with up to 15- to 35-foot-deep accumulations in some areas (as of November 2023) assuming the northern-most ponds were originally dug 15 to 35 feet below grade as shown on the as-built drawings. As of November 2023, the delta covered approximately 19.5 acres. Coho Salmon adults were observed in the ponds and just upstream of the levee breach during the November 2023 site visit, indicating that they were able to utilize and traverse the new river channel. In November 2023, the bottom of the channel was approximately 10-12 feet below the top of the levee at the breach location. Upstream from the levee breach, the river has been eroding and headcutting as it adjusts to the new base level.

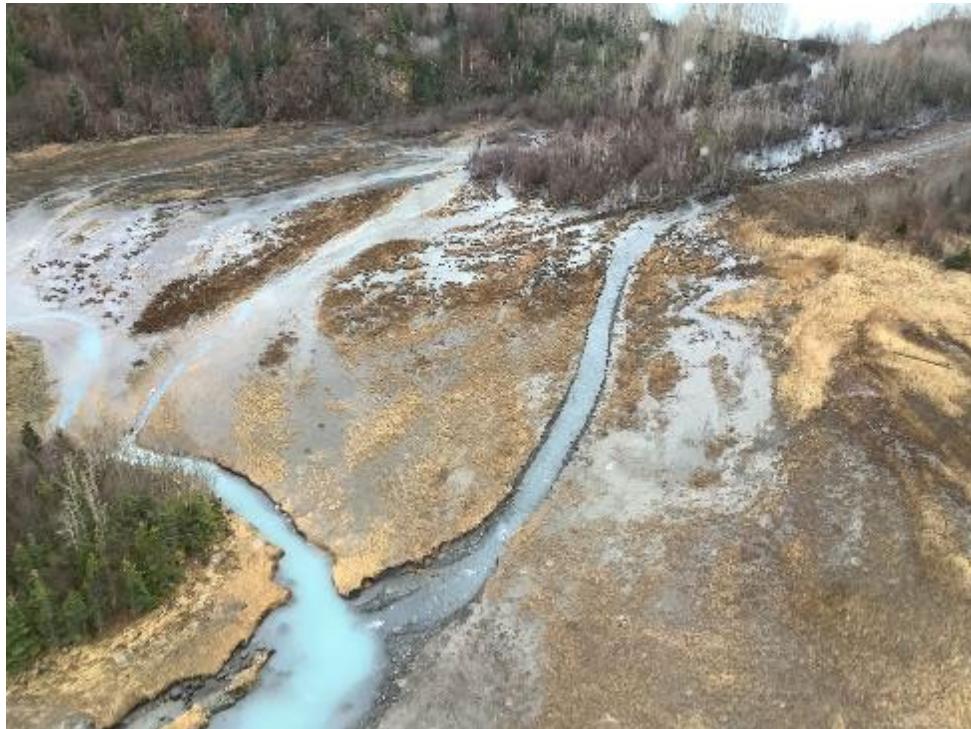
Photo 5-4 New outlet of Martin River looking upstream from tidewater to the northeast corner of the lowermost mitigation pond, November 2, 2023.

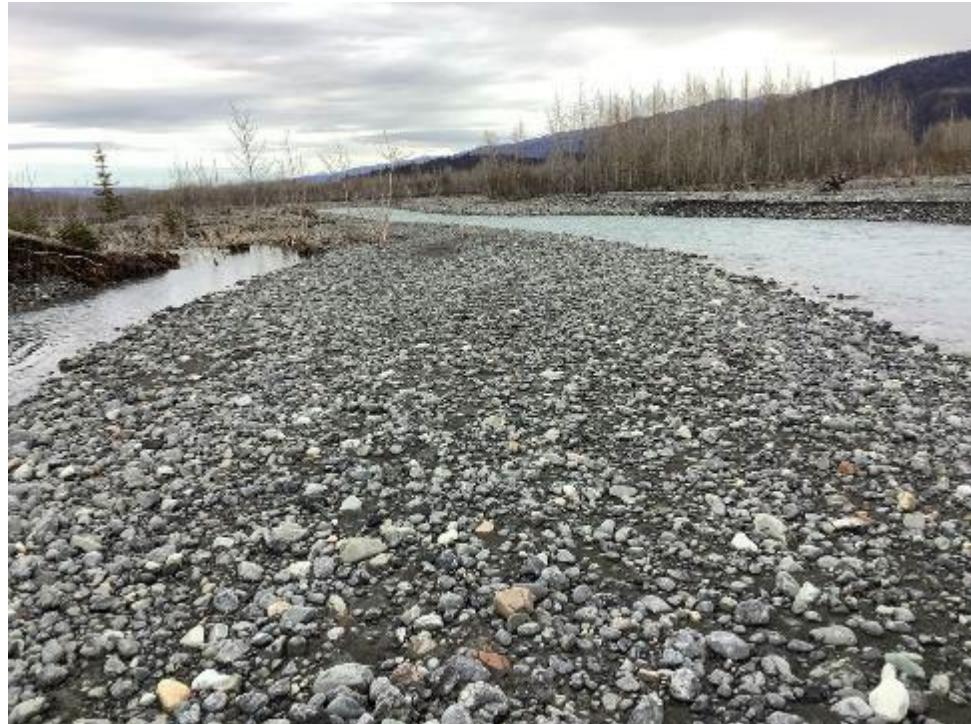
Photo 5-5 Mid-channel bar just downstream from levee breach (pebble count 2023-16 location), looking downstream, November 2, 2023.

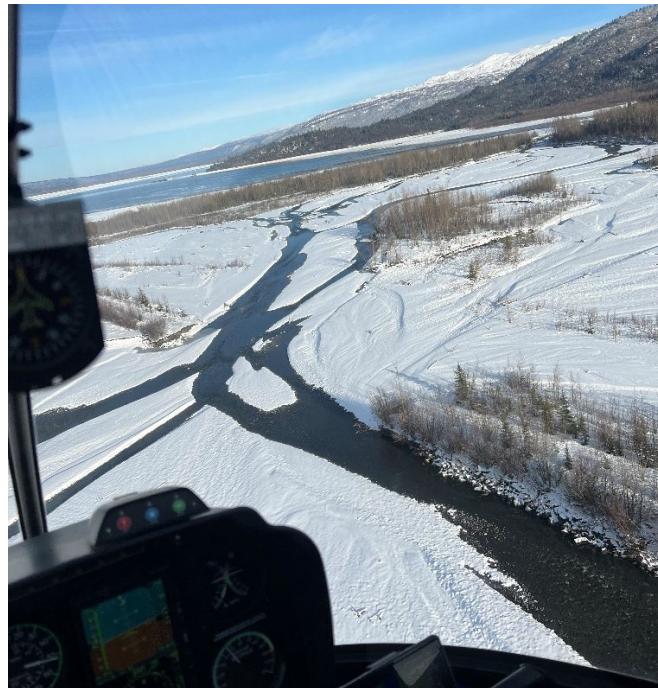
Photo 5-6 Martin River mouth looking downstream from levee breach, October 30, 2024.

As of the end of October 2024, the river had filled both northern mitigation ponds with sediment and had cut a wider channel through both the levee and the eastern pond/river outlet (Photo 5-6). There was evidence of multiple channels flowing across the airfield. The river will continue to aggrade in the former pond area over the next few decades.
