2024 MARTIN RIVER AQUATIC STUDIES REPORT

BRADLEY LAKE HYDROELECTRIC PROJECT
DIXON DIVERSION

FERC No. P-8221

Kleinschmidt Associates

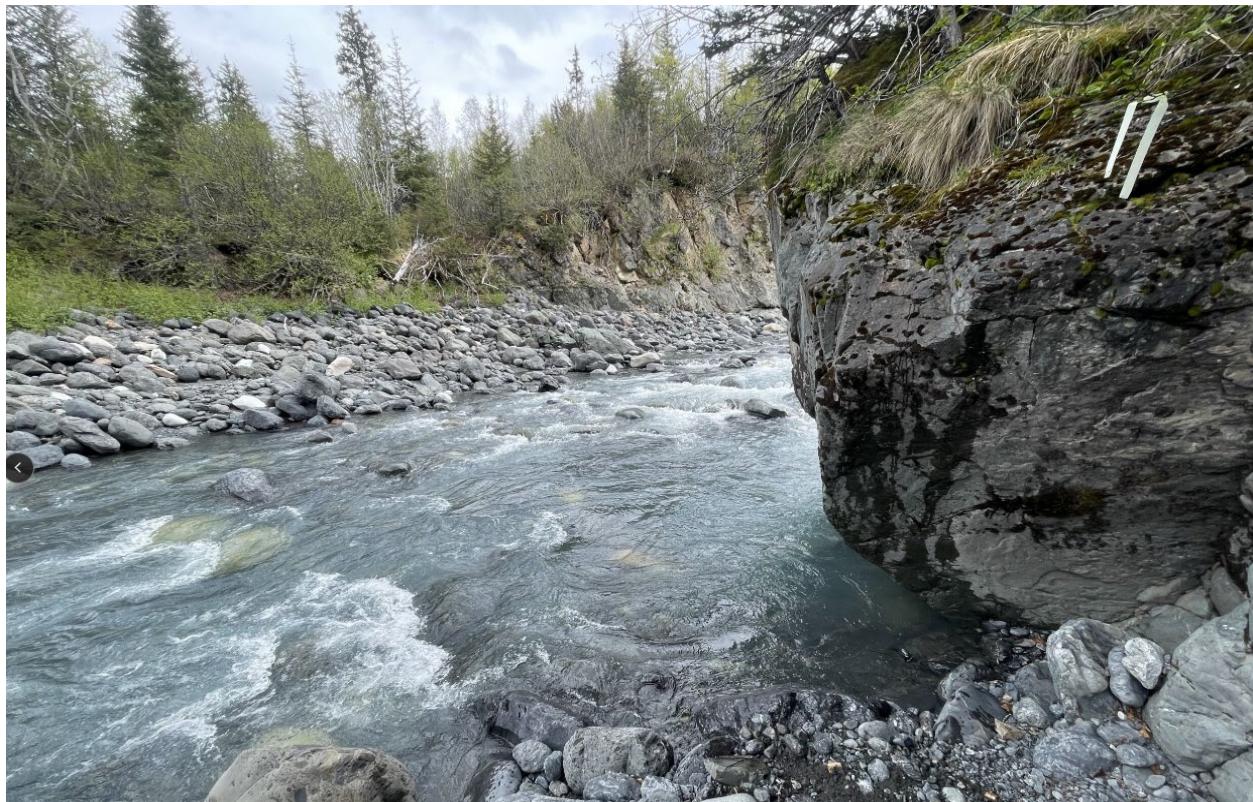
Photo 2-1 EFMR temperature logger installation location.

At the EFMR USGS Gage, temperature logging equipment was installed at a bedrock-bank constriction (Photo 2-1). At the WFMR RM 0.1 site, the backup thermistor was attached to an anchor in bedrock. At the Martin River off-channel site OCH4.2R (Photo 2-2), thermistors were anchored to stable trees at two locations (Photo 2-2), one immediately downstream of the lake and another closer to the confluence between OCH4.2R and the mainstem Martin River. This monitoring site was intended to determine the temperature of outflow from two source lakes and their inflowing streams. The lake is shallow, encroached with grasses, sedges, and aquatic vegetation, has dark, tannic water, and full sun exposure (Photo 2-1).

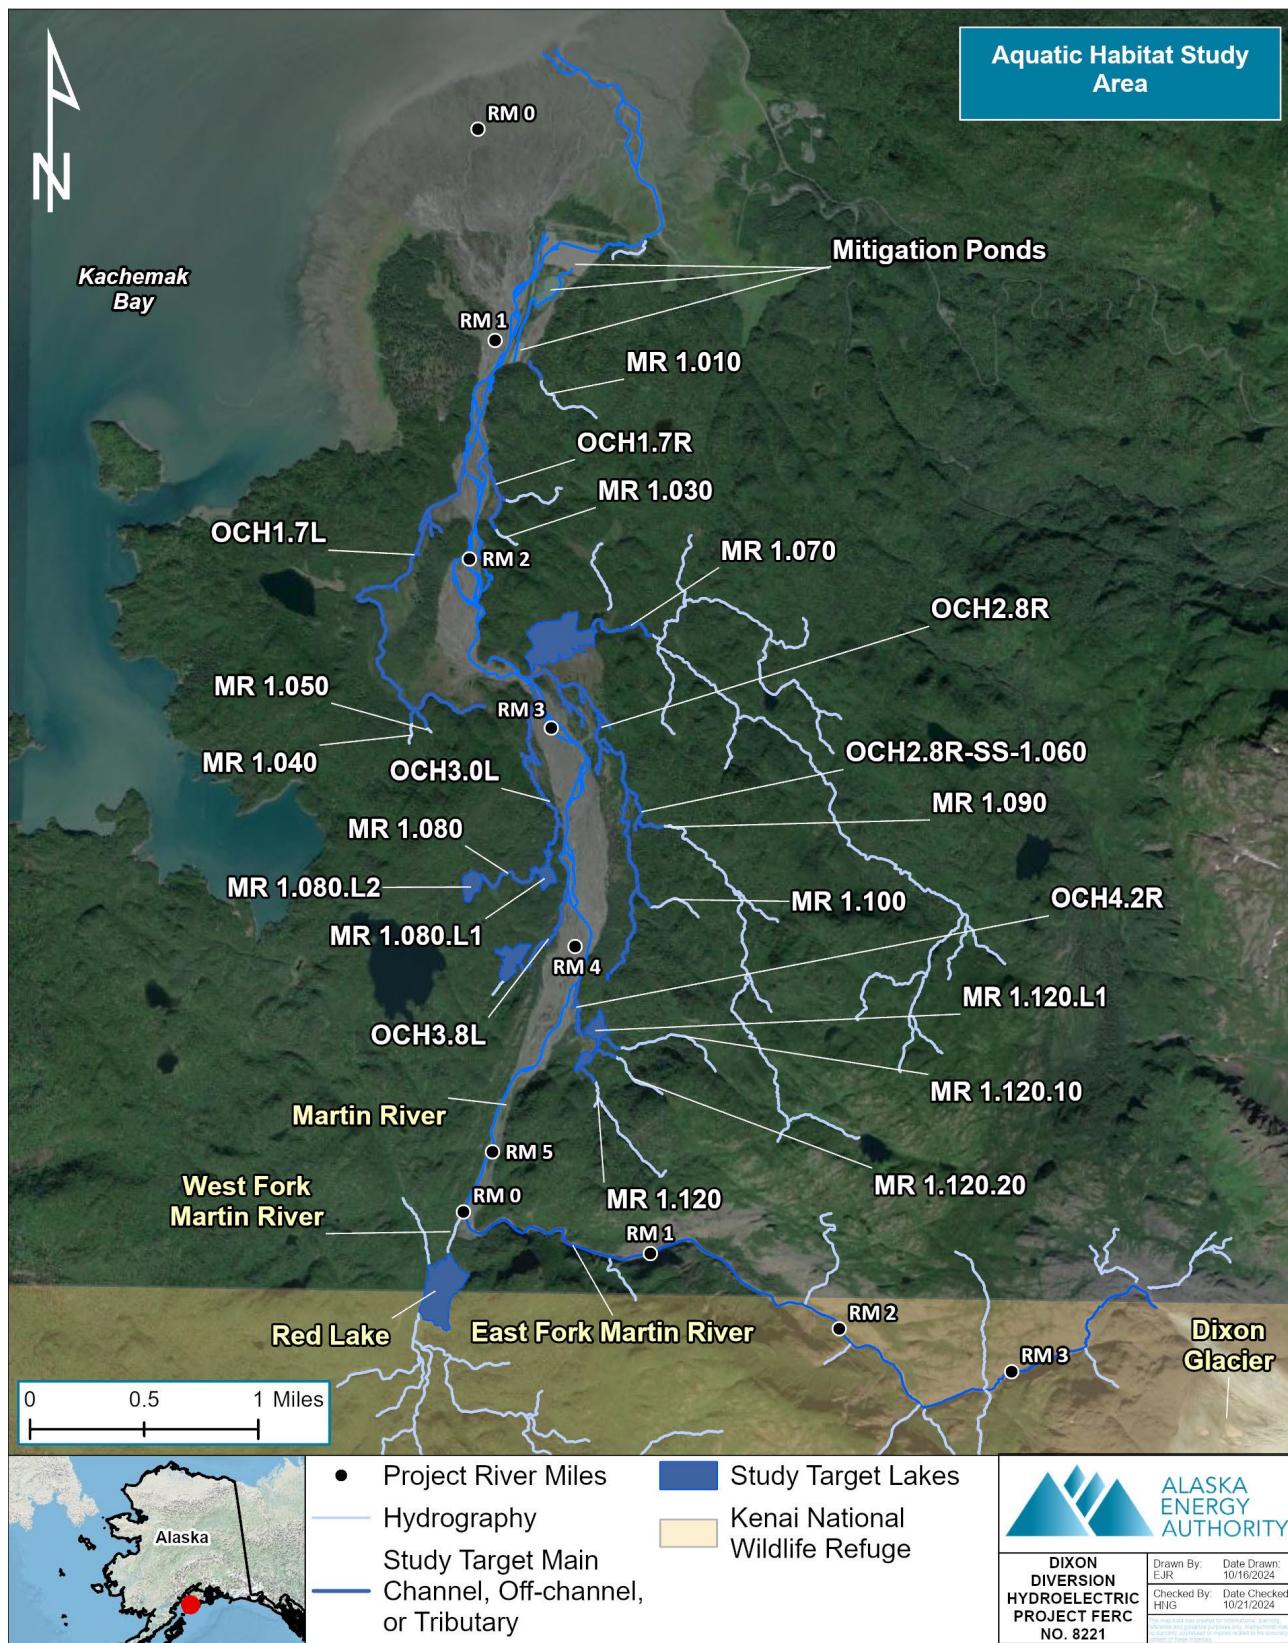
Figure 3-1 Martin River aquatic habitat study area.

The study area for the Aquatic Habitat Characterization Study includes the mainstem Martin River and associated off-channel, side-channel, and tributary habitats between the upper extent of tidewater at the downstream point and the lower portion of the EFMR and Red Lake outlet at the upper extent. Habitats within the watershed that were identified during GIS remote line mapping and were determined to be potentially assessable to fish were selected for ground-based habitat surveying (Figure 3-1).

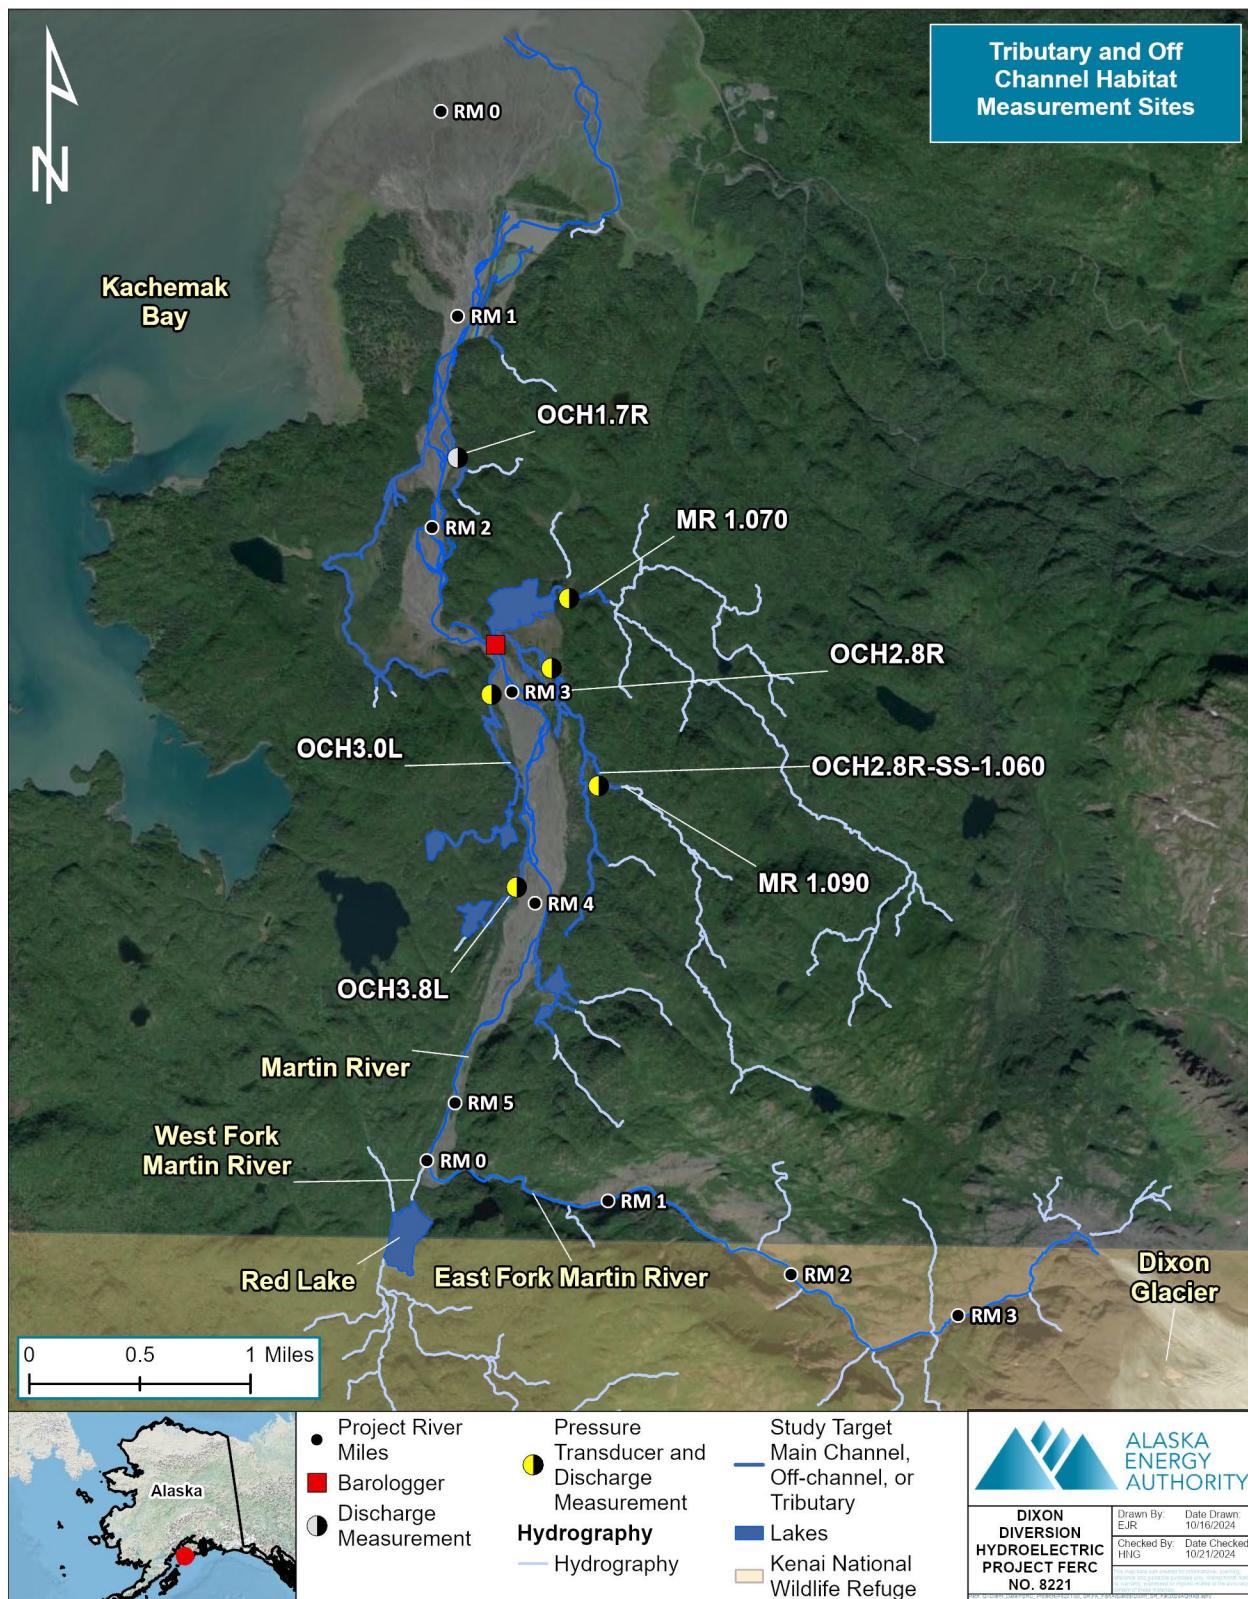
Figure 3-3 2024 stream flow monitoring sites.

Flow monitoring sites were established at five locations (Figure 3-3) to help characterize aquatic habitat in inflowing tributaries and to provide additional resolution to the existing flow monitoring network established as part of the Martin River Stream Gaging Study (AEA 2022b). The establishment of flow monitoring sites included the installation of pressure transducers and opportunistic discharge measurements.

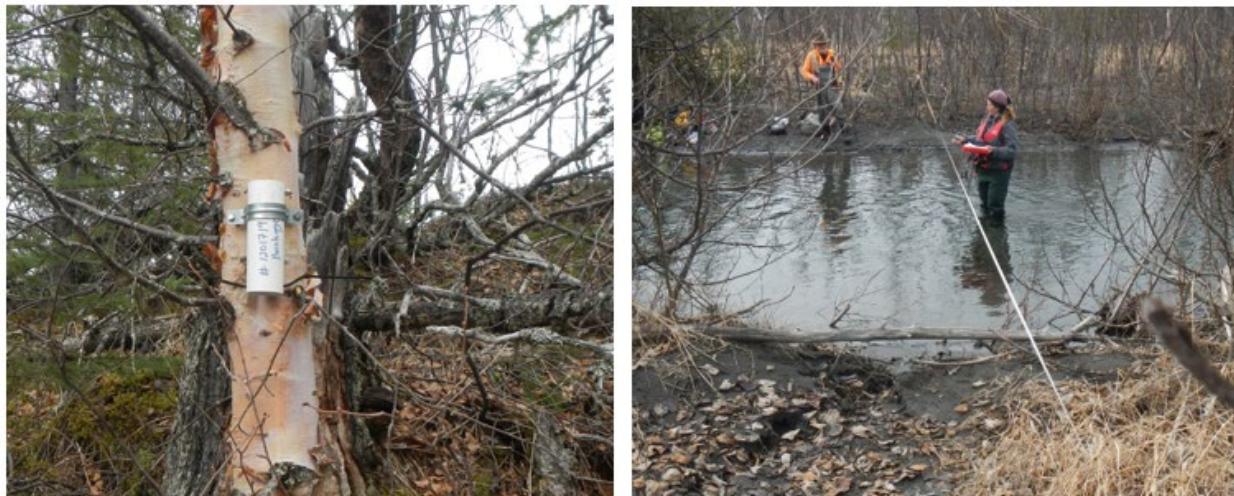
Photo 3-2 Position of barologger installed on a tree, and discharge measurements underway at OCH2.8R-SS-1 in May 2024.

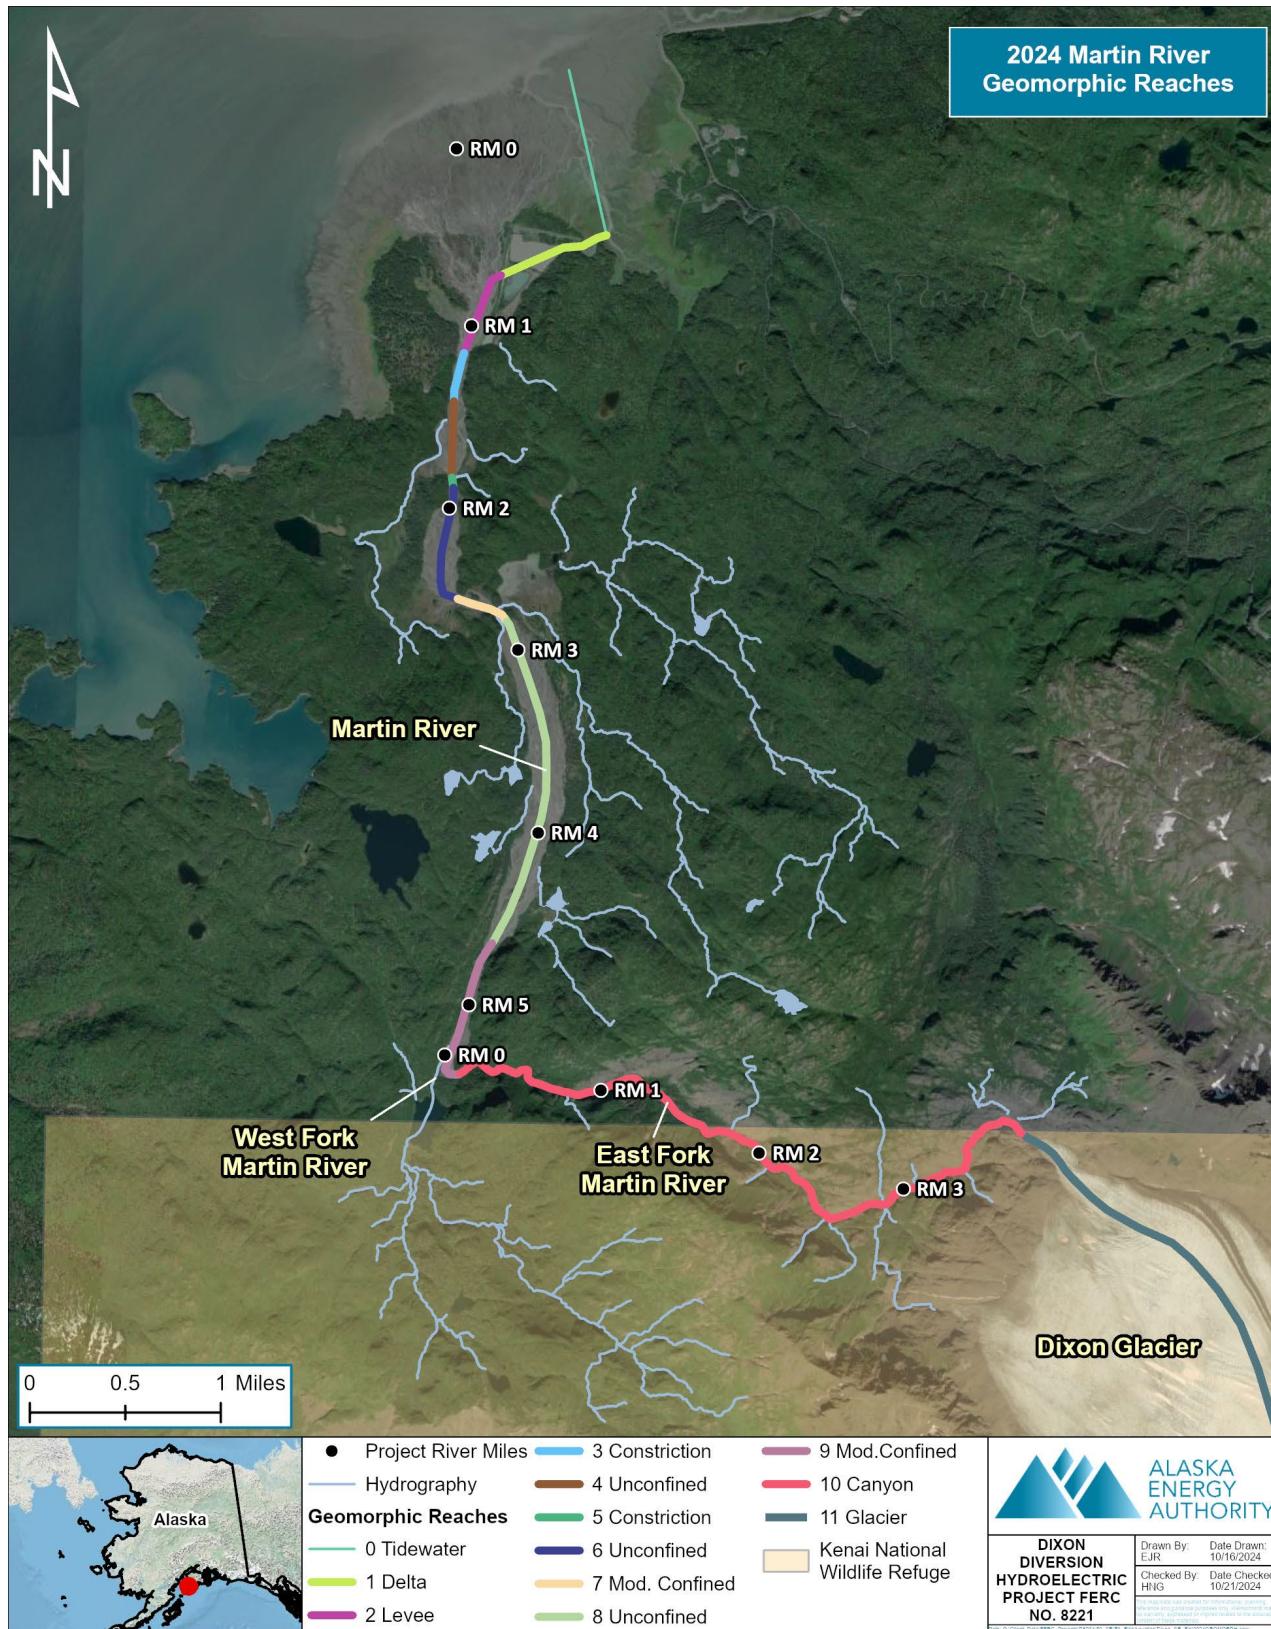
Figure 3-5 Martin River 2024 geomorphic reaches.

Reach No.	Reach Characteristics	Length (ft)	Length (m)	Average Gradient
0	Tidewater	--	--	--
1	Delta	3,145	959	0.7%
2	Levee	2,447	746	0.7%
3	Constriction	1,365	416	0.6%
4	Unconfined, left bank off-channel enters	2,114	644	0.8%
5	Constriction	283	86	1.1%
6	Unconfined; left bank off-channel area at the upstream end	3,400	1,036	0.8%
7	Moderately confined; right bank side channel enters	1,537	468	0.8%
8a	Unconfined, multiple channels	5,536	1,687	1.2%
8b	Unconfined single channel (constrained by high terrace)	3,820	1,164	1.2%
9	Moderately confined single thread Red Lake outflow (WFMR) near upper end of reach	4,238	1,292	1.5%
10	EFMR Canyon	19,671	5,996	6.7%
11	Glacier	33,256	10,136	9.8%

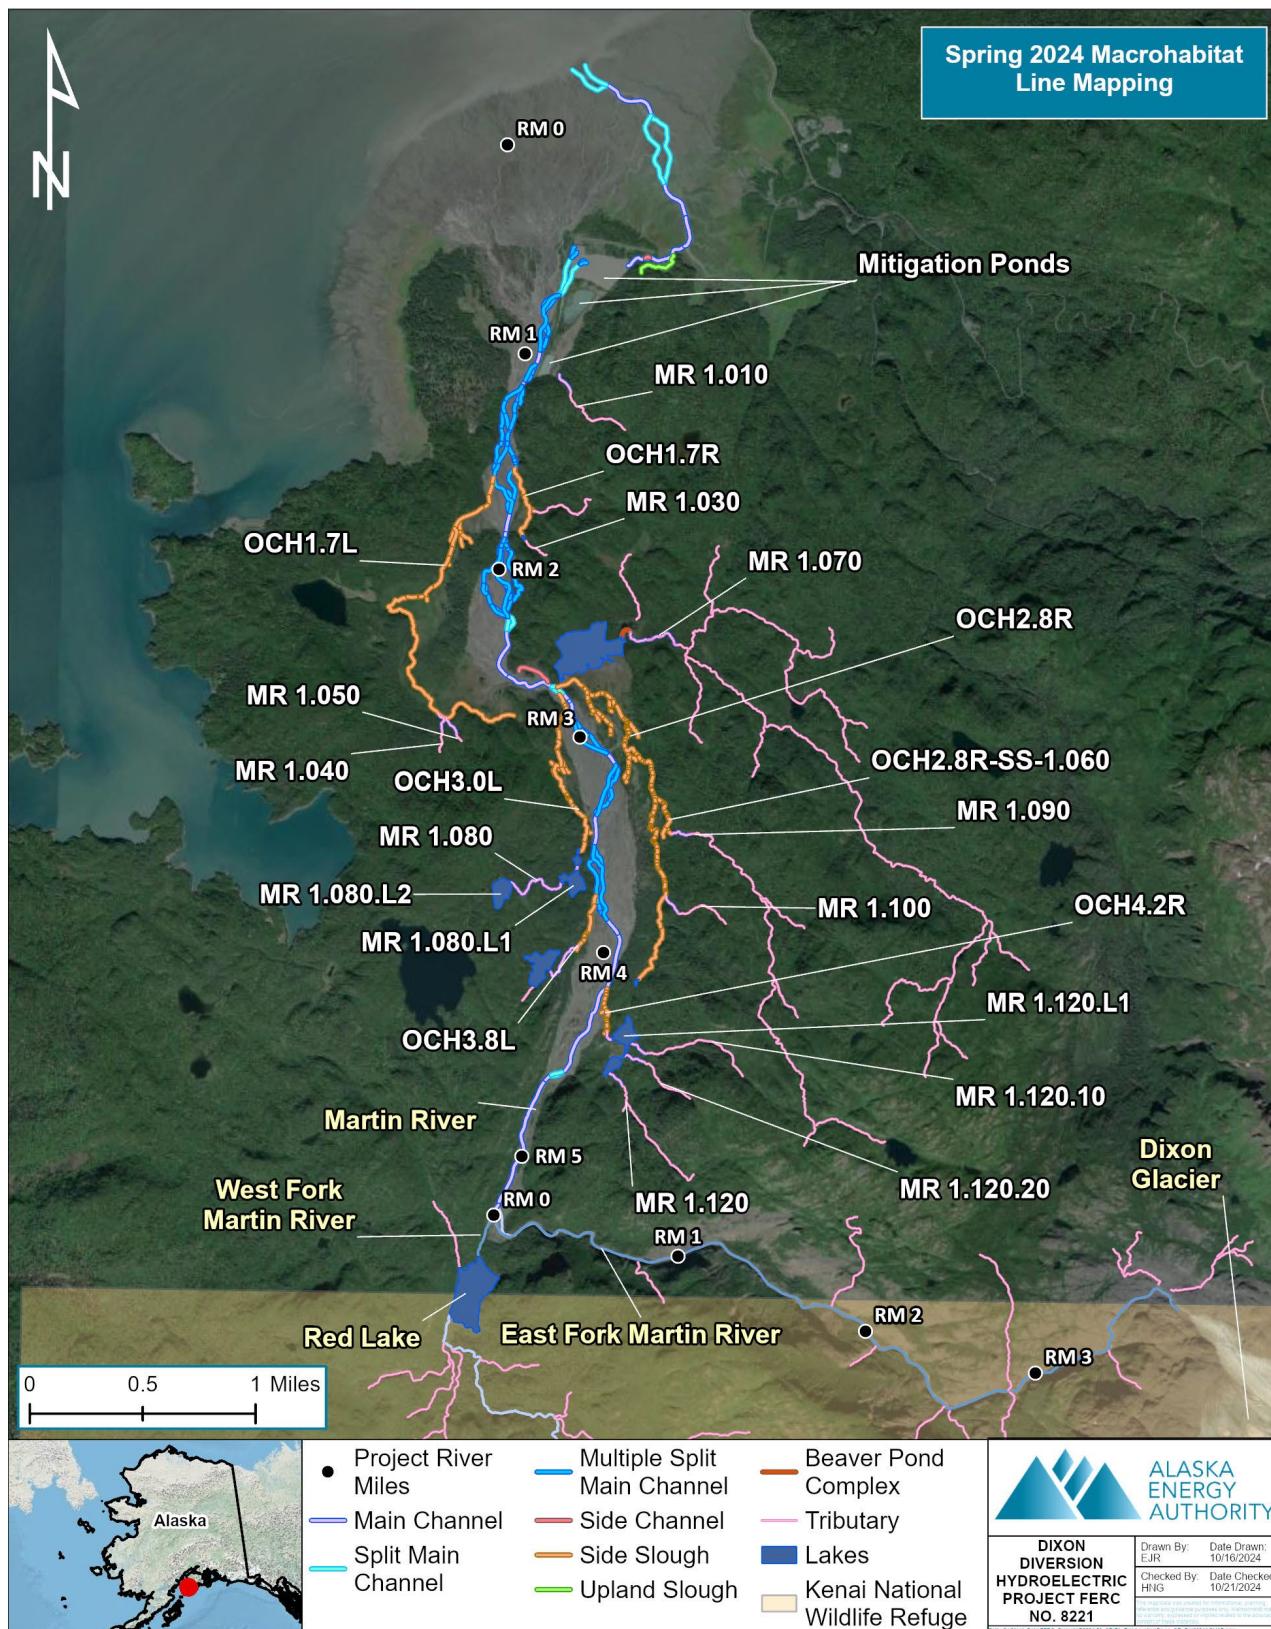
Figure 3-6 Martin River aquatic macrohabitats based on May 2024 stream and channel conditions.

The results of the line-mapping of macrohabitats are provided in Table 3-6 and displayed in Figure 3-6. A close-up of the macrohabitats in the area between Martin River RM 2.7 and 4.2 are presented in Figure 3-7. The macrohabitats were ground-truthed during spring 2024 at flows similar to when the aerial imagery and LiDAR was acquired. Many of the macrohabitats identified, especially in off-channel areas, were very complex and included multiple connected and unconnected channels and tributaries. The major flooding event that occurred in the region following heavy rains on about August 7, 2024 resulted in changes to many of these habitats, underscoring the baseline condition in this watershed of a shifting mosaic of dynamic habitats across the landscape.

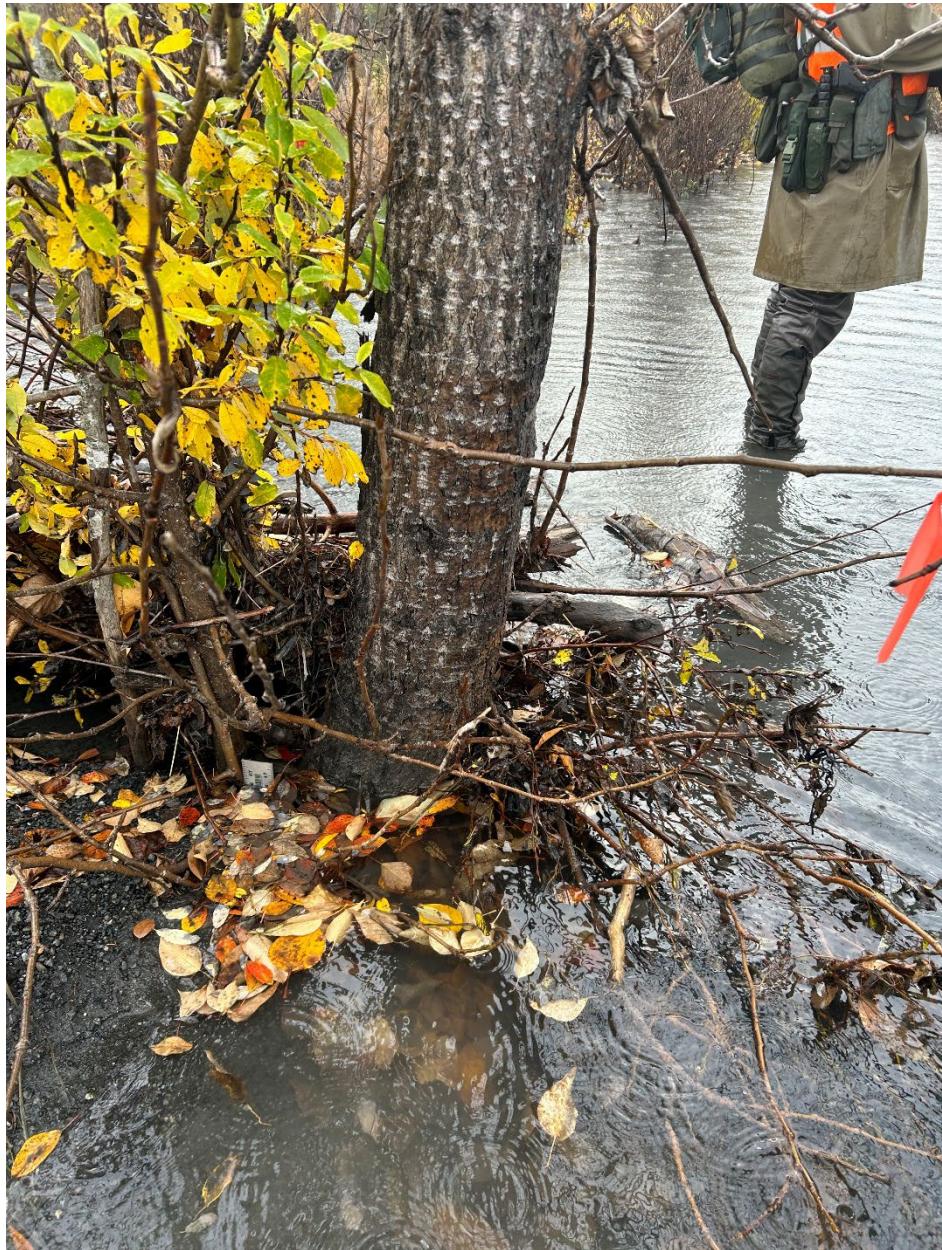
Photo 3-3 Pressure transducer at site OCH2.8R-SS-1 buried after August 7, 2024 flood event. Photo taken September 28, 2024.

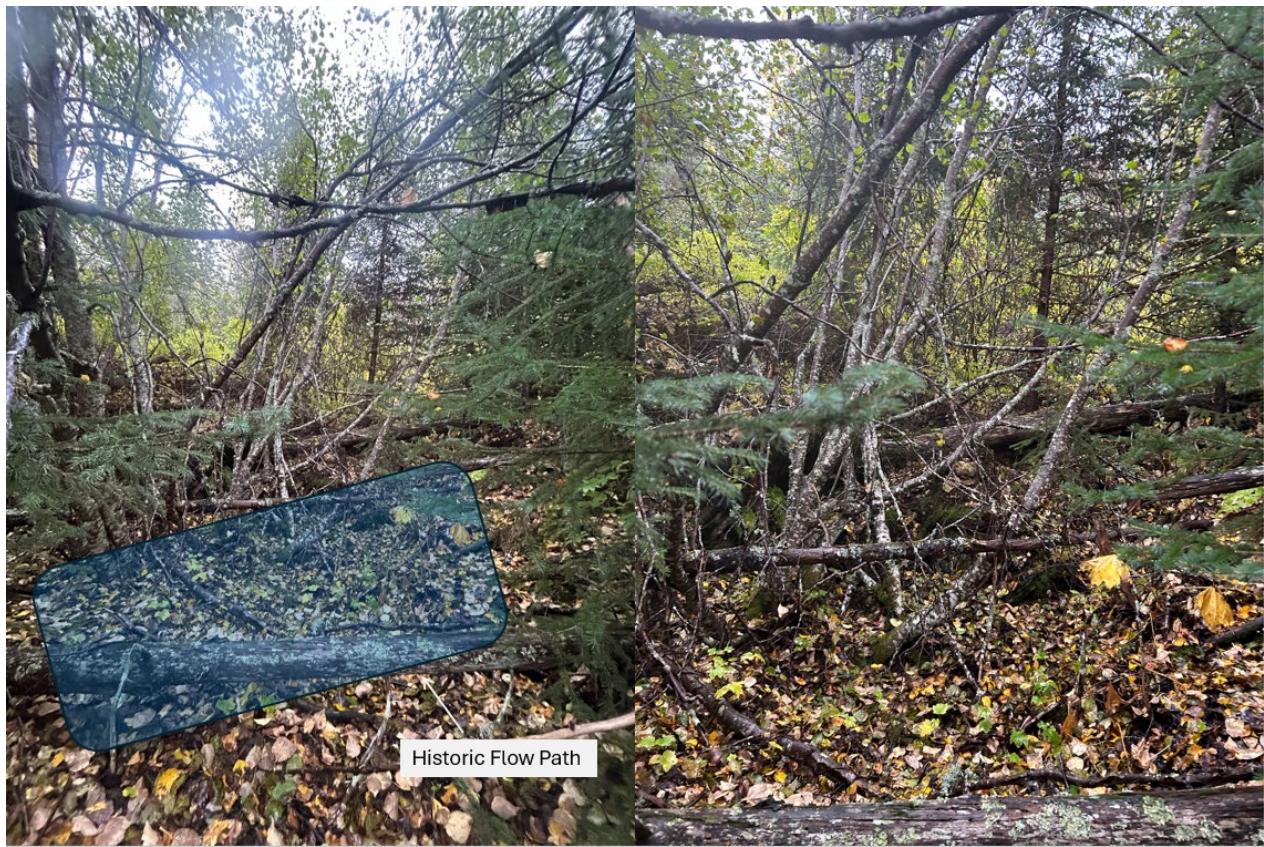
Photo 3-4 Tributary MR1.010 was identified as a flow path on September 24, 2024.

This macrohabitat was identified from aerial imagery as a potential tributary to the mainstem Martin River entering near RM 1.0. This site was visited on September 24, 2024, for mesohabitat and fish surveying. The field crew identified a shallow vegetated run-off gully on the east slope of the valley, but there was no defined channel that contained any habitat, wet or dry, that would be connected to the mainstem under higher flow conditions (Photo 3-4).

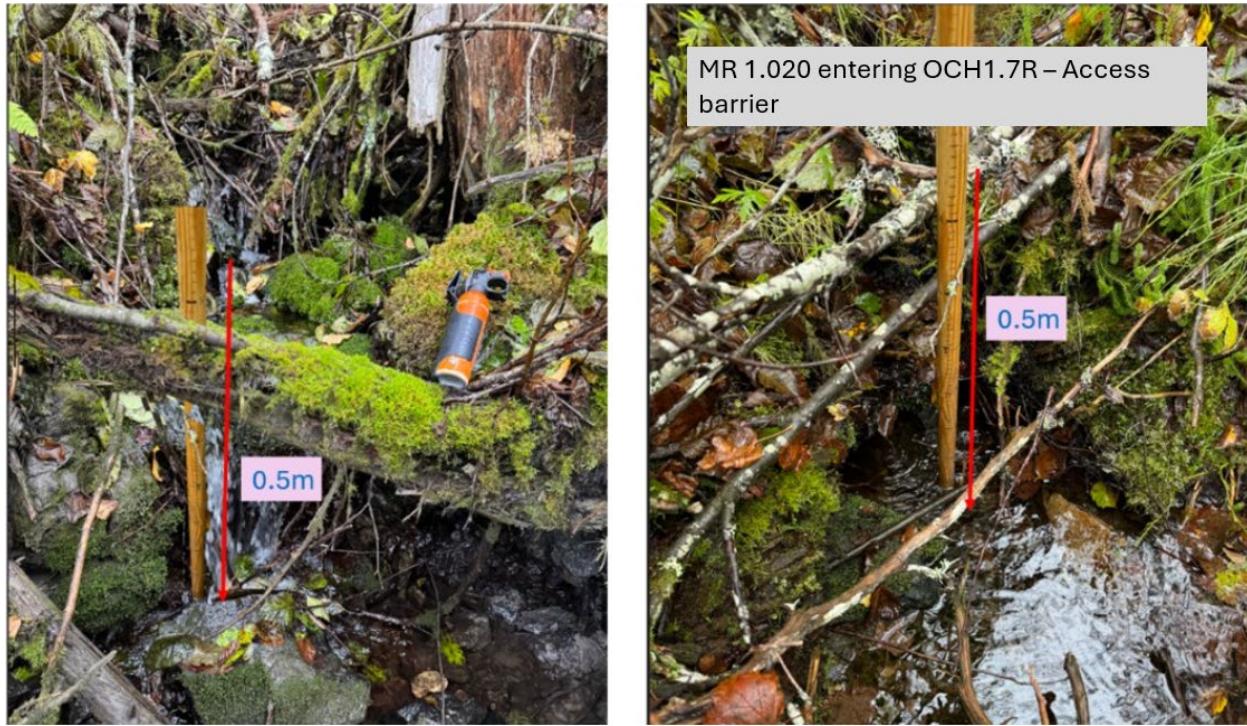
Photo 3-5 Tributary MR1.020 on September 23, 2024.

This macrohabitat is an off-channel complex composed of a side slough with a short secondary side slough and two small tributaries: Tributary MR1.020, a steep tributary with shallow flow, and Tributary MR1.030 (Photo 3-5). The side slough was surveyed during the fall field events and was wetted at the time of the survey; however, neither Tributary MR1.030 nor the secondary side slough had sufficient water to support a surface connection to OCH 1.7R-SS-1 that would allow access for fish year-round. Shallow riffles less than 0.02 m in depth separated OCH 1.7R-SS-1 from these smaller habitats (Photo 3-6 and Photo 3-7). Despite isolated conditions in late September, both areas contained rearing fish of multiple age classes (see Fish Use Study, Section 4.0) and provide accessible fish habitat at some time during the year.

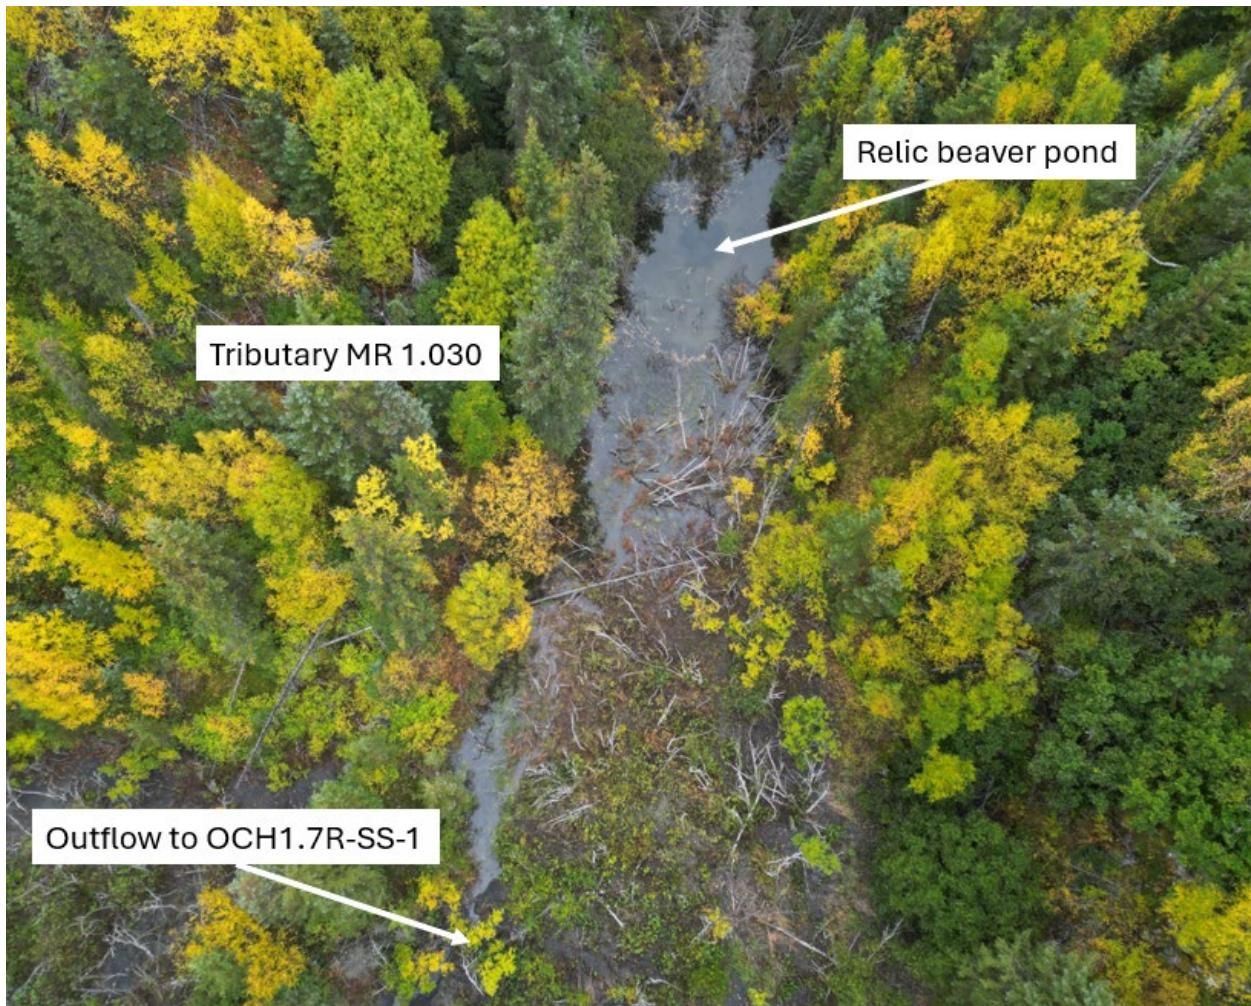
Photo 3-8 Tributary MR1.030 relic beaver pond and outflow to OCH1.7R-SS-1.

This was a short tributary outflowing from a relict beaver pond perched above the valley grade into OCH 1.7R-SS-1 through a new sediment deposit at the downstream (Photo 3-8). The beaver pond which was at least 1.5 m in depth, backs up to the valley hillslope from which a vegetated gully drains. The beaver pond and outflowing pooled habitat was 99 m in length and measured 13.5 m at the widest point and 3.8 m at a constriction at the confluence with OCH 1.7R-SS-1. Pool habitat comprised the entirety of this habitat unit. A large wedge of fine gravel sediment was present at the mouth of the tributary and was in the process of being reshaped into a new channel by the outflowing water which was 0.2 m in depth. It was assumed that this sediment wedge was deposited by the flood event which occurred on August 6-7, 2024, and both the channel and tributary mouth were likely more established before this event.

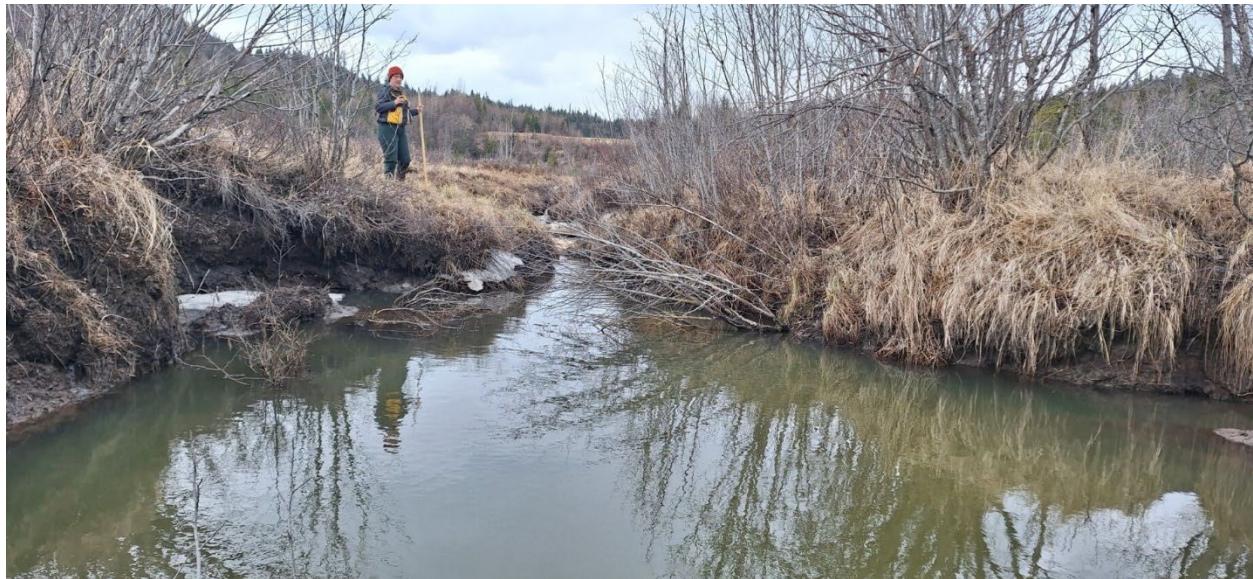
Photo 3-10 OCH1.7L-SS-1 pool-glide complex surveyed on May 3, 2024.

During the spring, 883 m of OCH 1.7L-SS-1 was surveyed for mesohabitat composition. Slough OCH1.7L-SS-1 was the second largest of the OCHs surveyed. The mean wetted width was 6.02 m (Photo 3-10). The mean thalweg depth was 0.5 m and the mean pool depth was 0.68 m (Table 3-8). The slough was composed of 12 mesohabitat units predominantly glide habitat, estimated as 84 percent by area, with riffle and pool habitat considerably less at 11 and 5 percent respectively (Table 3-8). Two large glides covered 80 percent of the slough by area with a mean thalweg depth of 0.86 m and substrate dominated by sand and organics, indicative of suitable habitat for yearling salmon resident fishes. In contrast, the three pools totaled 319.30 m² with a mean depth of 0.68 m, indicating a relatively small area of early-rearing salmon habitat. Both secondary channels contained only a small amount of glide habitat (97 m² in OCH1.7L-SS-1.040 and 16 m² in OCH1.7L-SS-1.050) and contained 100 percent organic substrate.

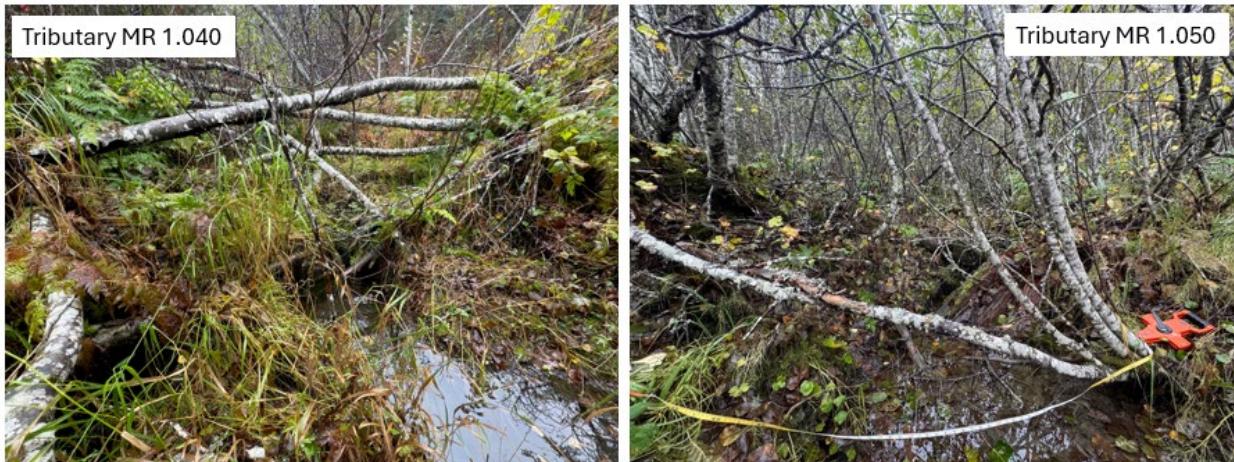
Photo 3-11 Drainage channels at locations identified as Tributary MR1.040 (left) and Tributary MR1.050 (right).

During fall field efforts to survey tributaries MR1.040 and MR1.050, the field crew identified a shallow vegetated run-off gully on the west slope of the valley at each location, but there was no evident channel that contained any habitat, wet or dry, that could be connected to the mainstem under higher flow conditions or could provide fish habitat under any flow condition (Photo 3-11). Small pockets of accumulated rainwater or stormwater were present in leafy depressions.

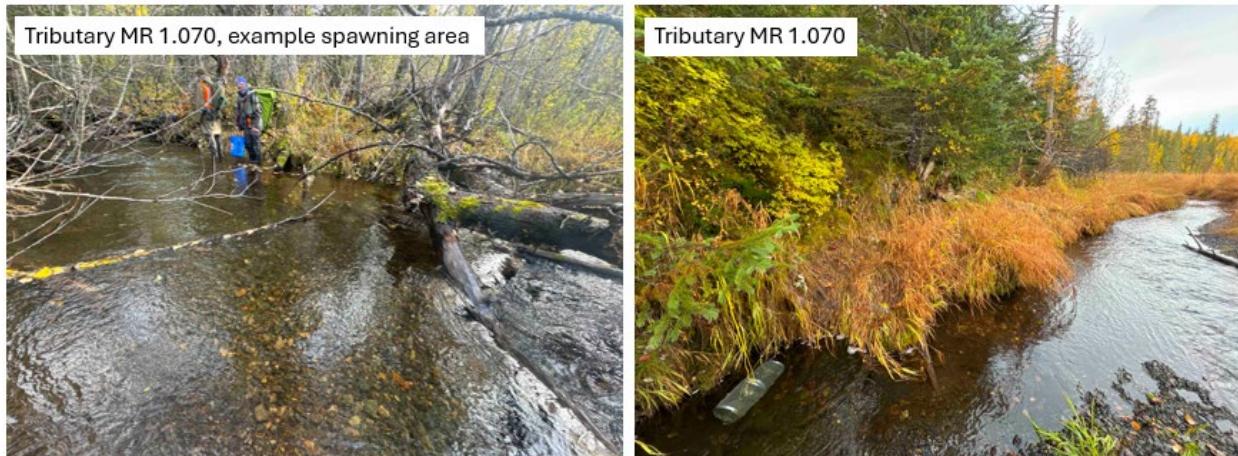
Photo 3-12 Tributary MR1.070 near the confluence with Swan Lake (right) and an example of spawning habitat identified in the tributary (left).

Tributary MR1.070 drains the east slopes, joining the Swan Lake complex on the right side of the floodplain. Tributary MR1.070 is fed by a perched lake several hundred feet above the valley floor and is not influenced by mainstem flow, but did contribute cold water ($<4^{\circ}\text{C}$) in all seasons. Tributary MR1.070 is a relatively large tributary that extends approximately 3.6 km from its confluence with Swan Lake and the mainstem Martin River at RM 1.7 (Photo 3-12). The tributary becomes steeper approximately 3.6 km from the lake confluence where it flows through a steep gully with larger cobble and boulder substrate and step pools. A total of 517 m of Tributary MR1.070 were mesohabitat surveyed in May of 2024 including 24 distinct mesohabitat units which were present in a typical repeated riffle-glide-pool sequence which ranged from 0.1 m water depth in riffles to 0.5 m water depth in pools when flows were low.

Tributary MR1.070 was by far the longest tributary surveyed and contained the most fish habitat for rearing and overwintering of juveniles and resident species and spawning of adult anadromous and resident fish.

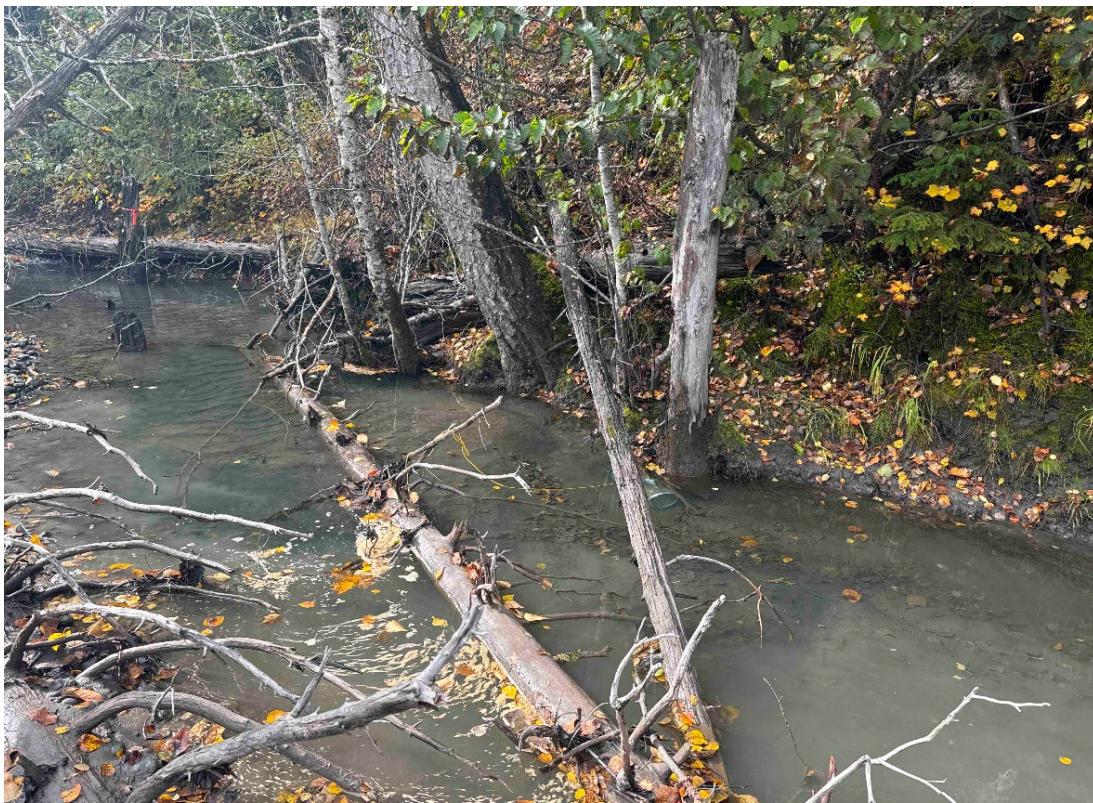
Photo 3-20 Middle reach of OCH3.8L-SS-1 showing a pool habitat with silt/sand sediment.

This macrohabitat is a side slough that is fed by a combination of outflow from a perched tannic lake known as Hawk Lake (due to its bird-like shape), and surface or subsurface flow from the main channel at some flow conditions (Photo 3-20). On April 30, 2024 OCH3.8L-SS-1 contained 12 mesohabitat units totaling 378.9 m in length and covering 1,139.6 m² in wetted area. The average total wetted width was 2.8 m and average BFW of 6.3 m. Total wetted depth averaged 0.25 m and ranged from riffle habitat less than 0.1 m in depth to pool habitat 0.7 m in depth.

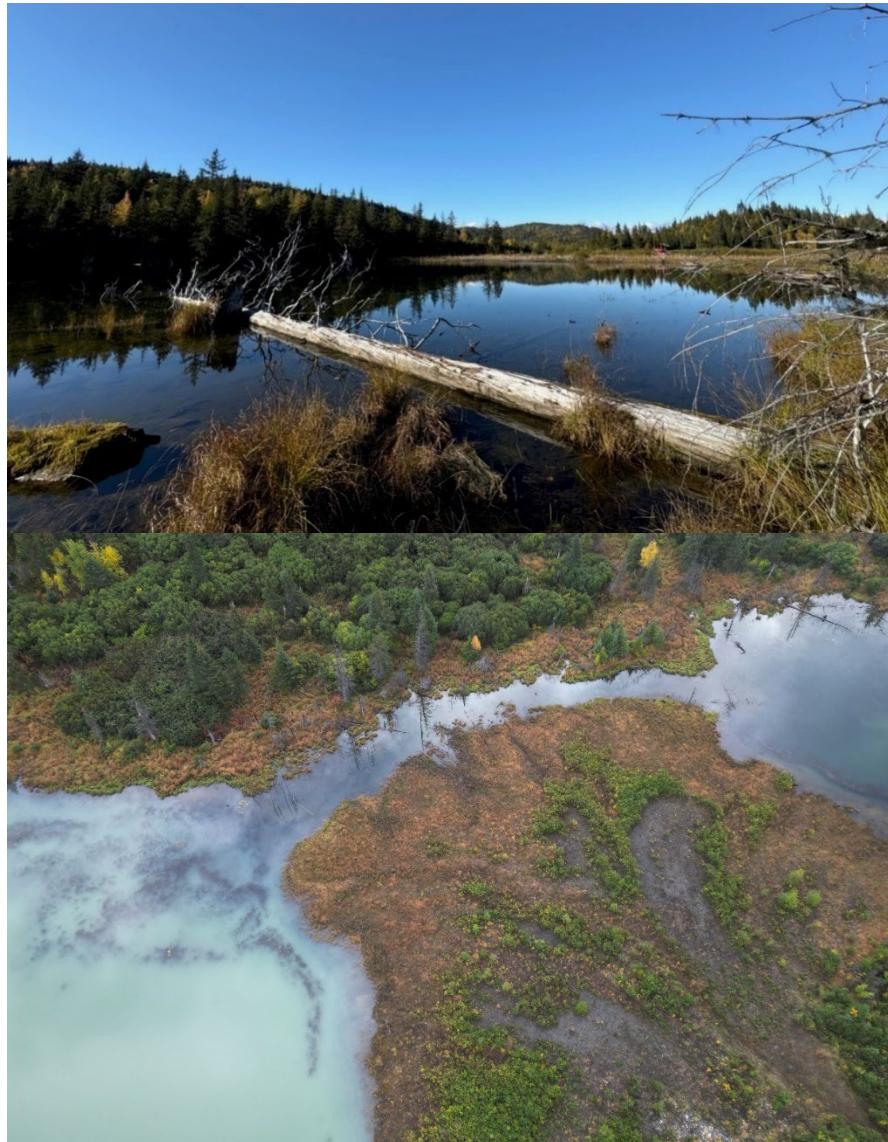
Photo 3-22 South lobe of Lake MR1.120.L1, September 29, 2024 (upper image) and bifurcation between clear and turbid lobes (lower image).

This macrohabitat is a lake that drains the surrounding hillslopes via several runoff gullies (Photo 3-22). MR1.120.L1 is bisected in the center by a shallow constriction where the water was less than 1.0 m in depth with soft, organic substrates, fine particulate organic matter, and aquatic macrophyte growth. The southern half of the lake was less turbid than the north half of the lake during September 2024 fish survey efforts, suggesting that inundation from the mainstem occurred more recently in the north half of the lake, and that the north portion may be at a slightly lower elevation than the southern lobe.

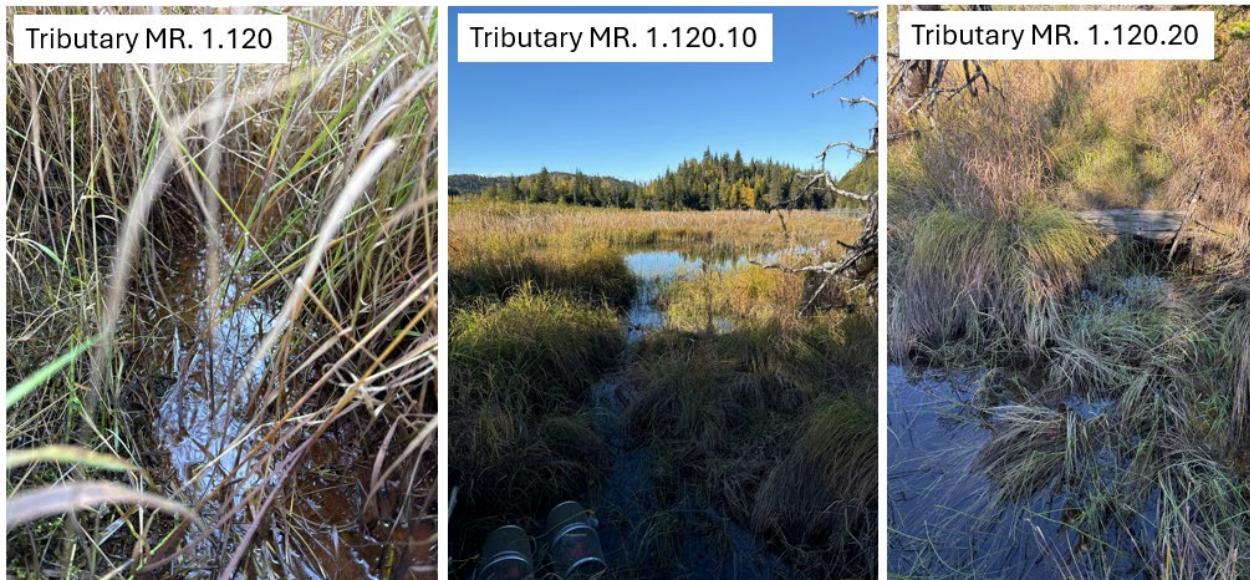
Photo 3-23 Encroached drainage channels at tributaries MR1.120, MR1.120.10, and MR1.120.20.

These macrohabitats were identified from aerial imagery as potential tributaries to OCH4.2R-SS-1. This site was visited on September 29, 2024, for mesohabitat and fish surveying. The field crew identified a shallow, grassy channel on the east slope of the lake basin; however, no evident channel contained surface water or any discernible habitat—wet or dry—that could support fish rearing or spawning under different flow conditions (Photo 3-23).

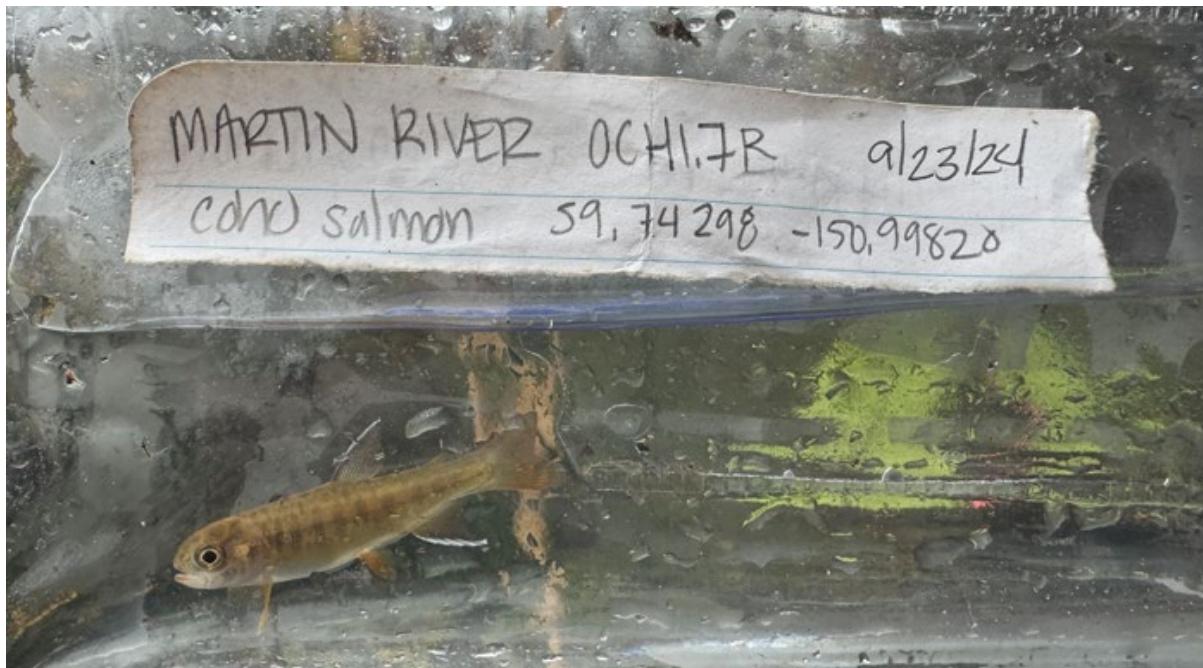
Photo 4-2 Example reference photograph of a juvenile Coho Salmon collected from OCH1.7R on September 23, 2024. The clear vinyl sachet allowed clear identification of species.

All fish sampled were immediately transferred into dark-colored buckets with fresh river water. The first 25 individuals of each size class of fish captured at each site were measured in 10-mm size bins, after which tallies were made by species to reduce the time fish spent in buckets. For measuring, fish were transferred quickly into clear vinyl sachets with enough water to allow clear view of the fish for identification, taking reference photographs as necessary, and measuring by placing a ruler along the fish's body outside the sachet (Photo 4-2, Photo 4-3).
