2024 MARTIN RIVER AQUATIC STUDIES REPORT

BRADLEY LAKE HYDROELECTRIC PROJECT
DIXON DIVERSION

FERC No. P-8221

Kleinschmidt Associates

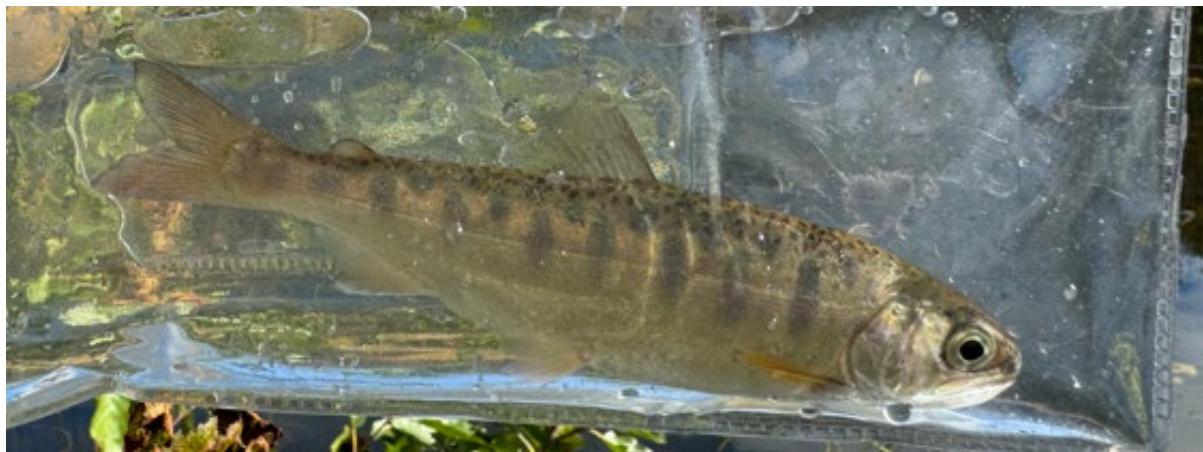
Photo 4-3 Example reference photograph of a juvenile Coho Salmon collected from the Lake MR1.080.L1 on September 27, 2024.

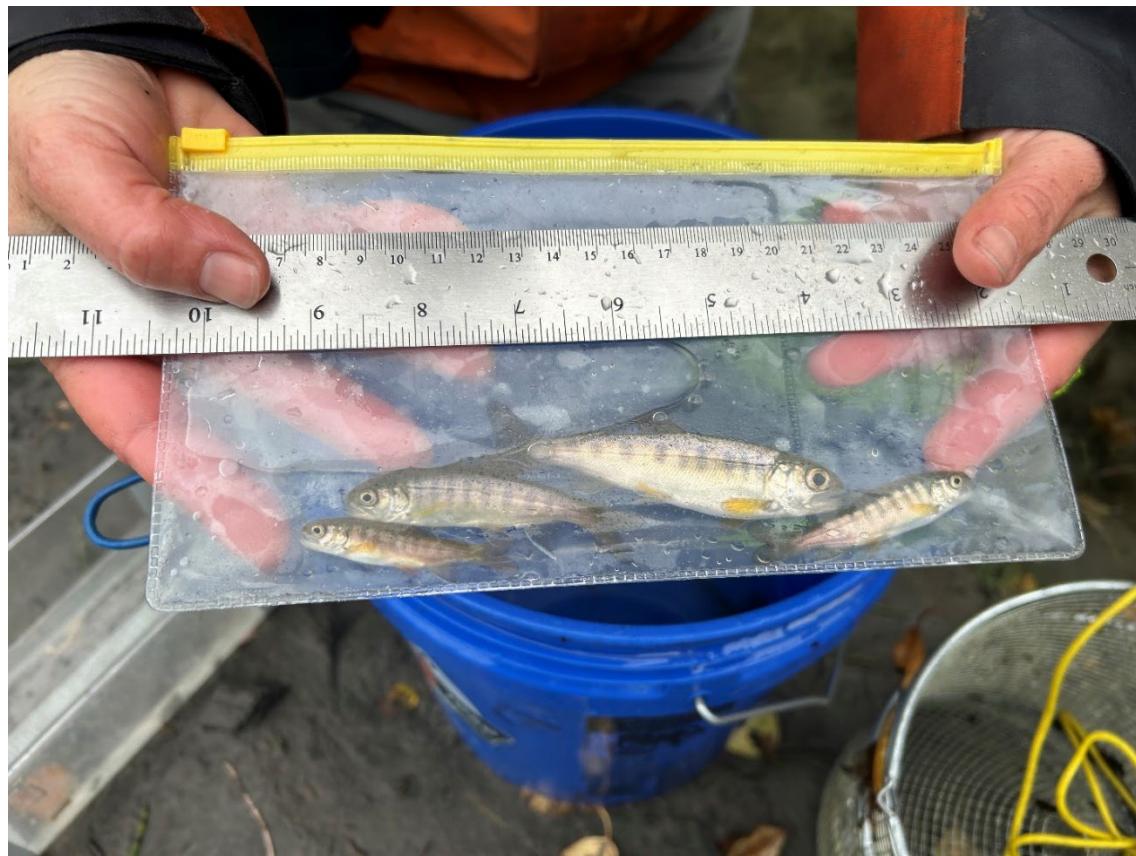
Photo 4-4 Fish captured in OCH1.7R-SS-1.

The size distribution of juveniles captured in OCH1.7R-SS-1 indicated early life-stage use of this shallow habitat, with most juveniles of both salmonid species being less than 80 millimeters (mm) in fork length. The median fork length bin of juvenile Coho Salmon was 40-49 mm which accounted for half of all Coho Salmon juveniles captured. The very small size of Coho Salmon juveniles suggested that spawning in the previous year may have occurred nearby, however, the large flooding event in August of 2024 likely resulted in redistribution of rearing fish among off-channel floodplain habitats. The size of Dolly Varden juveniles appeared normally distributed, with a median fork length bin of 60-69 mm (Figure 4-4). No larger specimens of either species were observed. Fish captured can be seen in Photo 4-4.

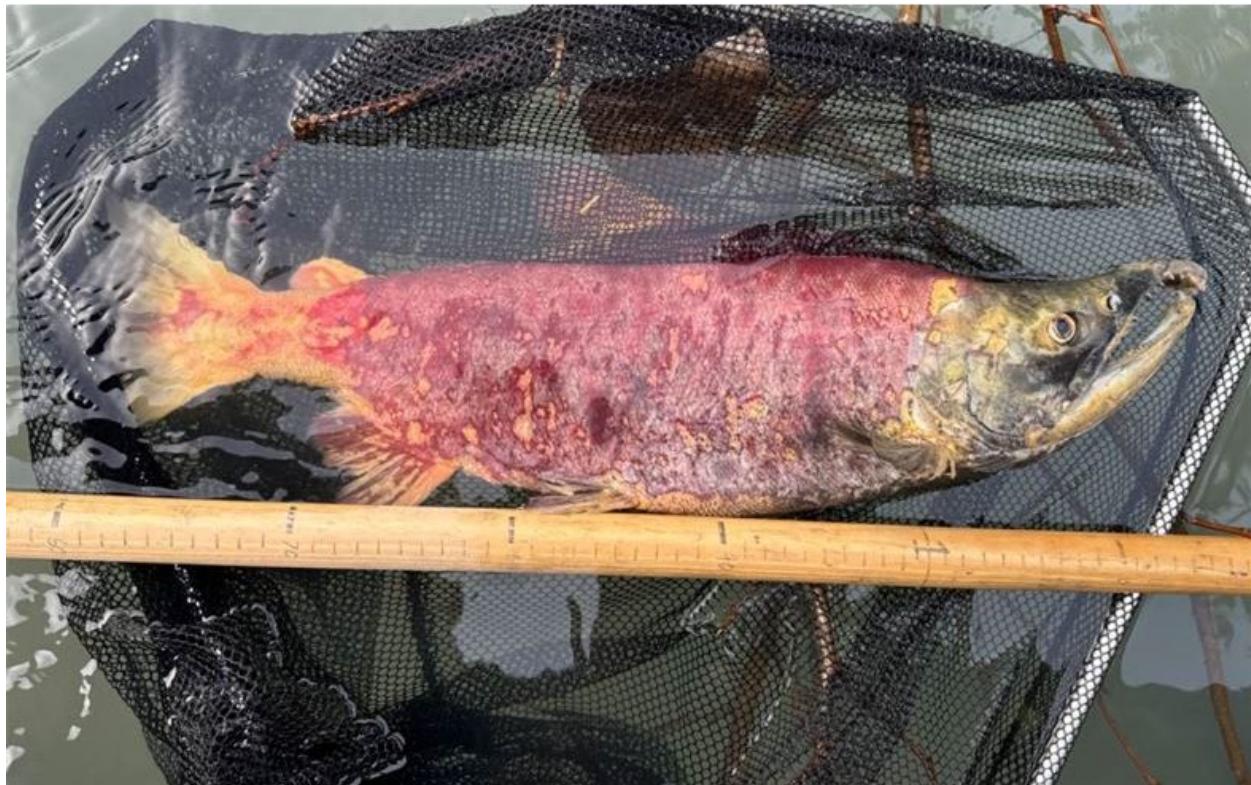
Photo 4-6 WFMR (Red Lake) Sockeye Salmon September 30, 2024.

Sockeye Salmon were documented along shorelines of Red Lake and in the WFMR downstream of Red Lake, though in lower numbers than observed in OCH2.8R-SS-1 and MR1.070. It is possible that the 15-20 fish observed milling in the inlet to Red Lake were also Sockeye Salmon, though this could not be verified (Photo 4-11). Certainly, use of the watershed by both Sockeye and Coho salmon varies between lake and OCH, though no fish spawning or post-spawned carcasses were observed in the mainstem during fall 2024 sampling.

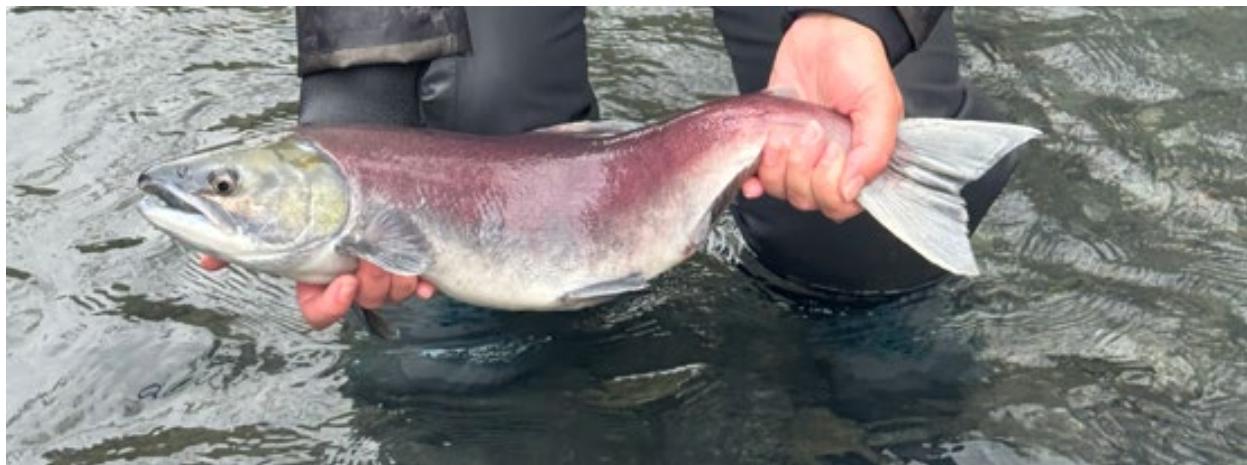
Photo 4-7 Sockeye Salmon female in OCH2.8R-SS-1 on September 24, 2024.

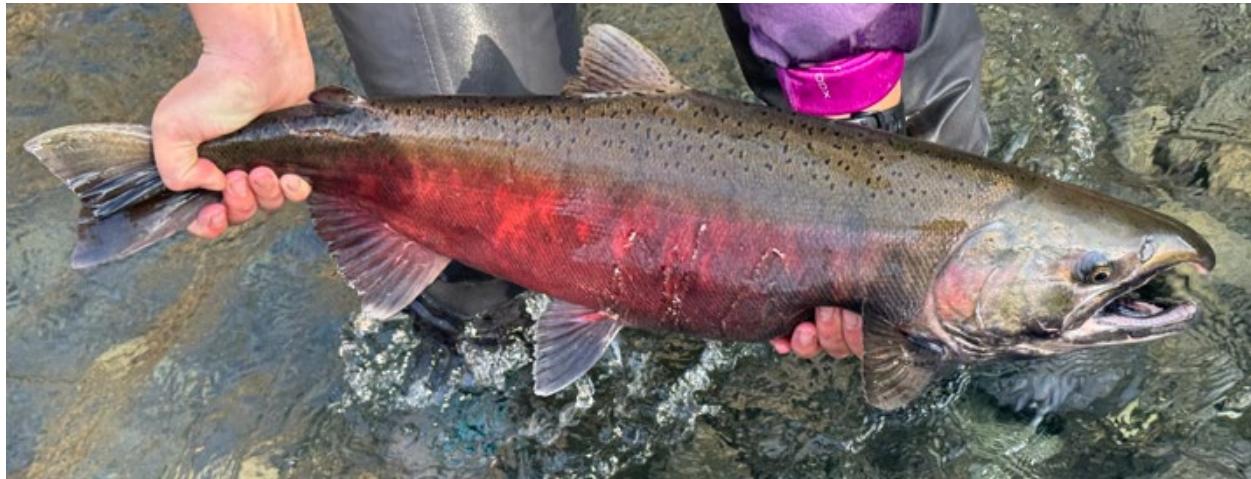
Photo 4-8 Coho Salmon adult female in OCH2.8R-SS-1 on October 1, 2024.

It was also noteworthy that adult spawners made use of all accessible OCH for spawning. Prior to the heavy rains on September 30, adult Coho Salmon were observed staging in the lake at the lower end of OCH2.8R-SS-1, and by October 1, had moved into OCH2.8R-SS-1 and MR1.070 and were observed digging and guarding redds in areas with quality spawning gravel and sufficient depth. Smaller-bodied Sockeye Salmon were documented further upstream in OCH2.8R-SS-1 than Coho Salmon and appeared in the system earlier. Sockeye Salmon spawning appears to have been complete prior to the arrival of the first Coho Salmon.

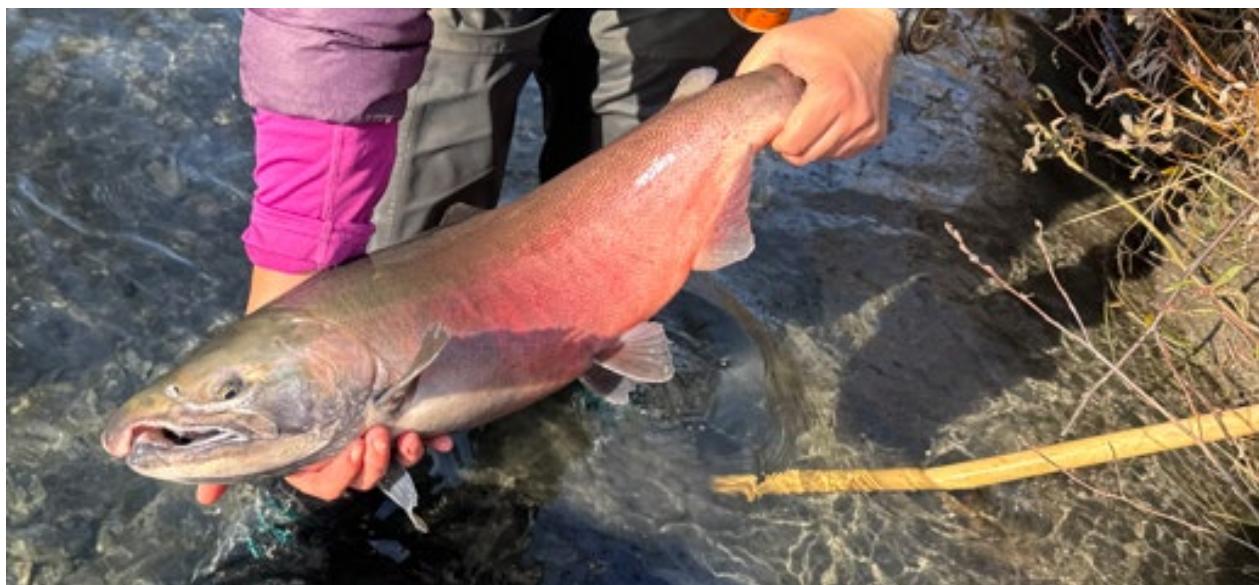
Photo 4-9 Coho Salmon adult male in Tributary MR1.070 on October 2, 2024.

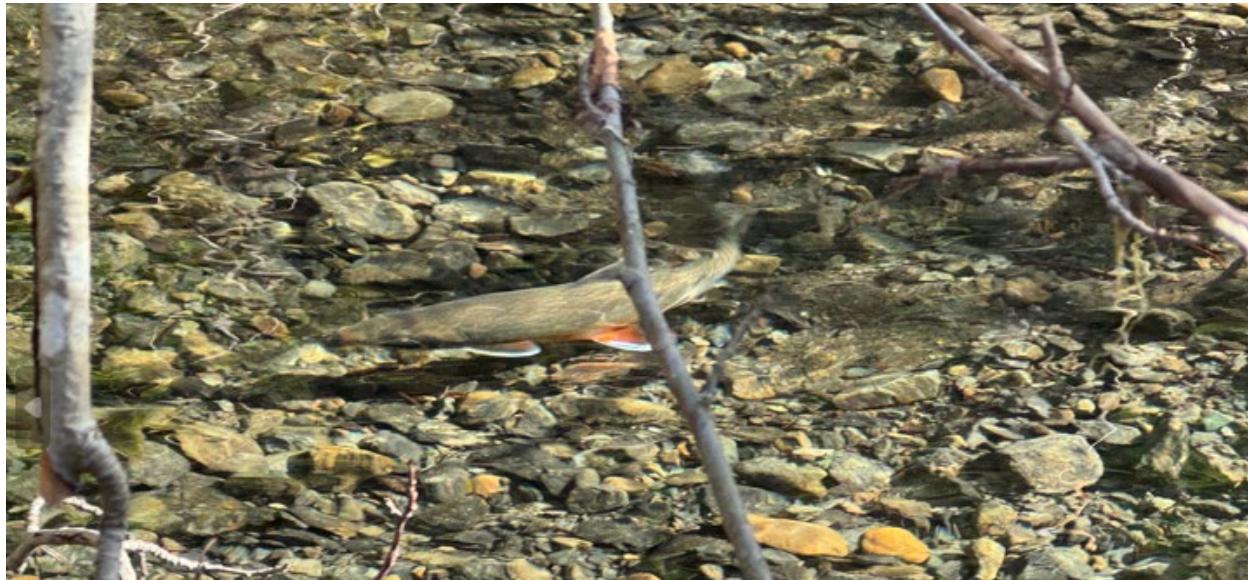
Photo 4-10 Adult Dolly Varden male spawners in Tributary MR1.090 on October 2, 2024.

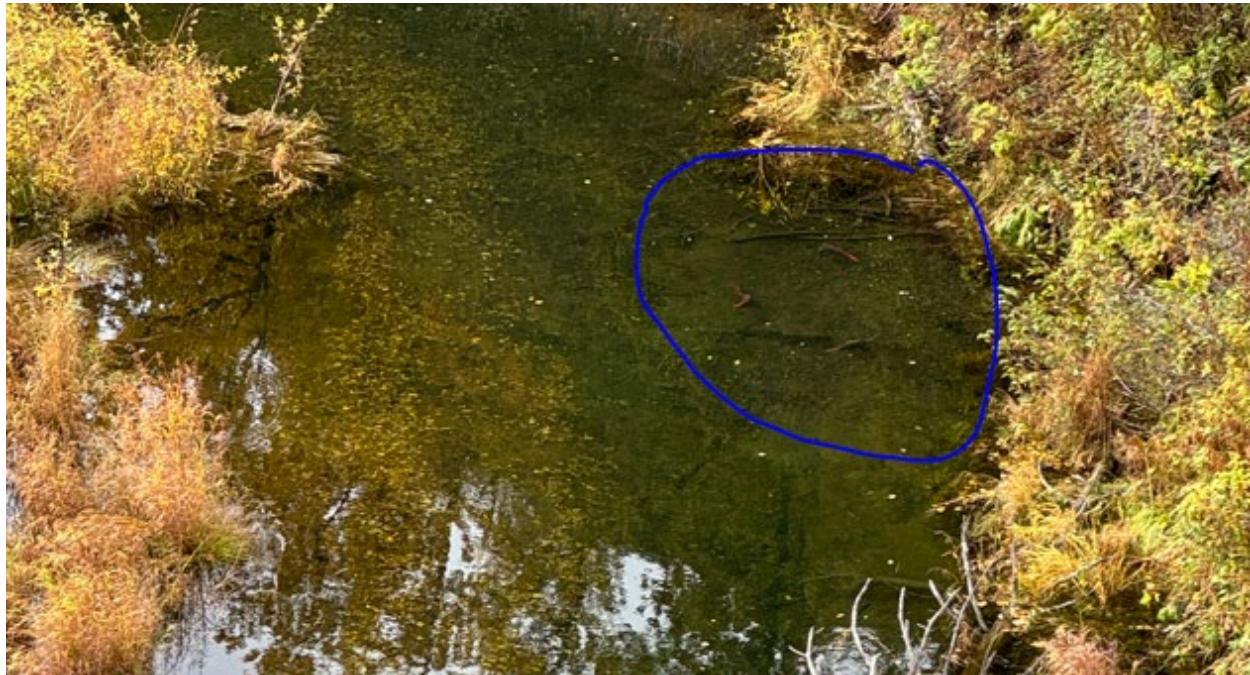
Photo 4-11 Aerial image from a helicopter of presumed Sockeye Salmon at the inlet to Red Lake on September 28, 2024.
