Dixon Diversion Project

Cultural Resources
and NHPA Section 106
Meeting

January 30, 2025

ALASKA
ENERGY
AUTHORITY

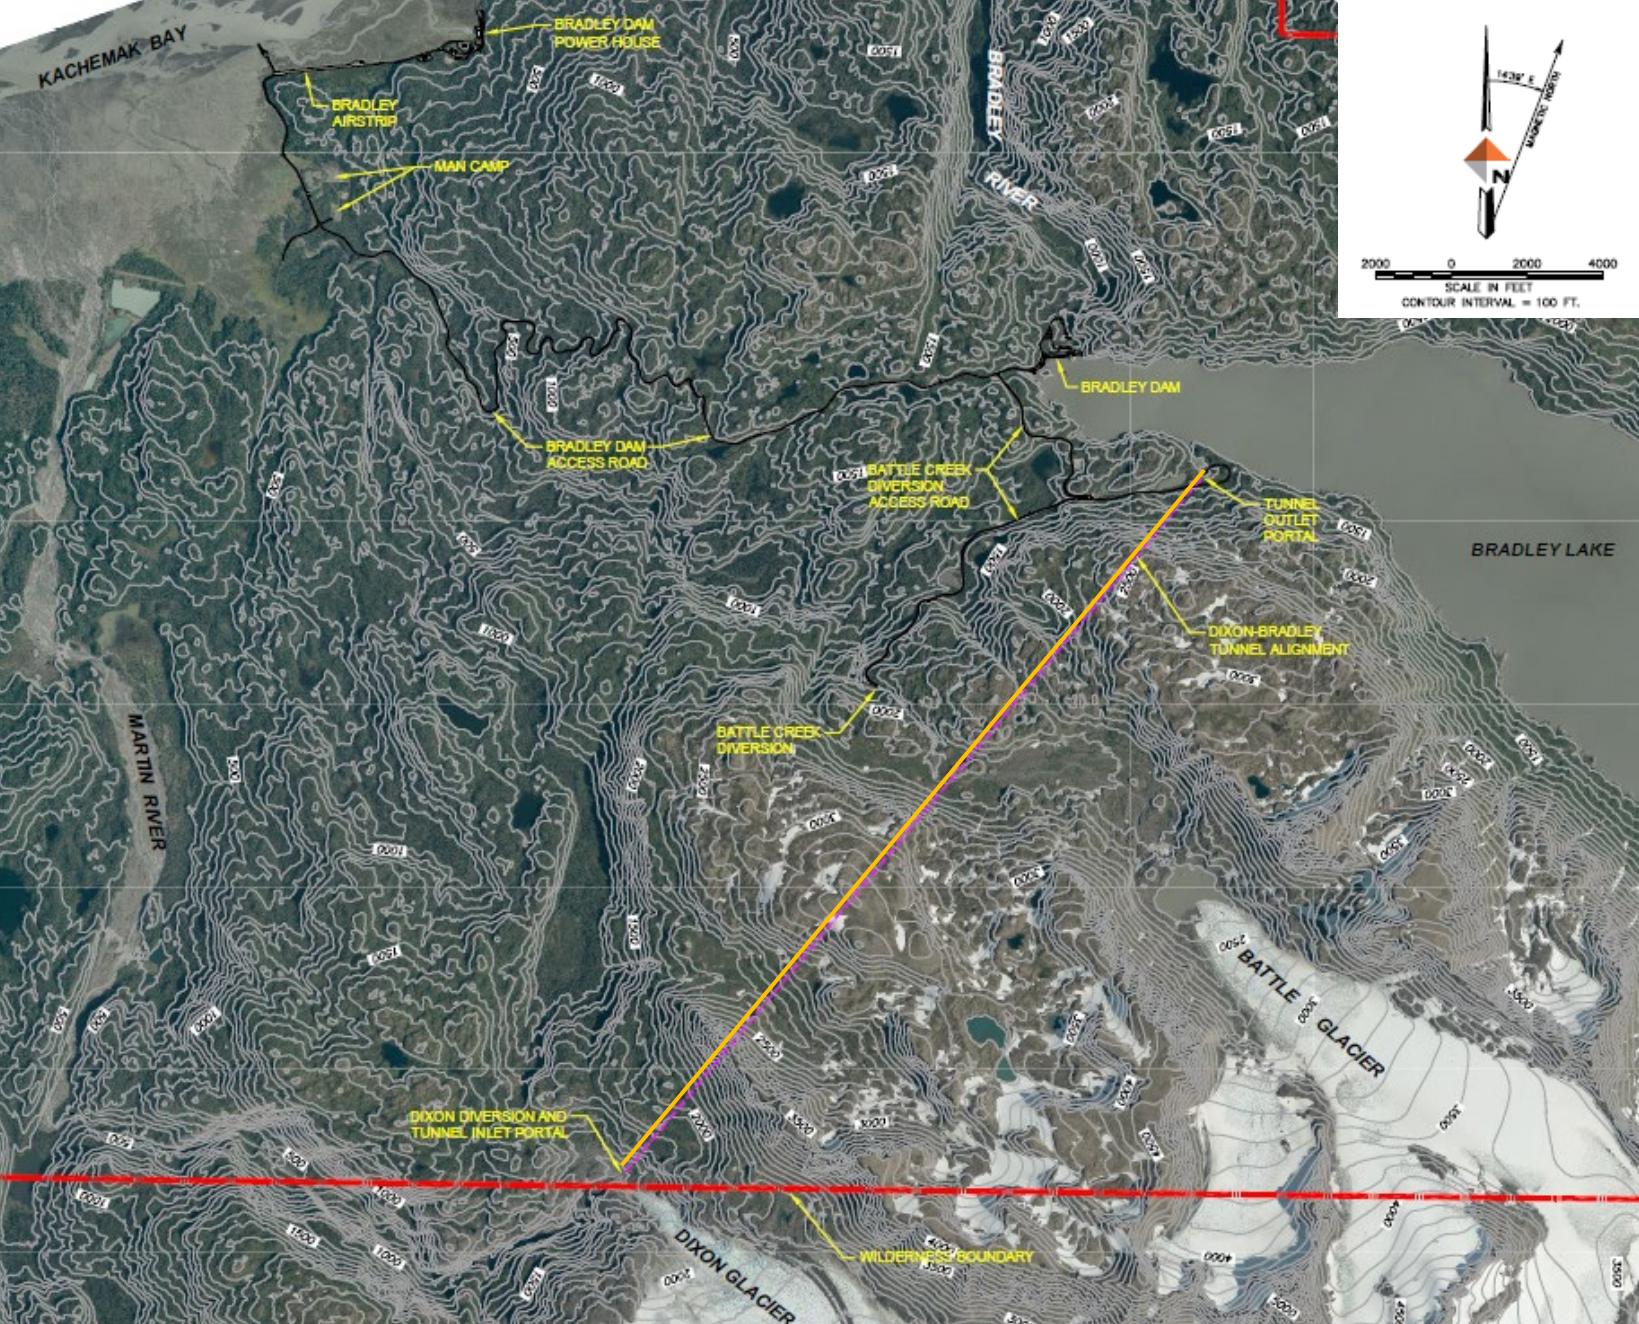
Dixon Diversion Dam and Tunnel

- Diversion Dam
 - ~25 feet high
- Subsurface Diversion Tunnel to Bradley Lake
 - 4.7 miles long
 - 1,400 cfs capacity
 - Divert water May-October

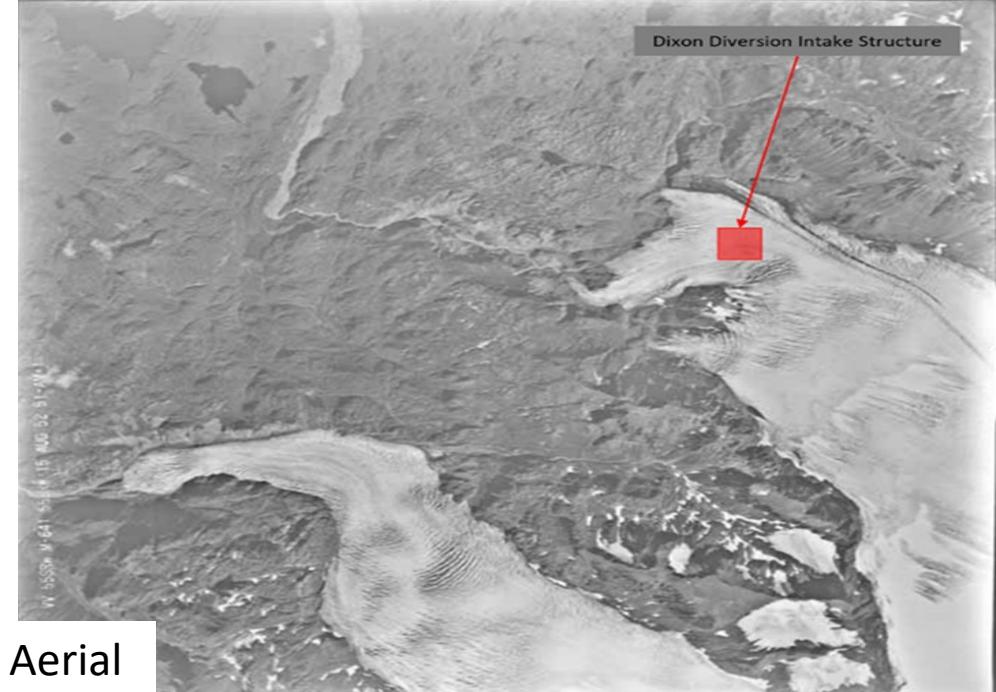
1952 Aerial

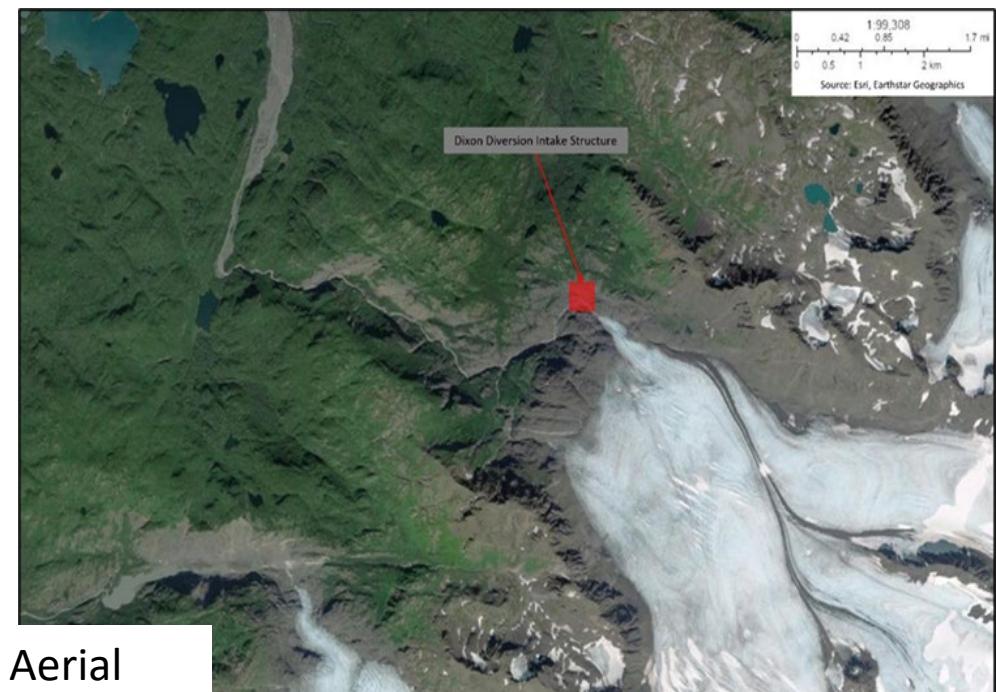
2020 Aerial

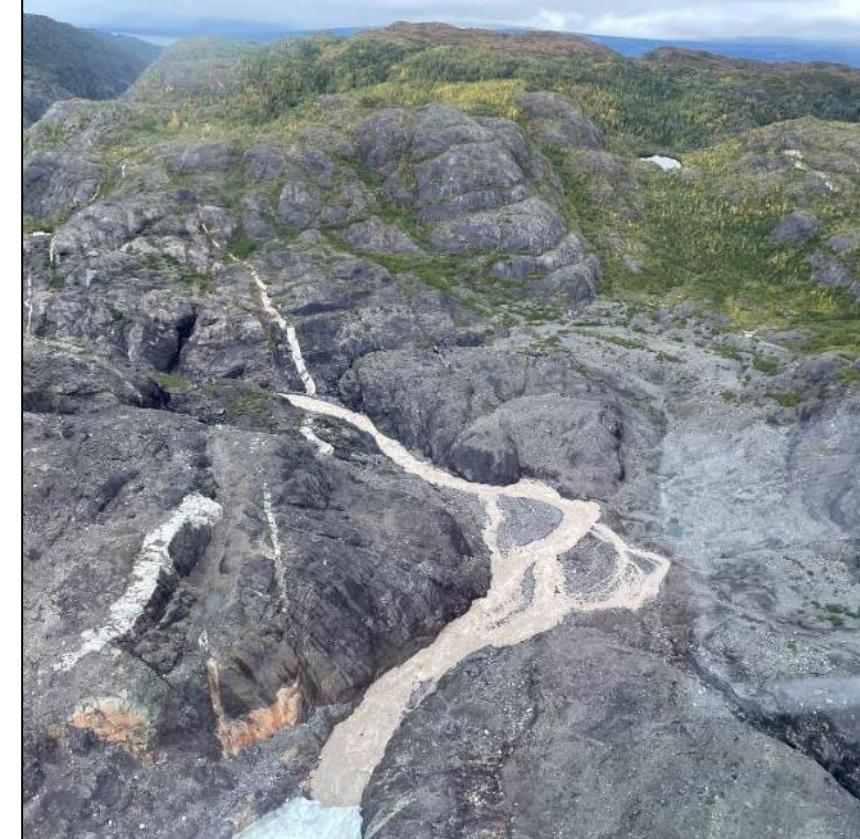
Dixon
Diversion
structure
and intake
location
July 2024

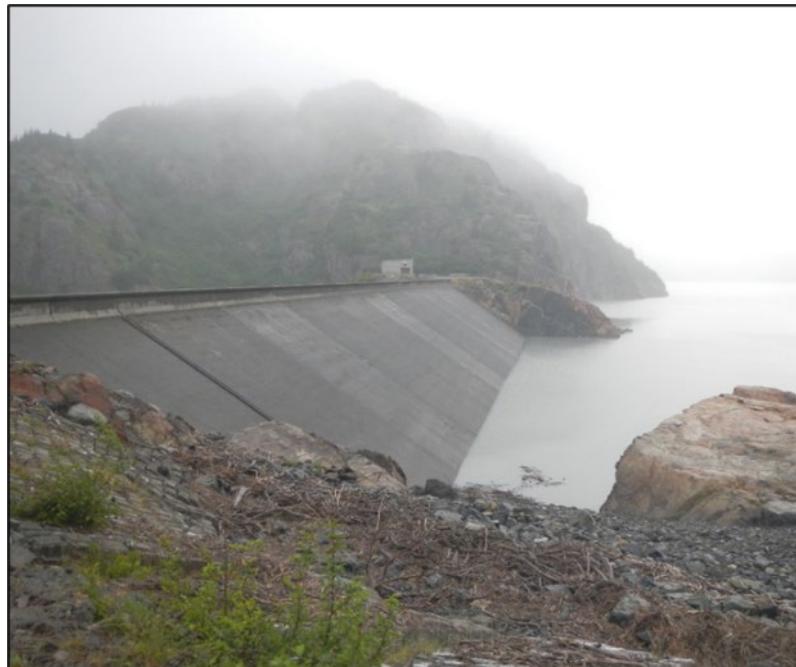
Existing Bradely Lake Dam within the APE, view to northeast, photo taken July 2024.

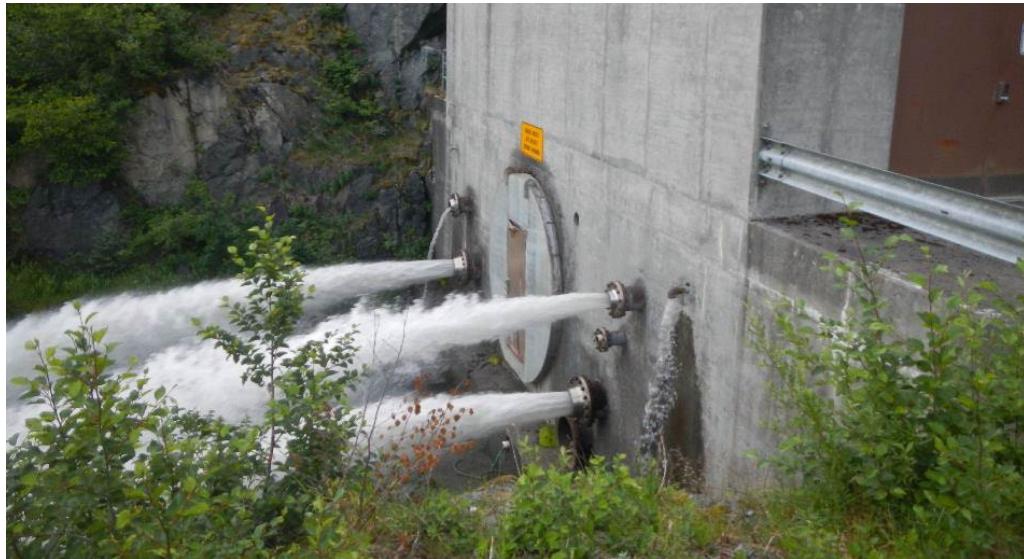
Bradley Lake Dam recorded at the dam during pedestrian survey, view to northeast, photo taken July 2024.

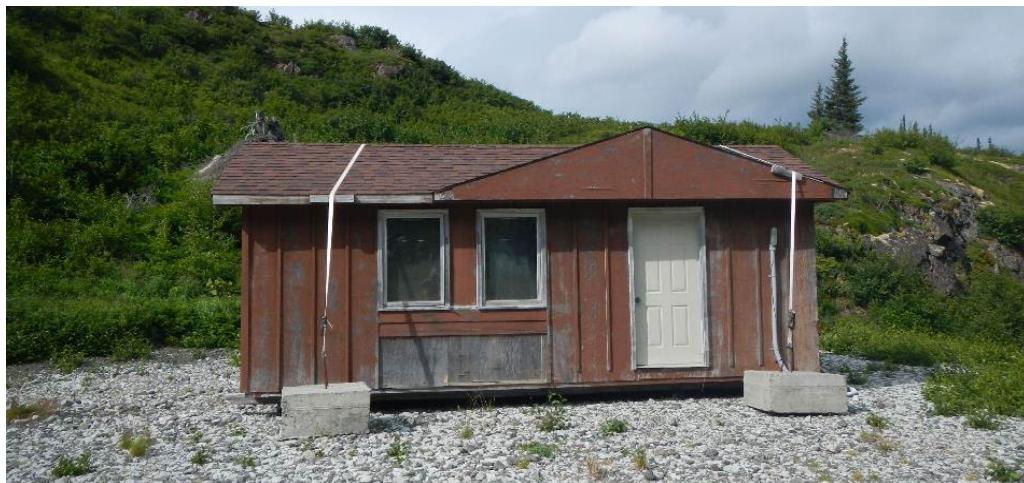
Bradley Lake Project structure recorded at the proposed access road during pedestrian survey, view to north, photo taken July 2024.

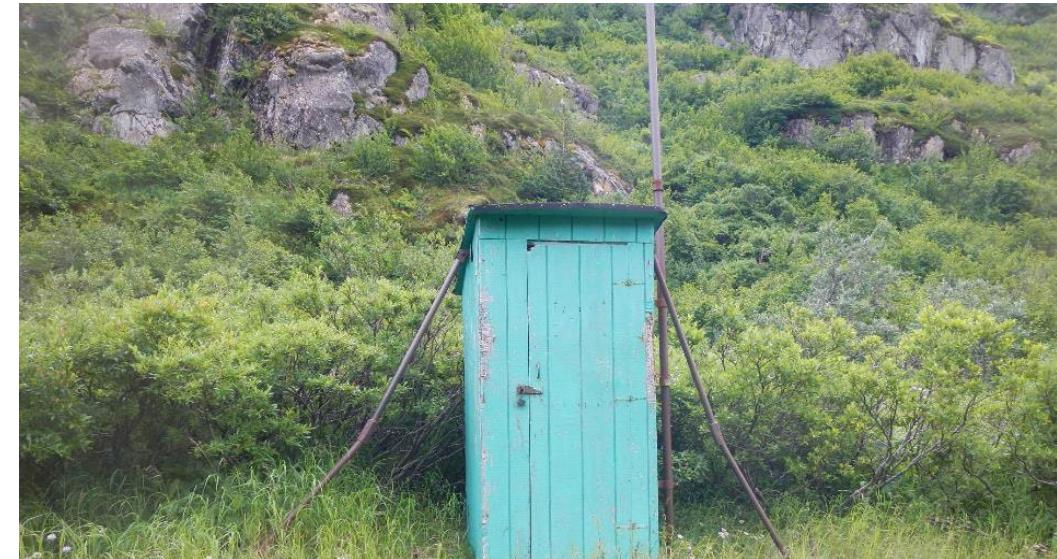
Bradley Lake Project structure recorded at the proposed access road during pedestrian survey, view to south, photo taken July 2024.

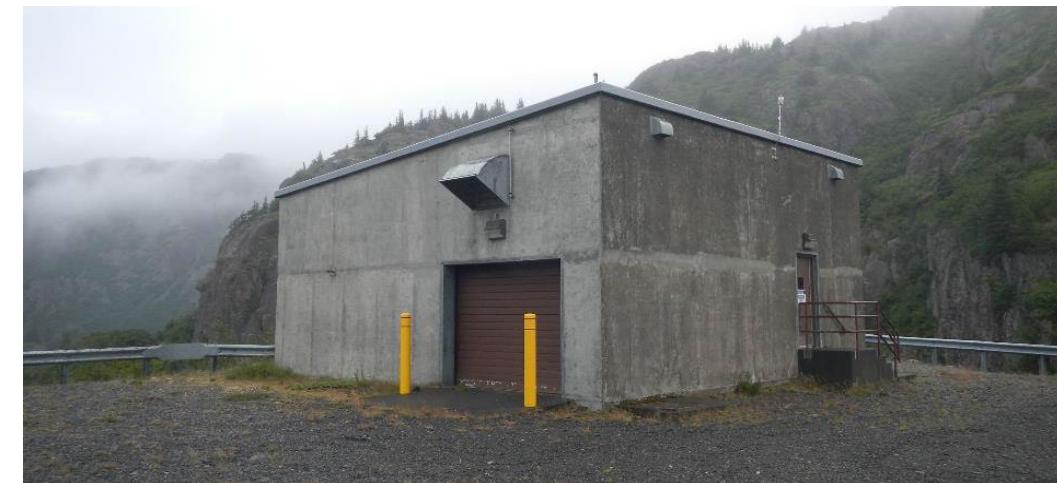
Bradley Lake Project related structure recorded at the dam during pedestrian survey, view to south, photo taken July 2024.

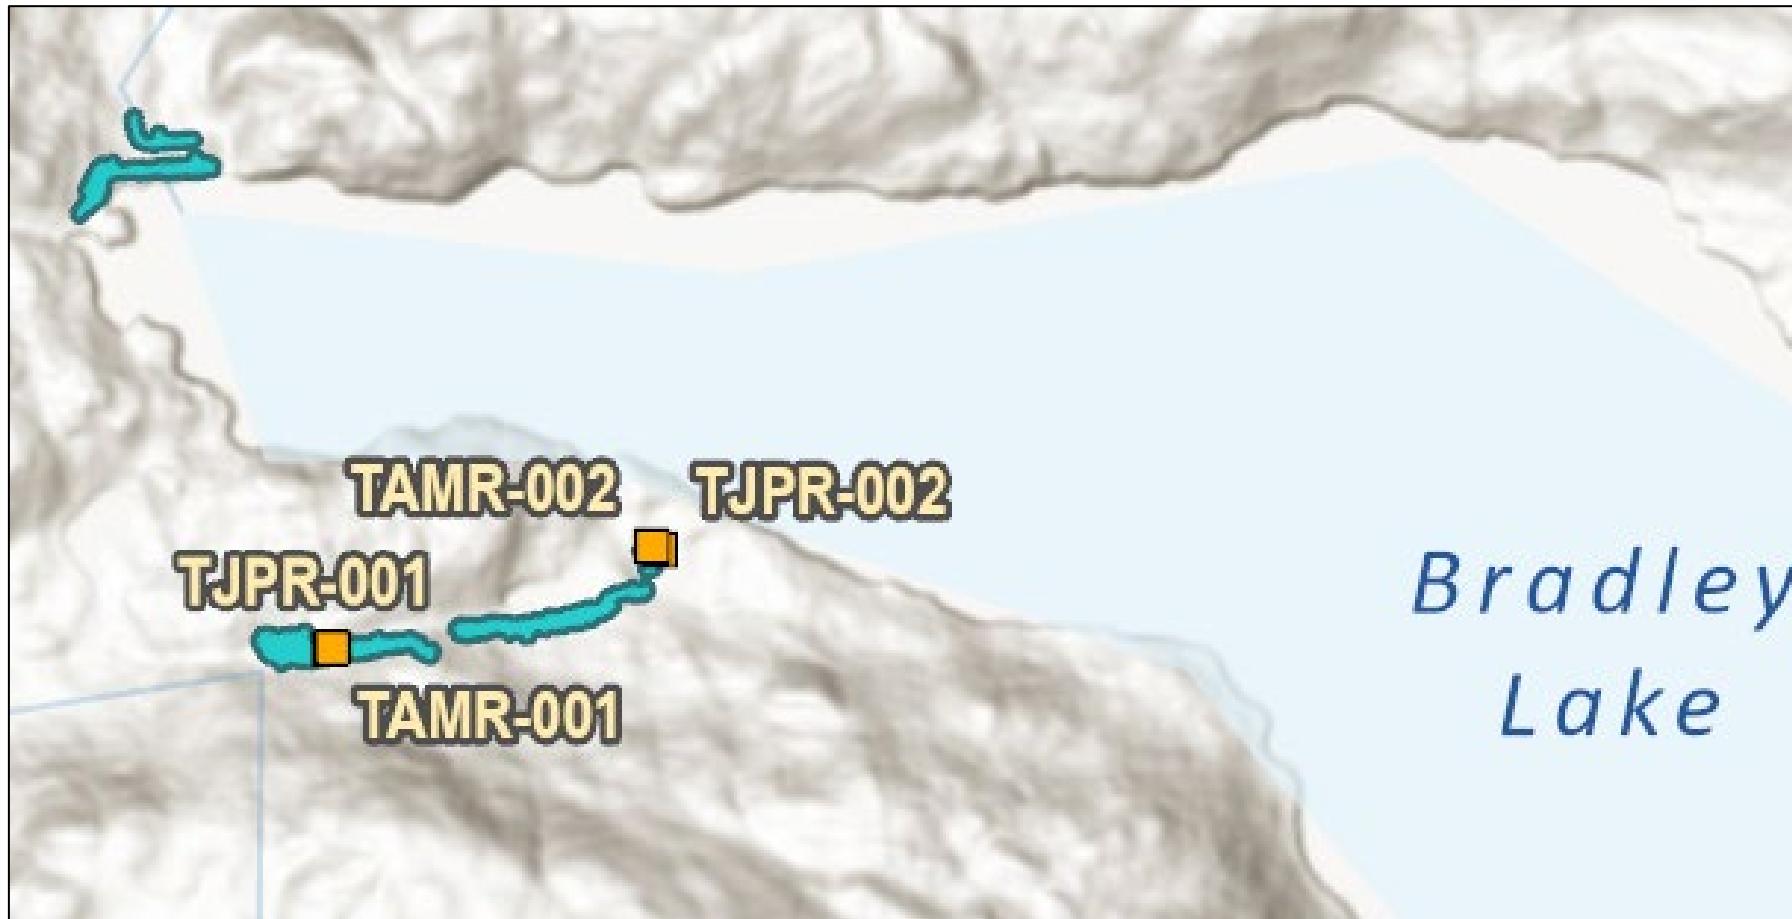
Subsurface Test Areas 1 & 2

- Upper West Fork Battle Creek Diversion, along the proposed gravel access road to outlet portal

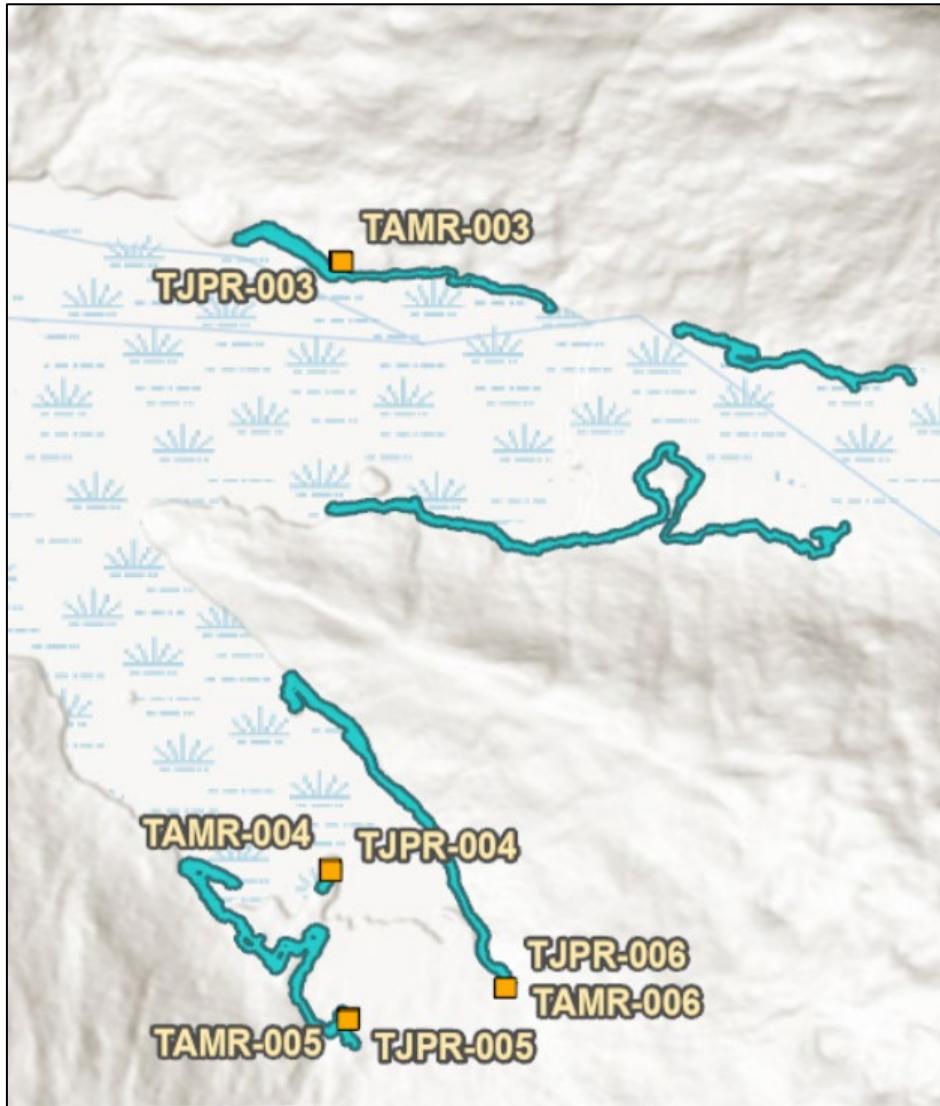
Subsurface Test Areas 3 through 6

- **Test Area 3**
 - Shoreline of Kachemak Creek arm of Bradley Lake
 - TAMR-003 and TJPR-003
- **Test Area 4**
 - Knoll surrounded by wetlands at Nuka Glacier arm of Bradley Lake
 - TAMR-004 and TJPR-004
- **Test Area 5**
 - Knoll surrounded by wetlands at Nuka Glacier arm of Bradley Lake
 - TAMR-005 and TJPR-005
- **Test Area 6**
 - Knoll surrounded by wetlands at Nuka Glacier arm of Bradley Lake
 - TAMR-006 and TJPR-006

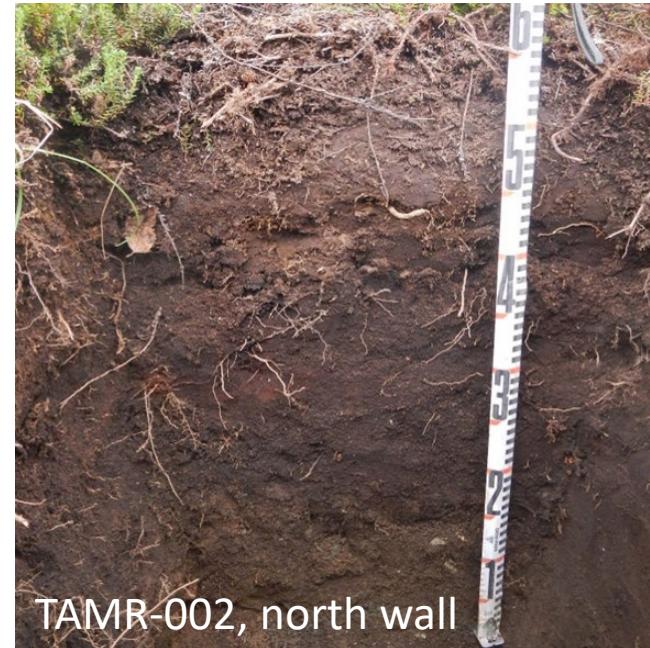
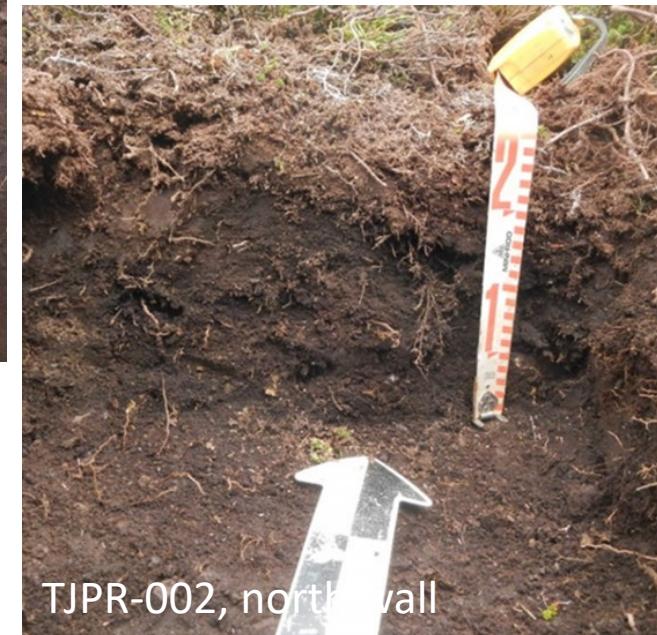
Subsurface Test Data - Area 2

Sub-surface Test	Strata	Strata Depth (cm)	Cultural Material
TAMR-002	Humic root mat and dark brown silt loam	0-5	None
	Dark brown silt loam with small gravel	5-40	None
	Light brown sand with gravel	40-58	None
	Light gray-brown glacial till matrix with gravel	58-60 (BOE)	None
TJPR-002	Humic root mat and dark brown silt loam	0-6	None
	Dark brown silt loam with small gravels	6-21 (BOE)	None

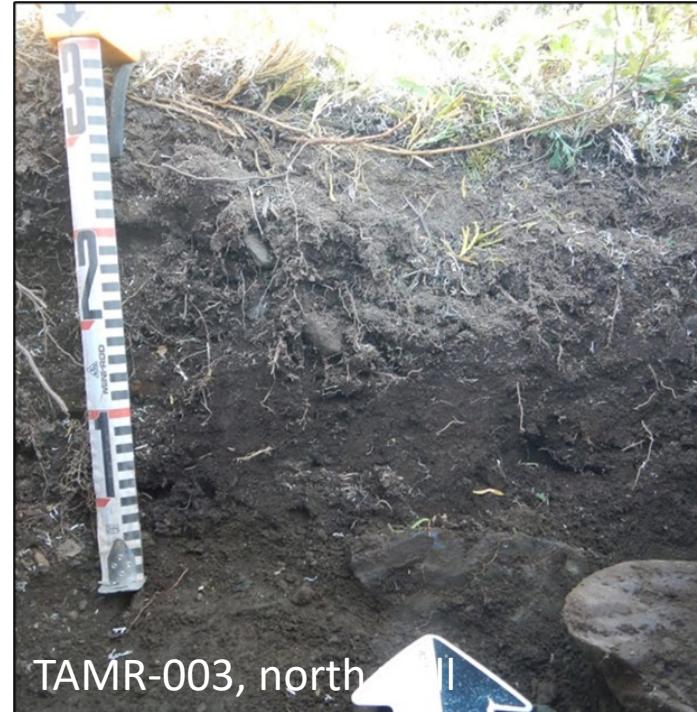
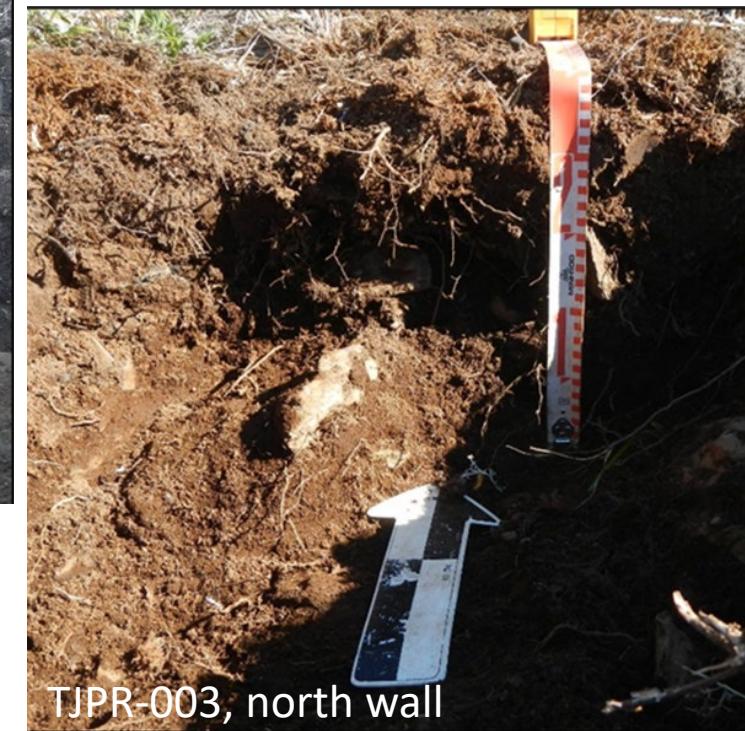
Subsurface Test Data - Area 3

Sub-surface Test	Strata	Strata Depth (cm)	Cultural Material
TAMR-003	Humic root mat and dark brown silt loam	0-12	None
	Dark brown silt loam with gravel and cobbles	12-30 (BOE)	None
TJPR-003	Humic root mat and dark brown silt loam	0-8	None
	Dark brown silt loam with gravel and cobbles	8-21 (BOE)	None

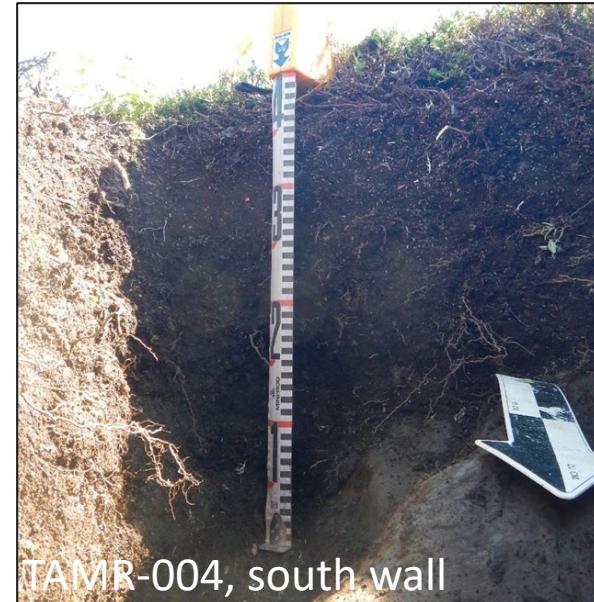
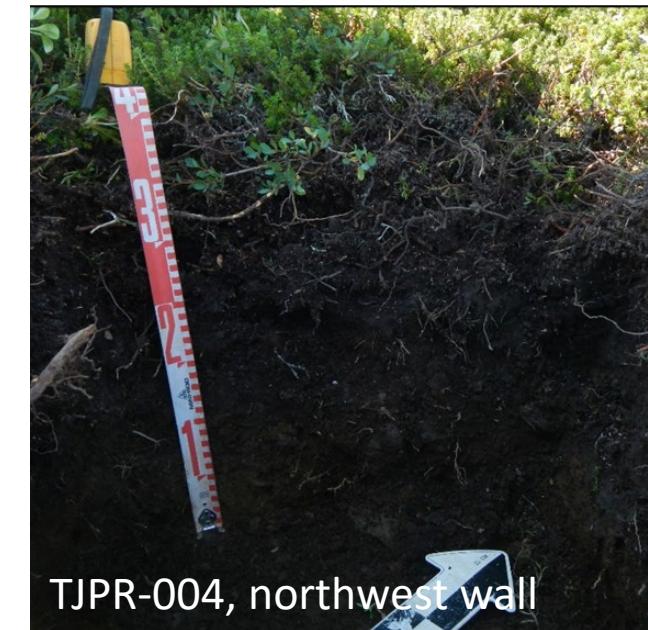
Subsurface Test Data – Area 4

Sub-surface Test	Strata	Strata Depth (cm)	Cultural Material
TAMR-004	Humic root mat and dark brown silt loam	0-9	None
	Dark brown silt loam with gravel and cobbles	9-20	None
	Gravelly sand and glacial till matrix	20-40 (BOE)	None
TJPR-004	Humic root mat and dark brown silt loam	0-4	None
	Brown silt	4-10	None
	Dark gray silt clay	10-23	None
	Reddish-brown silt clay with gravel and cobbles	23-30	None

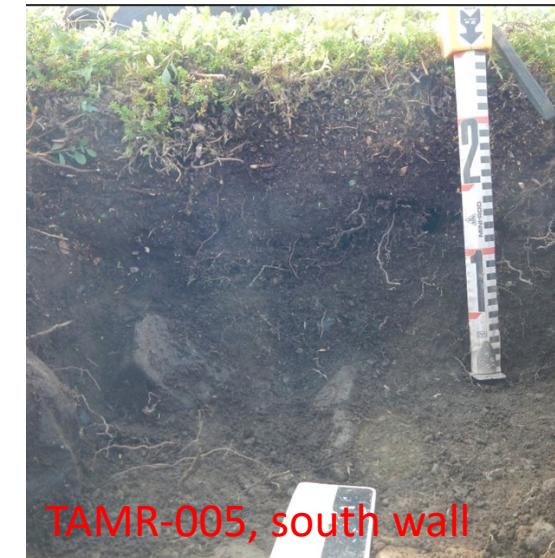
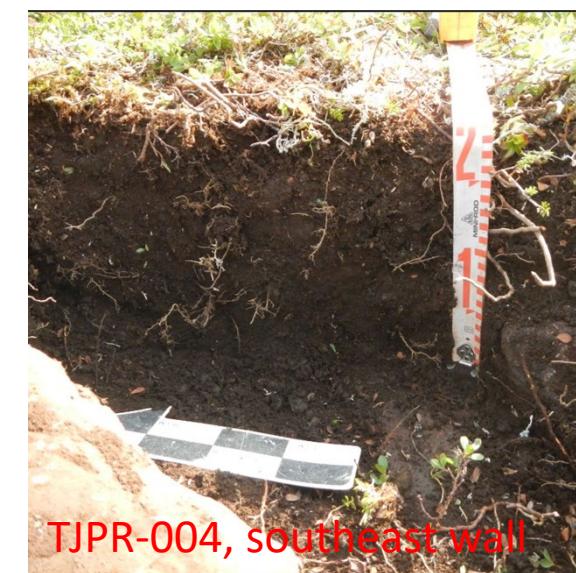
Subsurface Test Data - Area 5

Subsurface Test	Strata	Strata Depth (cm)	Cultural Material
TAMR-005	Humic root mat and dark brown silt loam	0-8	None
	Dark brown silt loam with roots and gravels	8-12	None
	Very dark brown silt with gravels and cobbles	12-22`	None
	Light gray brown glacial till matrix with cobbles and boulders	22-28 (BOE)	None
TJPR-005	Humic root mat and dark brown silt loam	0-6	None
	Light gray brown glacial till matrix with gravels, cobbles, and boulders	6-21 (BOE)	None

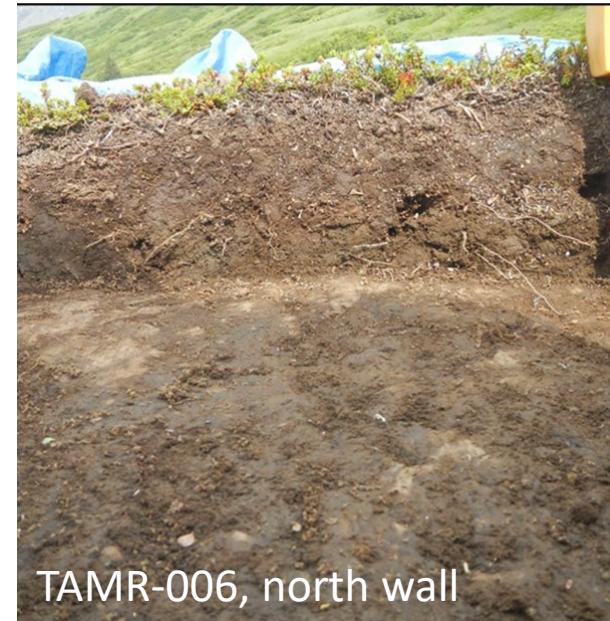
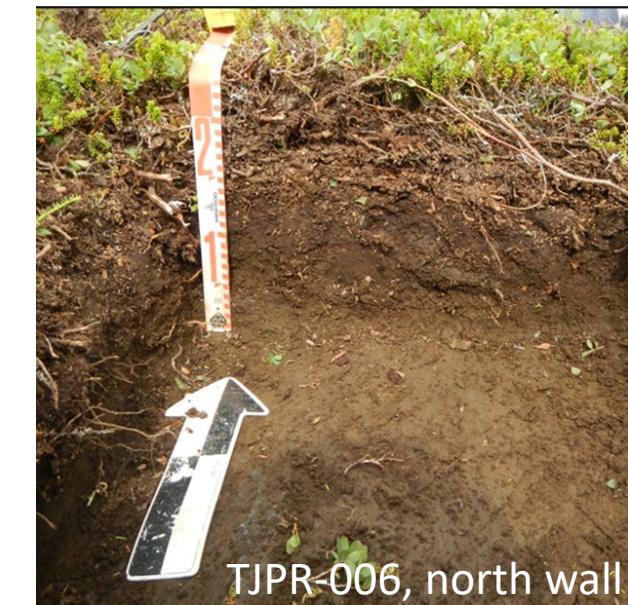
Subsurface Test Data – Area 6

Subsurface Test	Strata	Strata Depth (cm)	Cultural Material
TAMR-006	Humic root mat and dark brown silt loam	0-5	None
	Gray brown silt loam, bedrock	5-14 (BOE)	None
TJPR-006	Humic root mat and dark brown silt loam	0-8	None
	Brown silt with gravels	8-22 (BOE)	None
