# **AMENDMENT TO BRADLEY LAKE HYDROELECTRIC PROJECT (FERC No. 8221), BRADLEY LAKE EXPANSION PROJECT**

## **Geomorphology and Sediment Transport Study Report**

### **Prepared for:**

Alaska Energy Authority

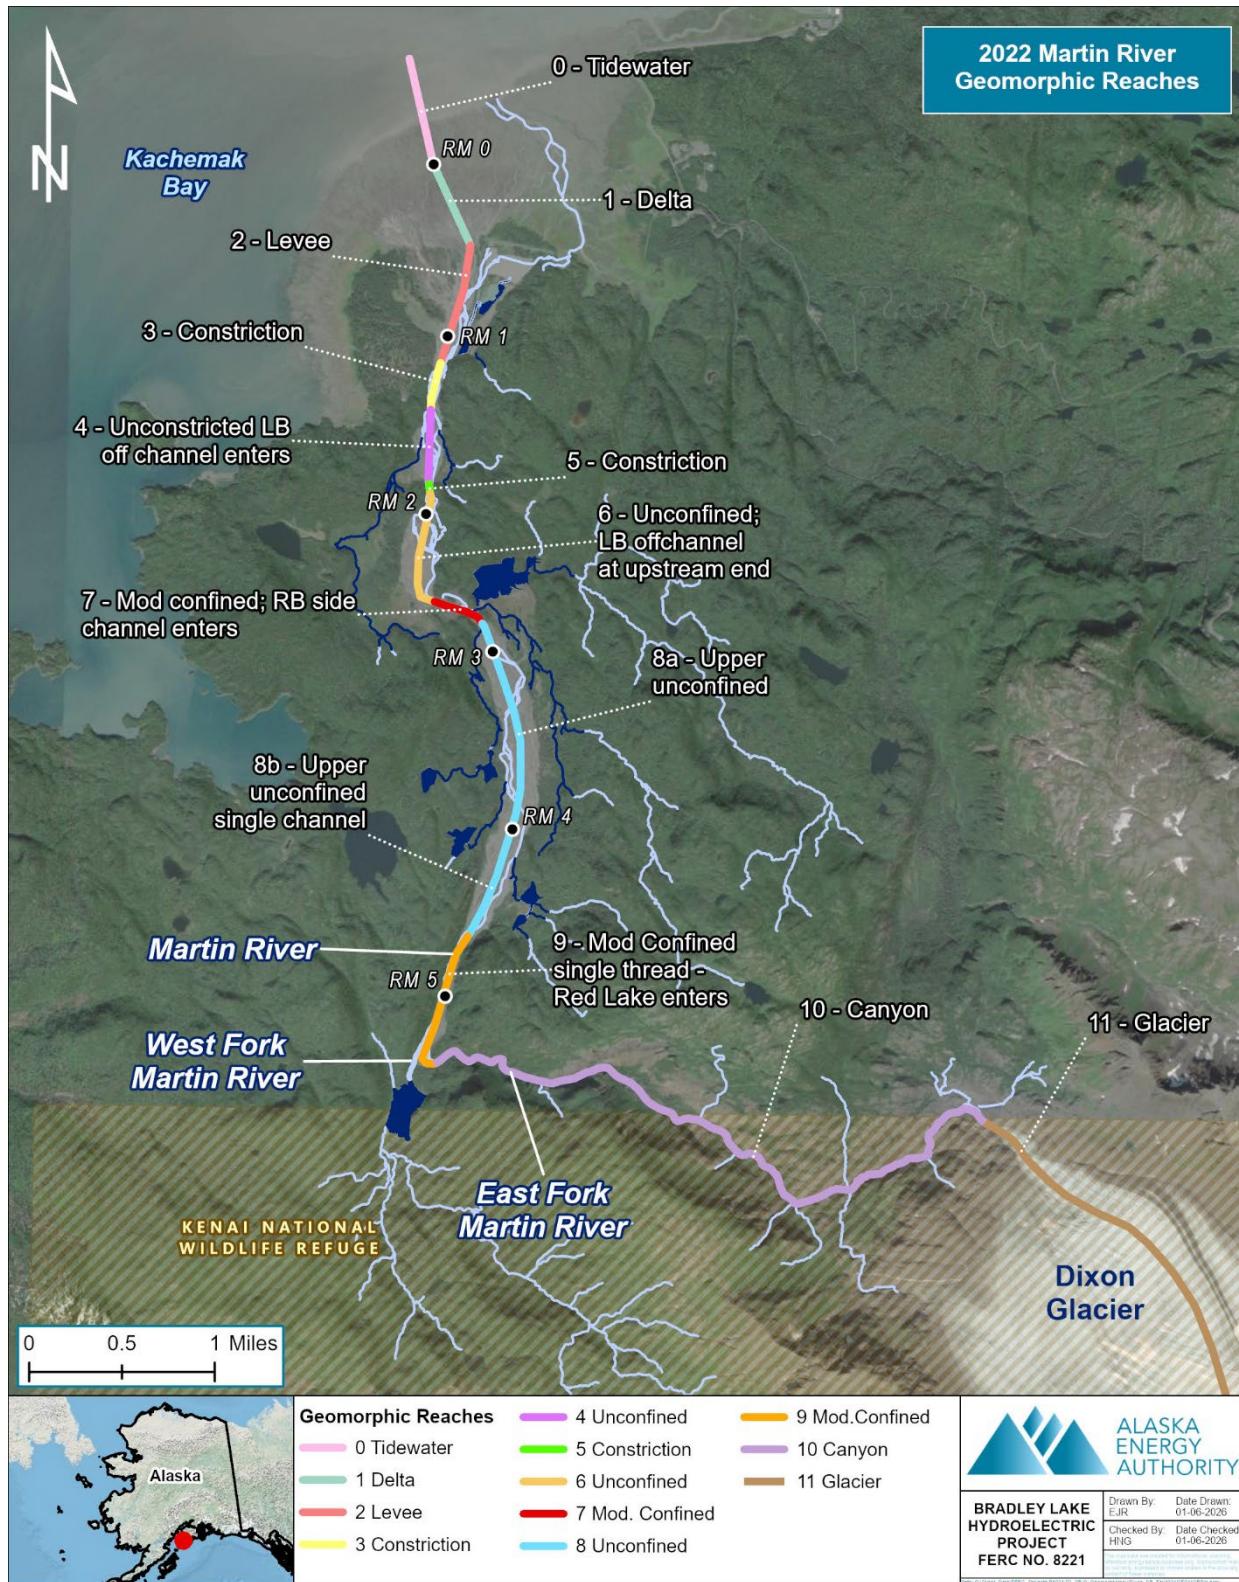
**Figure 5-1 Martin River 2022 geomorphic reaches.**

Twelve different geomorphic reaches were delineated along the Martin River and EFMR from tidewater to the Dixon Glacier in both 2022 and 2024 (Table 5-1, Figure 5-1, Figure 5-3). Reaches that are constricted/confined by bedrock or steep valley walls generally have one or two channels; unconfined areas generally have multiple channels (Figure 5-2). The number of wetted channels in each unconfined reach varies depending on flow conditions; at higher flows, more channels are wetted, while at lower flows, only one or two channels may be wetted. Note that Geomorphic Reach 8, while unconfined by valley walls, was subdivided into two distinct sub-reaches: a downstream unconfined sub-reach with multiple channels and an upstream sub-reach that is currently confined by a high terrace. The upstream reach (8b) is currently incising into past deposits to create the confining terrace; this section of the river was not confined to a single channel on historical aerial photographs (see discussion in Section 5.1.3).

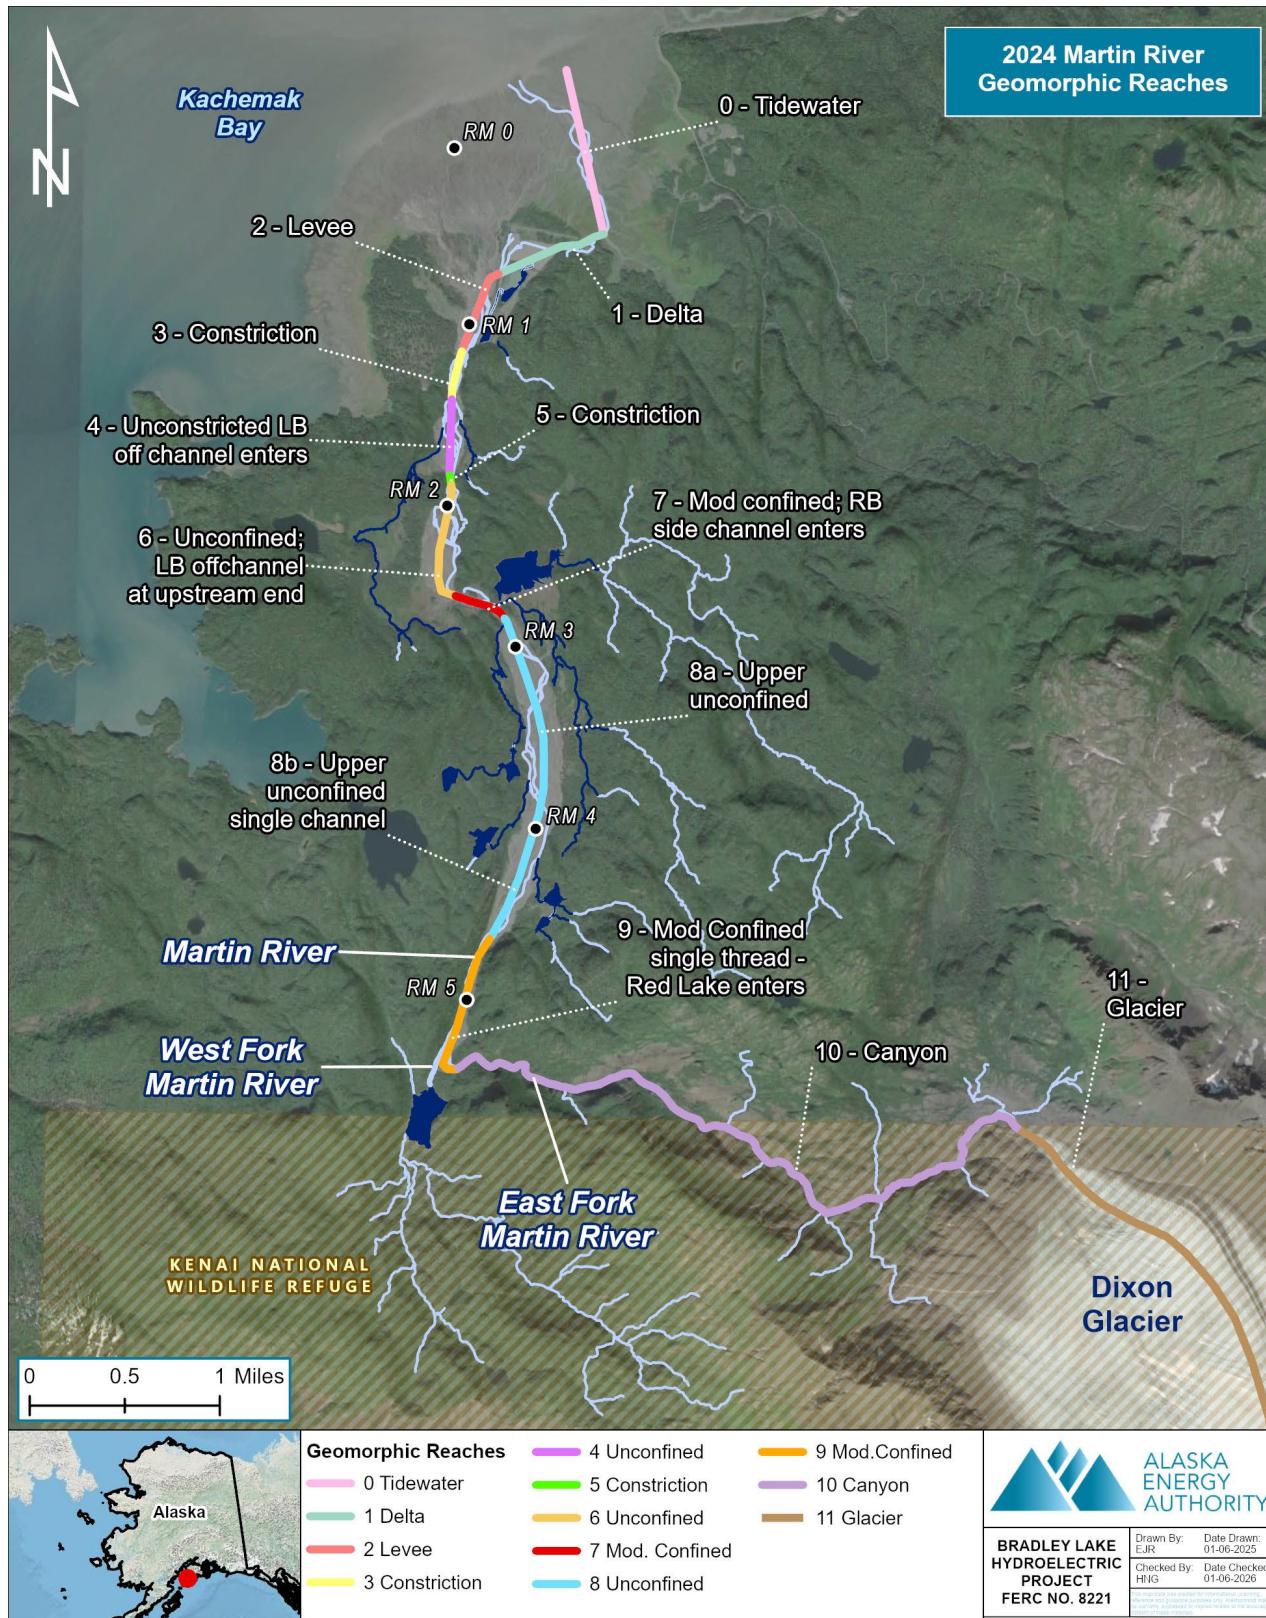
**Figure 5-3 Martin River 2024 geomorphic reaches.**

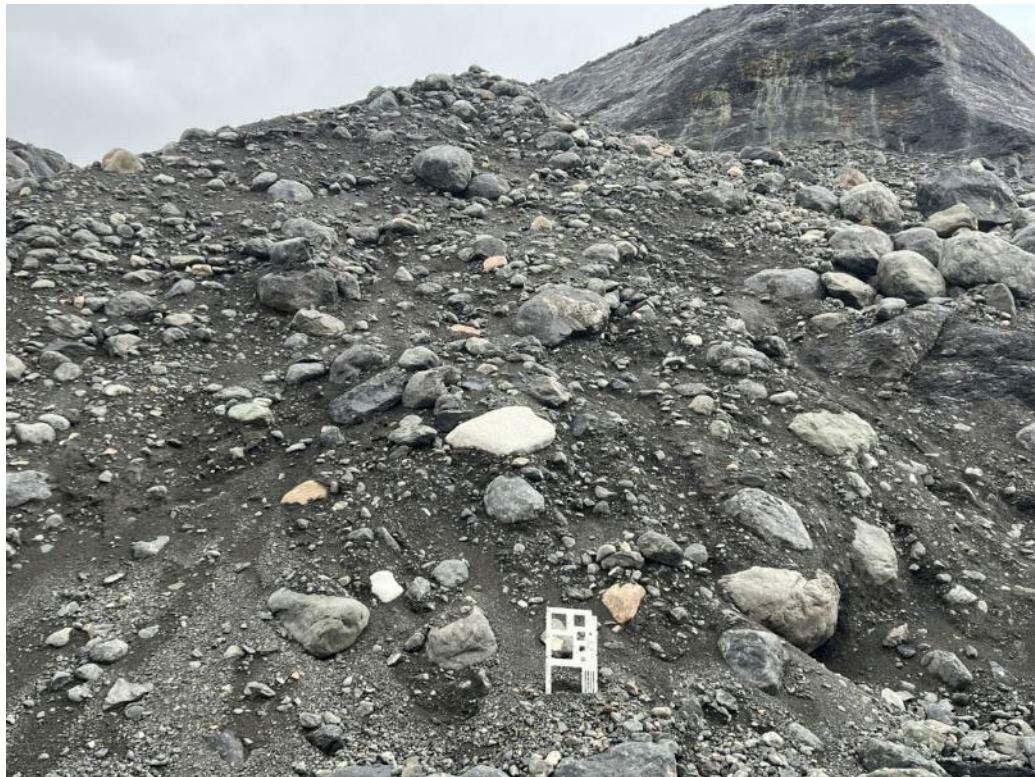
**Photo 5-1 Till deposits at the terminus of the Dixon Glacier, October 3, 2025.**

Again, there are no data from the Dixon Glacier to provide guidance for partitioning the total sediment output into fine-grained (suspended load) and coarse-grained sediment (bedload). Data from other glacier systems is sparse and suggest that underlying bedrock characteristics such as hardness and composition affect the ratio, but total sediment load in other glacial systems ranges from 5 to 50 percent bedload (coarse sand to boulder) with the remainder suspended load (fine sand, silt, clay). Increased sediment discharge during glacier retreat has been suggested by Delaney and Adhikari (2020), so sediment yields from the Dixon Glacier outflow will likely remain similar to yields since the Little Ice Age Maximum. Observations of till just downstream from the current terminus of the Dixon Glacier in October 2025 are likely representative of the mix of material supplied from the glacier. A particle size distribution was not made on the till, but it appears to be typical of alpine till, with an unconsolidated sandy matrix and a mix of larger gravel/cobble/boulder particles within the matrix. The material is loose and easily erodible by rain, streams, or raveling (Photo 5-1).

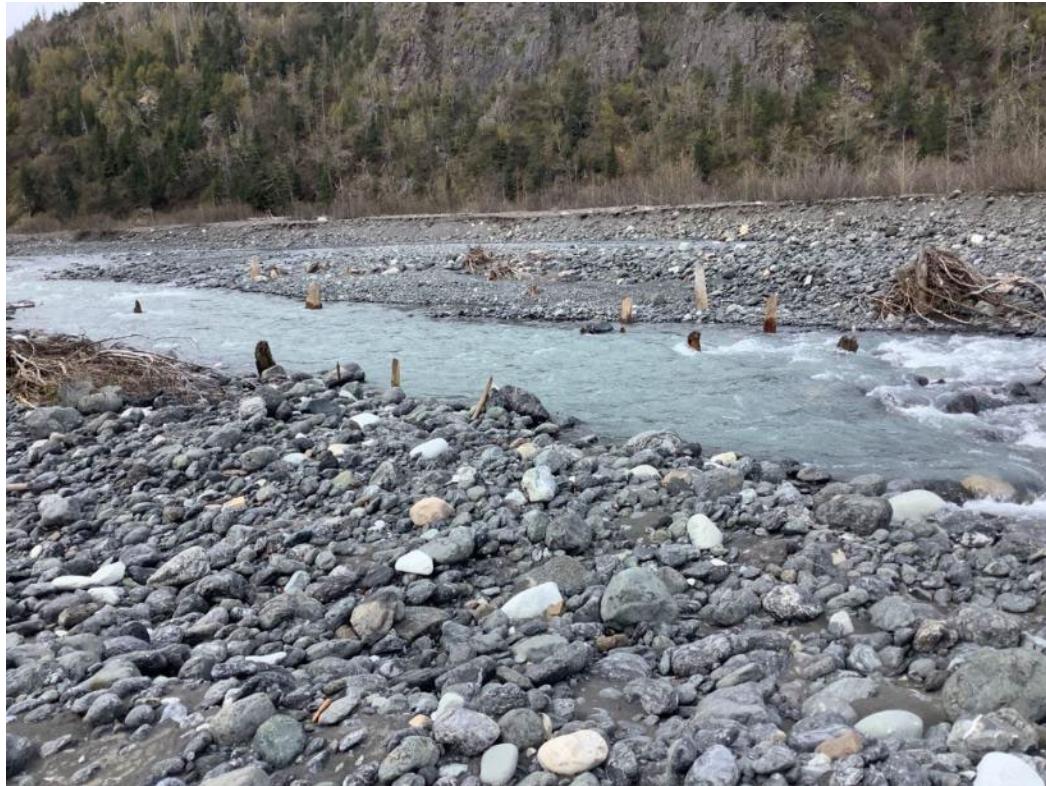
**Photo 5-2 Buried trees in growth position near Martin River PRM 4.4, photo taken looking upstream, May 22, 2023.**

Field observations of indicators of rapid aggradation in the Martin River valley include large buried trees in growth position in the middle of the Martin River valley, particularly in Geomorphic Reaches 8a and 8b (between PRM 3 and PRM 4.5; see Photo 5-2) and near the mouth of the river, which suggest periods of rapid aggradation in the past. The buried trees near PRM 4.4 are particularly interesting because they show: (a) a mature forest existed in the middle of the Martin River valley in the past; (b) there was relatively rapid aggradation of at least 7-8 feet that buried the trees and protected the stumps from erosion; and (c) subsequent incision of a similar amount exposed them. Field observations of river valley margins in 2023 and 2024 also showed indicators of aggradation, with valley-margin vegetation buried in recent gravel resulting in tree death, new channels into the left bank off-channel areas at PRM 2.5 and PRM 1.2, and overtopping of the right bank levee near the mouth of the river in late 2023 (see Section 5.1.3.3 for detailed discussion of the August 2023 levee breach).

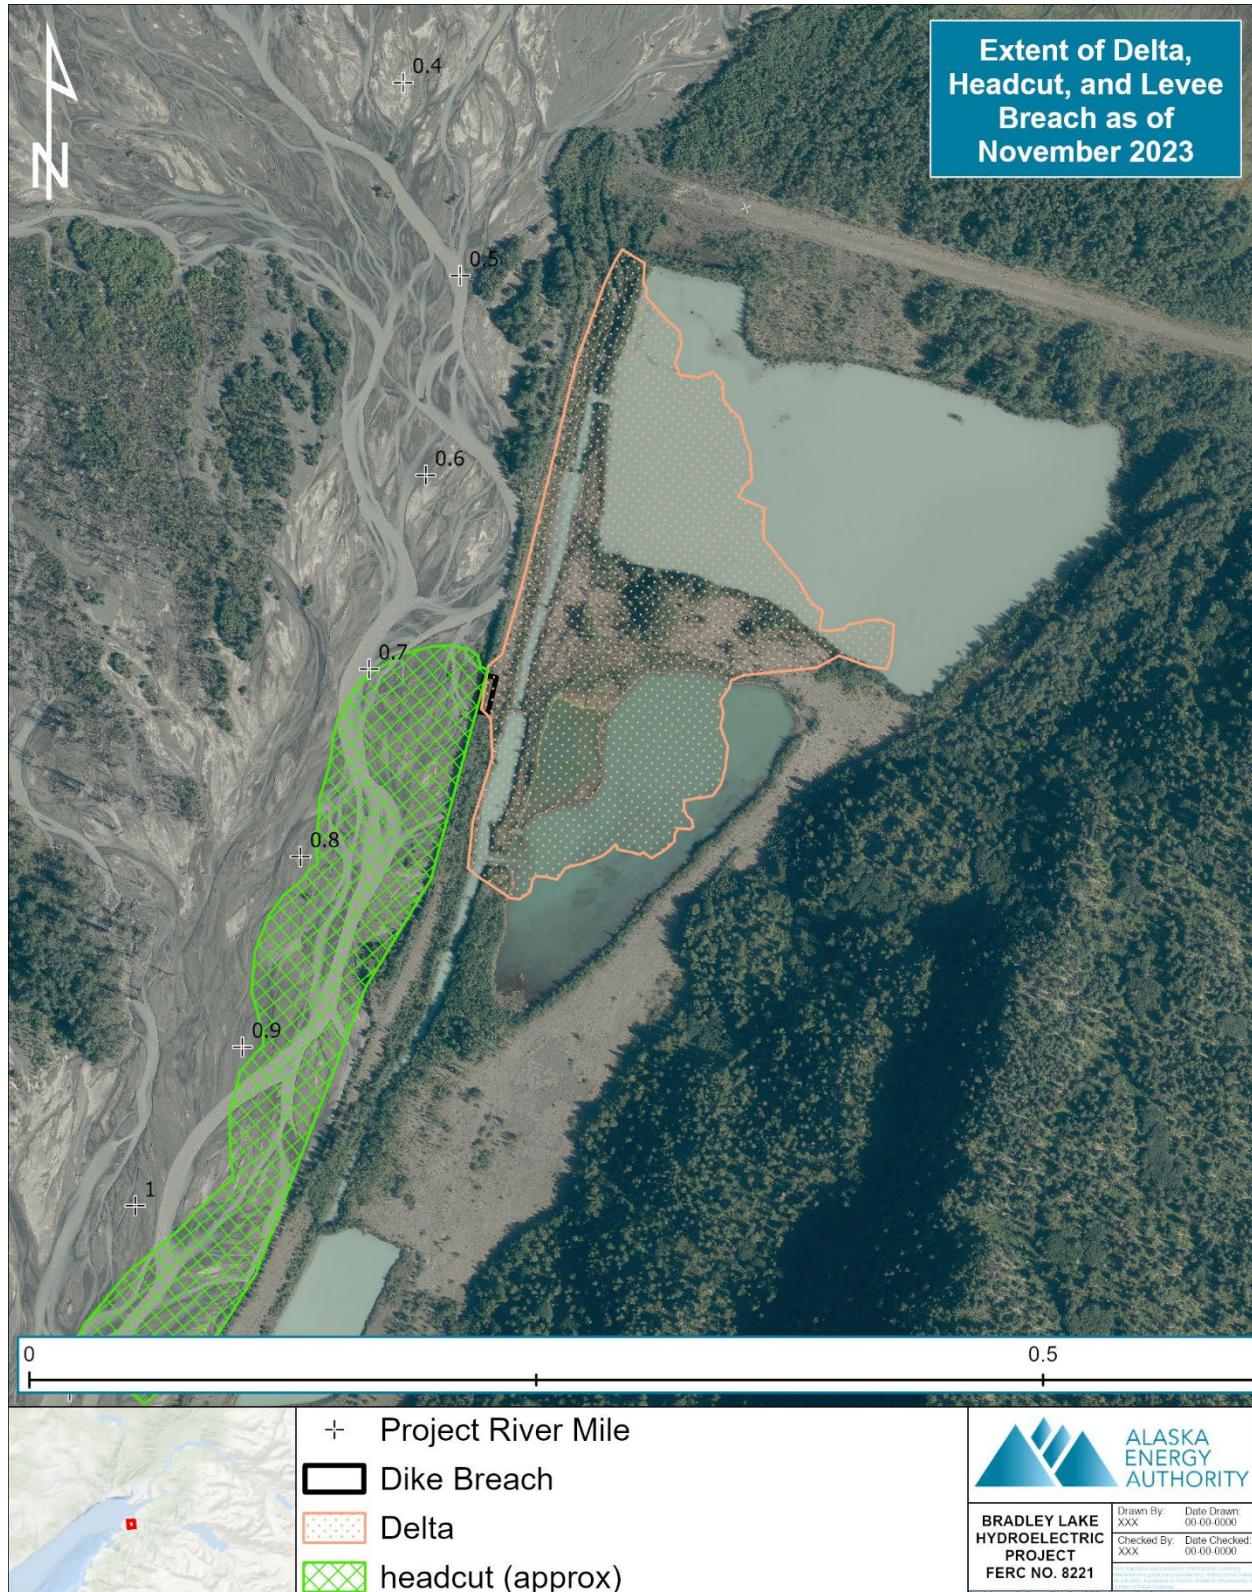
**Figure 5-15 Extent of new delta, headcut, and levee breach location near the mouth of the Martin River, November 2023.**

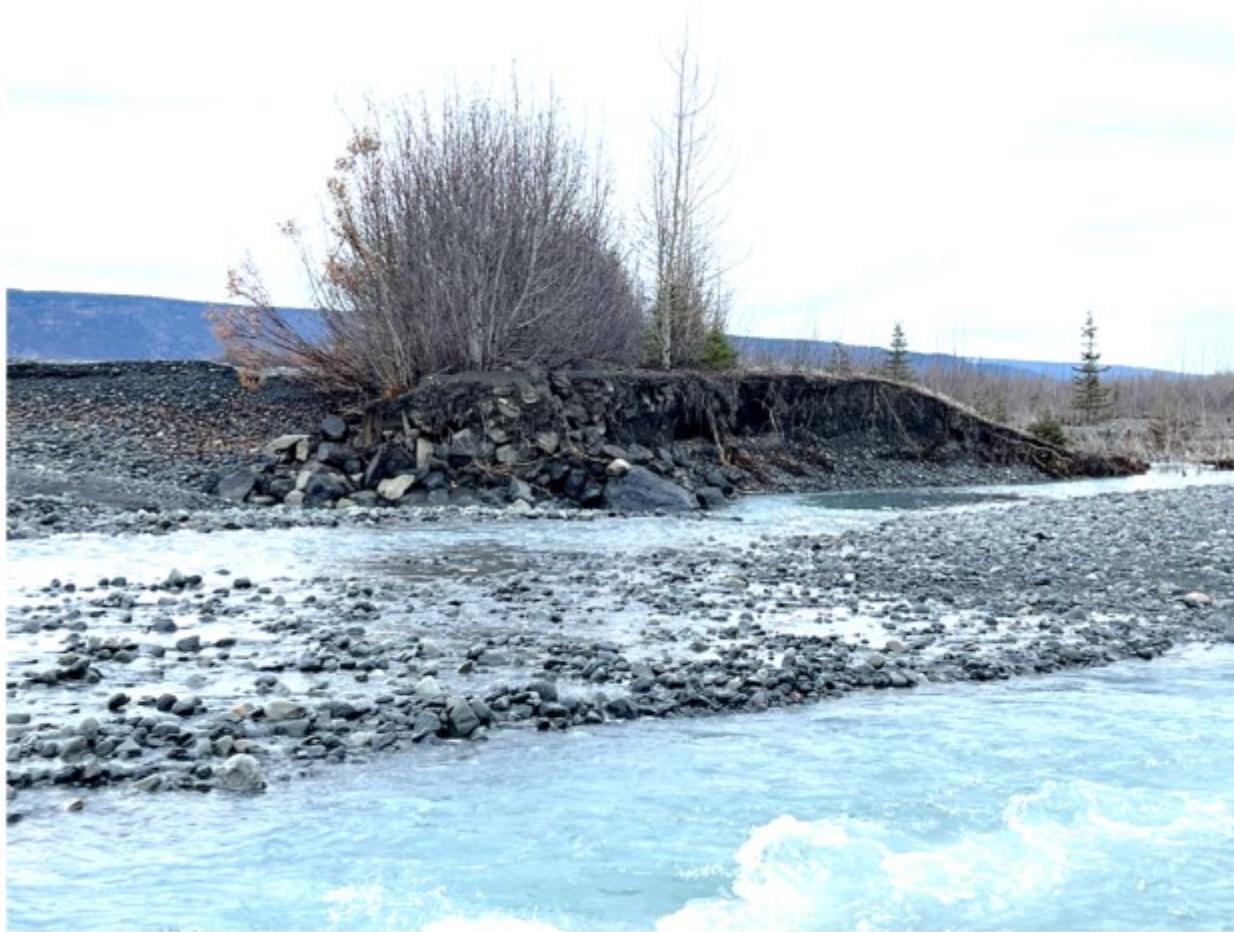
**Photo 5-3 Cross section of levee at breach location, November 2, 2023.**

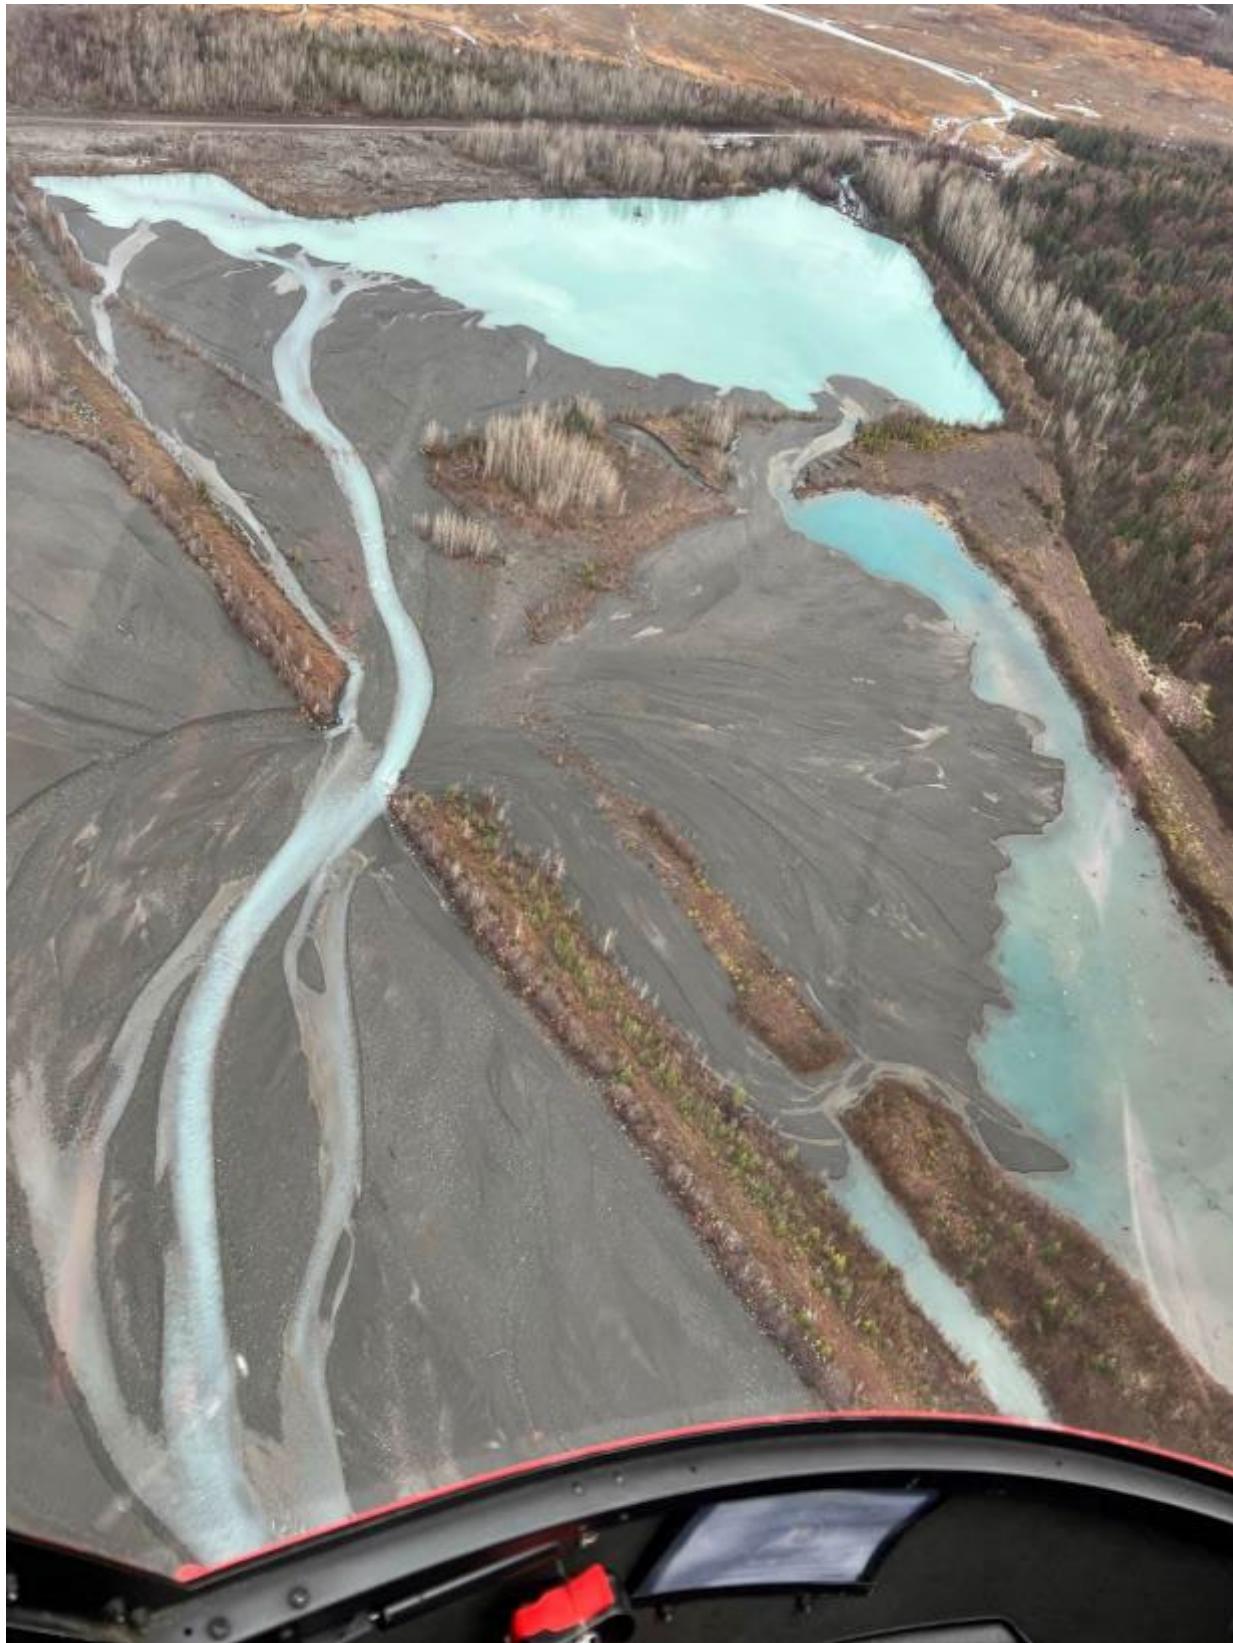
**Photo 5-4 Extent of deposition in mitigation ponds; new Martin River outlet to tidewater (top right), November 2, 2023.**

Since August 2, 2023, all flow from the Martin River flows through the levee breach, into the mitigation ponds, and out a low point at the northeast corner of the largest (northern) pond into Kachemak Bay (Photo 5-4, Photo 5-5, and Photo 5-6). The river has been building a delta into the ponds, with up to 15- to 35-foot-deep accumulations in some areas (as of November 2023) assuming the northern-most ponds were originally dug 15 to 35 feet below grade as shown on the as-built drawings. As of November 2023, the delta covered approximately 19.5 acres. Coho Salmon (*Oncorhynchus kisutch*) adults were observed in the ponds and just upstream of the levee breach during the November 2023 site visit, indicating that they were able to utilize and traverse the new river channel. In November 2023, the bottom of the channel was approximately 10-12 feet below the top of the levee at the breach location. Upstream from the levee breach, the river has been eroding and headcutting as it adjusts to the new base level.

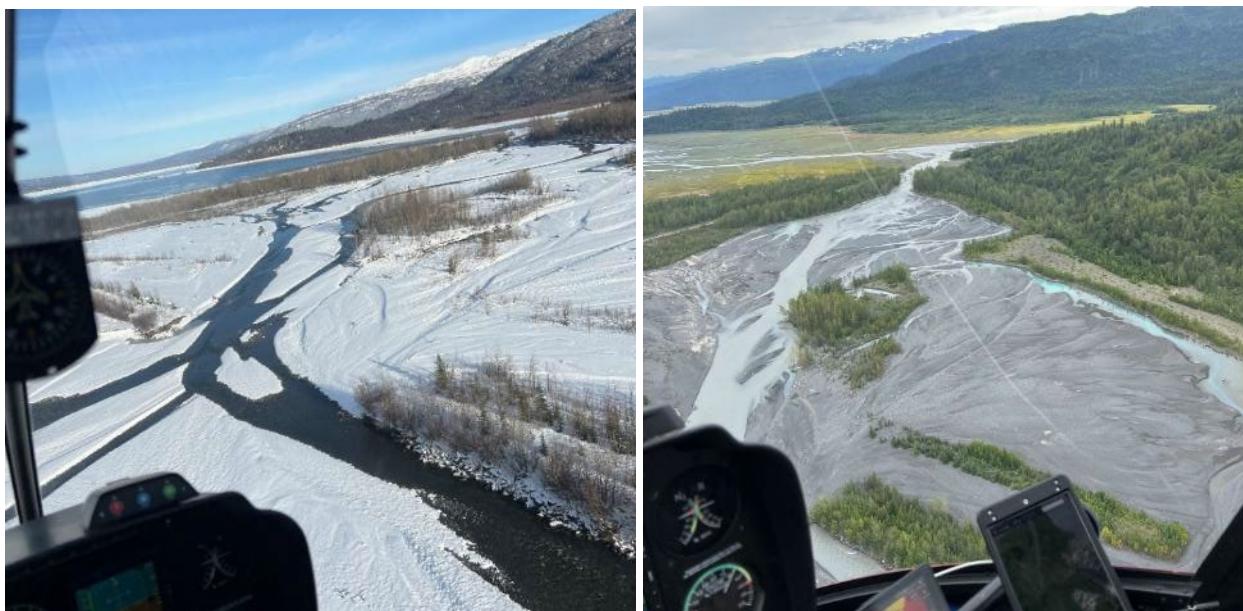
**Photo 5-7 Martin River mouth looking downstream from levee breach, October 30, 2024 (left), and July 29, 2025 (right).**

As of the end of October 2024, the river had filled both northern mitigation ponds with sediment and had cut a wider channel through both the levee and the eastern pond/river outlet (Photo 5-7). There was evidence of multiple channels flowing across the airfield under high flow conditions throughout 2025 field observations, with gravel transport out into the tidelands at the new river mouth (Photo 5-7).

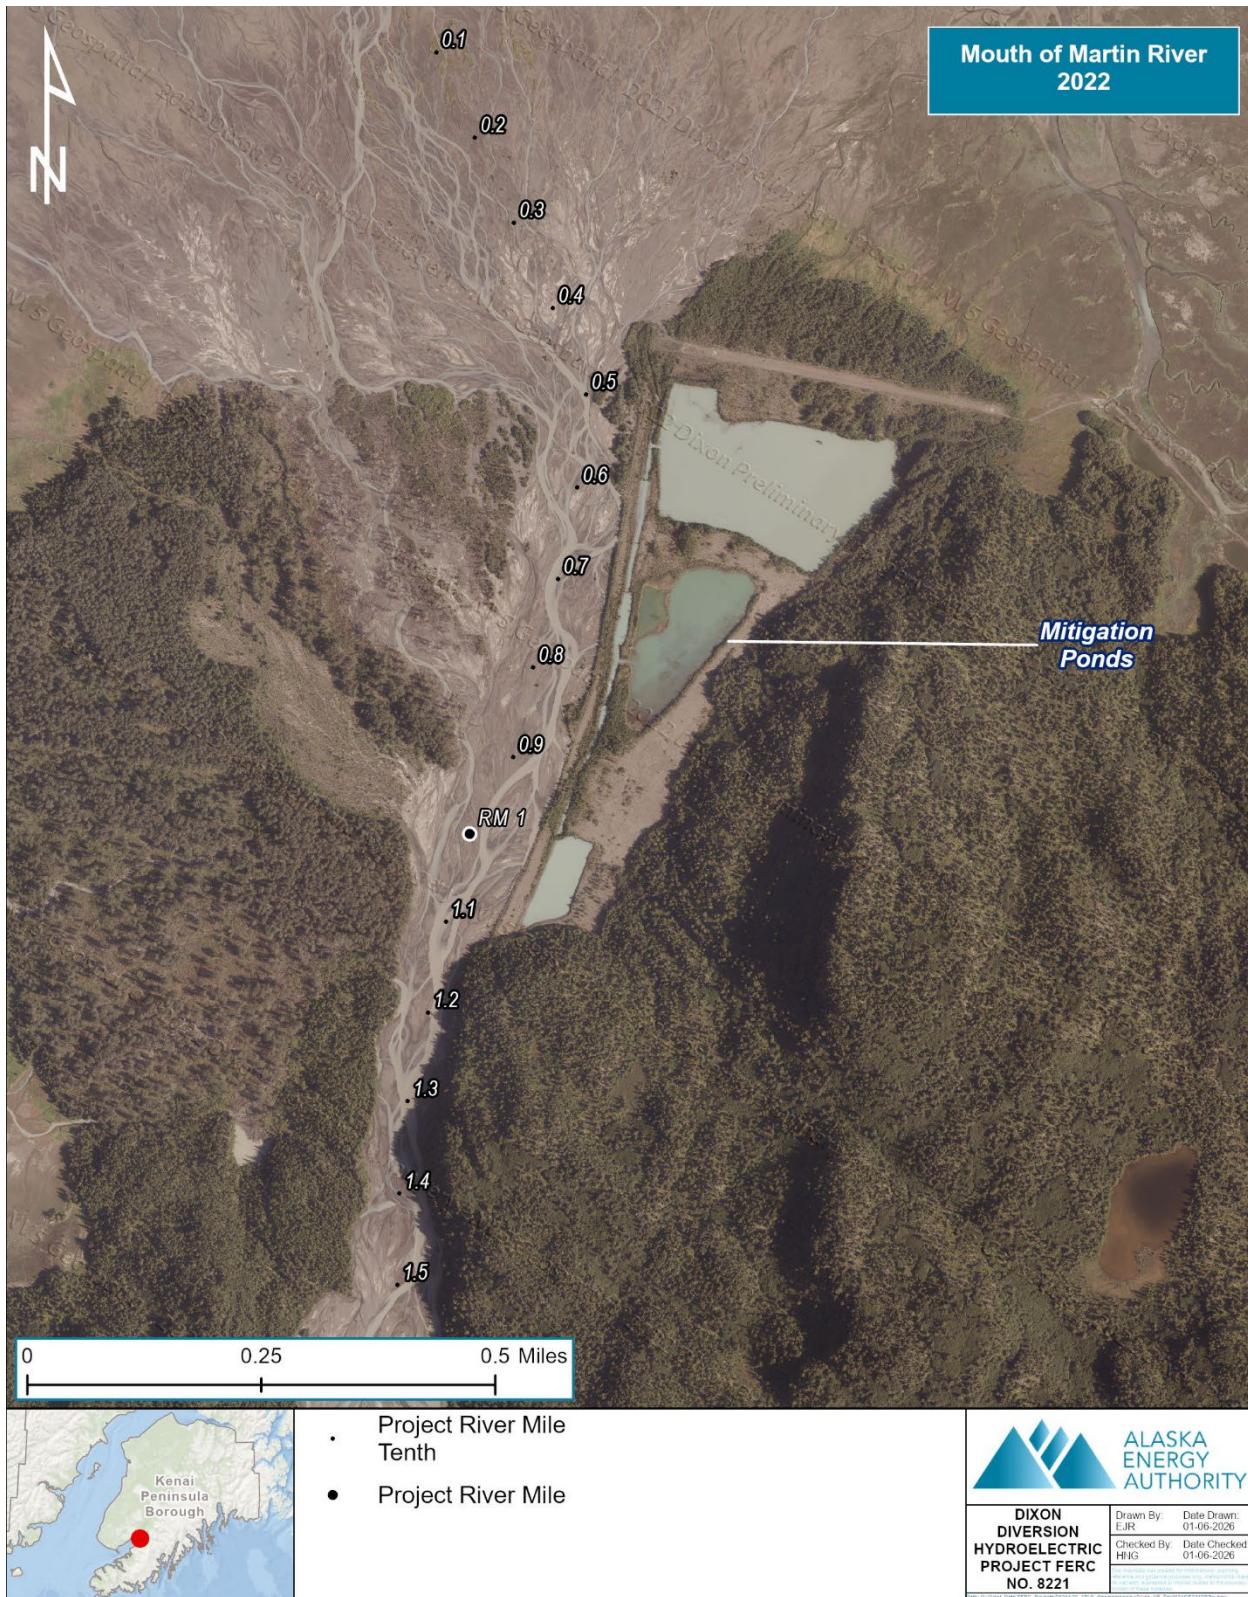
**Figure 5-16 Mouth of the Martin River, 2022.**

Aerial imagery and LiDAR data were acquired in May 2024 and showed the extent of the delta building at the mouth of the Martin River compared to 2022 conditions as well as the headcutting upstream from the breach location (Figure 5-16 and Figure 5-17). The difference between the 2024 and 2022 LiDAR data is shown in Figure 5-18 with aggradation in red and erosion in green. Note that the former mitigation ponds are shown as erosion (blue/green); this is because the 2024 LiDAR captured the elevation of the bottom of the ponds, and the 2022 LiDAR captured the surface elevation of the ponds—the difference shown is water depth in the ponds.

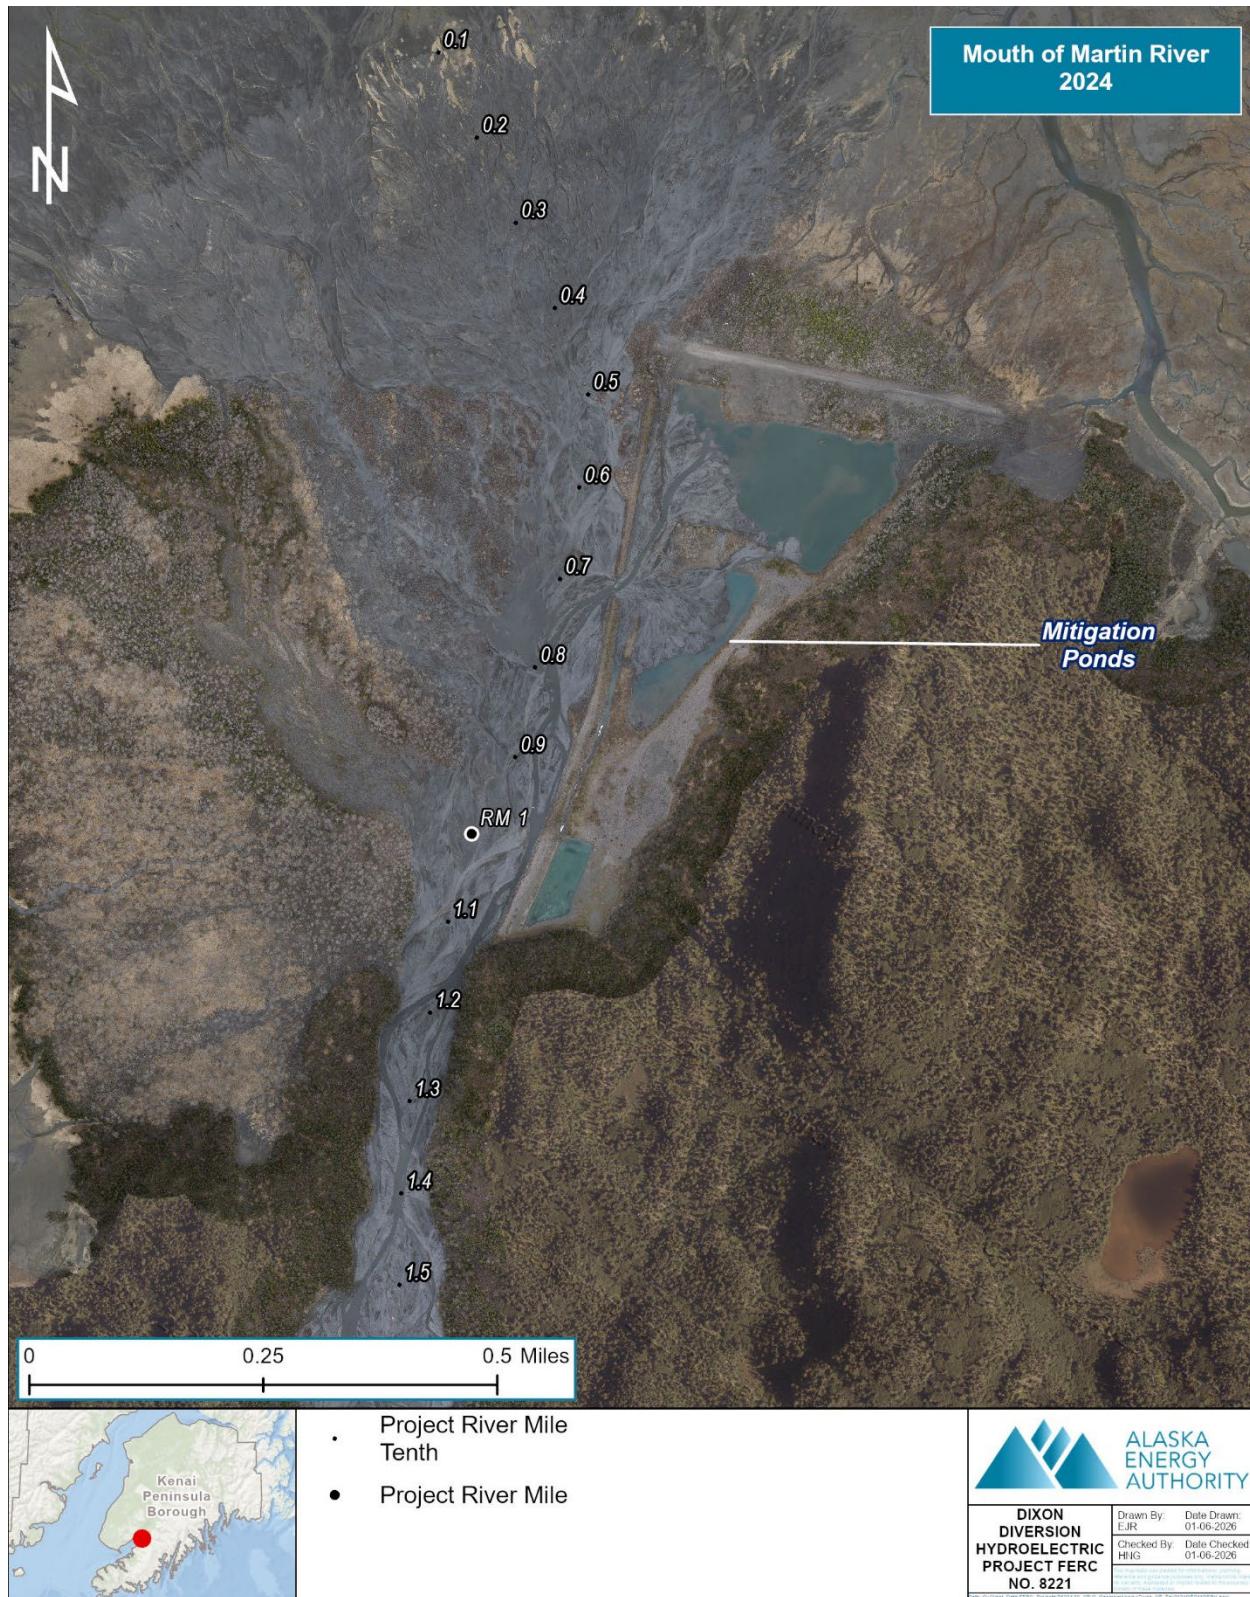
**Figure 5-17 Mouth of the Martin River, 2024.**

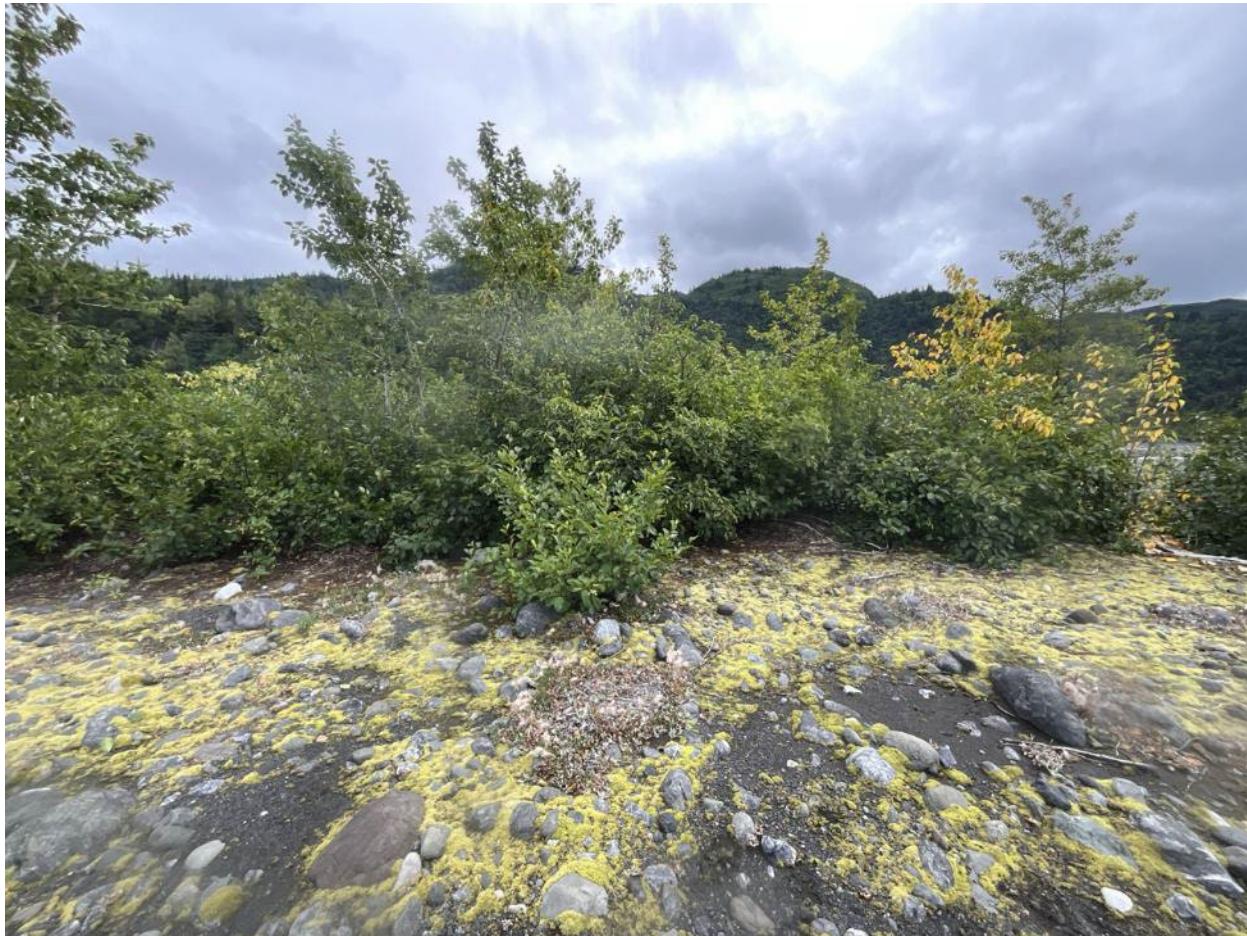
**Photo 5-8 Revegetation on the Martin River braid plain, PRM 4.2, July 31, 2025.**

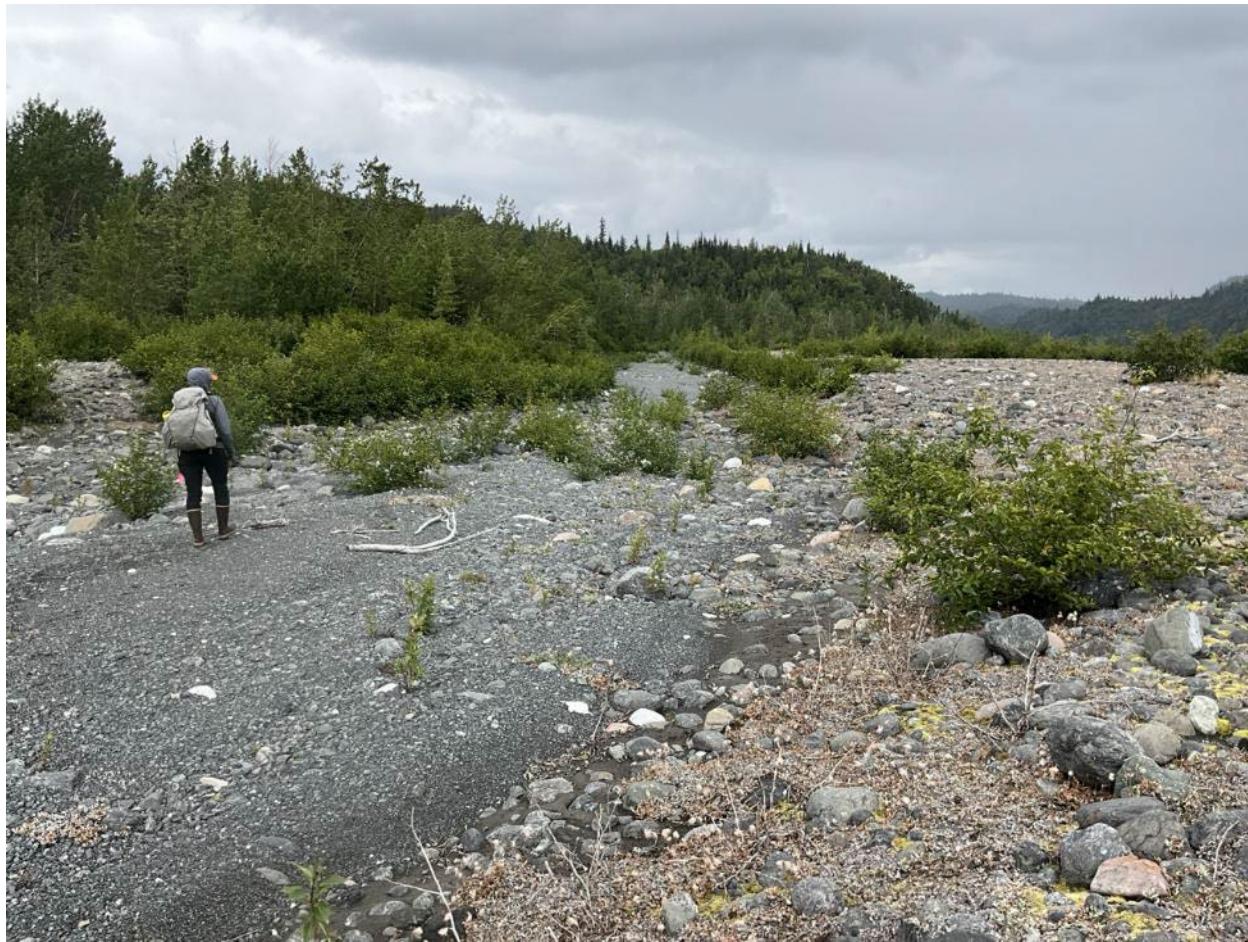
**Photo 5-9 Alder growth along edges of old side channel on the Martin River braid plain, PRM 4.1, July 31, 2025.**

in the late 1900s and had a braided pattern, but it has incised into primarily a single-channel system since the early 2000s (Figure 5-26). Riparian vegetation (alder/willow/cottonwood and *Dryas*) is starting to colonize areas of the braid plain because it is no longer subject to frequent inundation or braided channel movement (Photo 5-8). Alder is also colonizing the banks of old side channels in this area, again because the channels are more stable (Photo 5-9).
