2023 GEOMORPHOLOGY OBSERVATIONS

AMENDMENT TO BRADLEY LAKE
HYDROELECTRIC PROJECT
(FERC No. 8221)

PROPOSED DIXON DIVERSION

Prepared by:
Watershed GeoDynamics
for Kleinschmidt

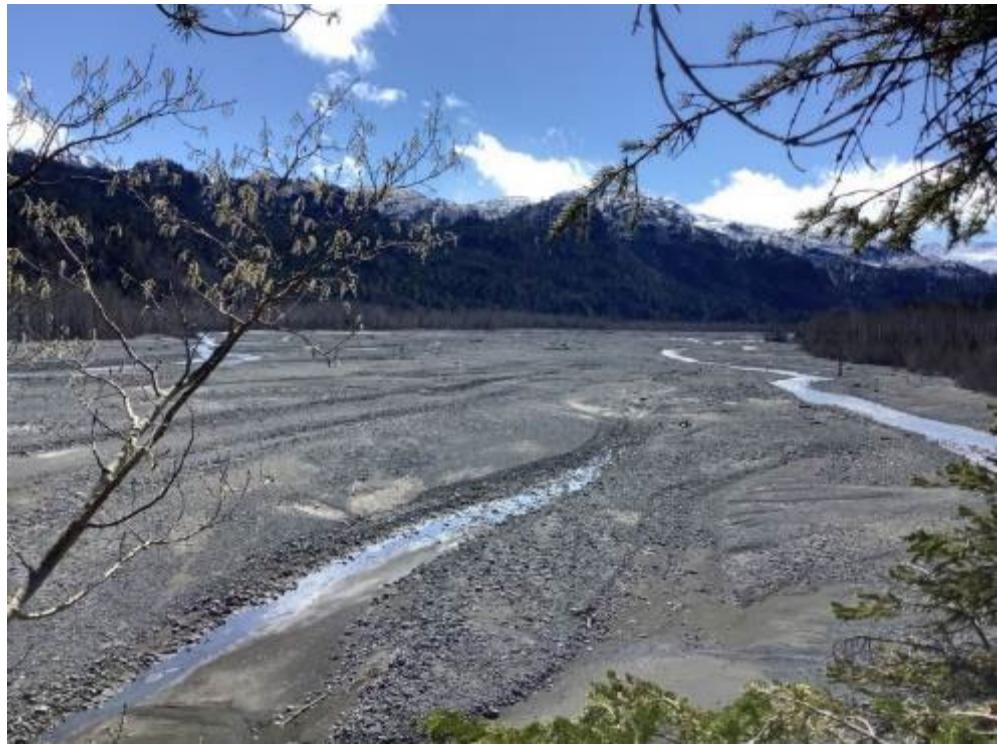
Photo 2-1 Martin River Timelapse Camera GE1 view looking upstream May 16, 2023

The upstream-most camera (GE 1) showed the least amount of channel change; this may have been due to the camera location that primarily showed a secondary, left bank channel that had less flow than the main channel (Photo 2-1 above). The GE 2 and GE 3 cameras both showed frequent channel changes (during at least eight different high flow events) during the 2023 flow season, consistent with braided glacial river dynamics. In addition, images from the GE 3 camera (Photo 2-3 above) showed channel incision, bank erosion, and resulting base level changes on August through October images following the downstream right bank levee breach.

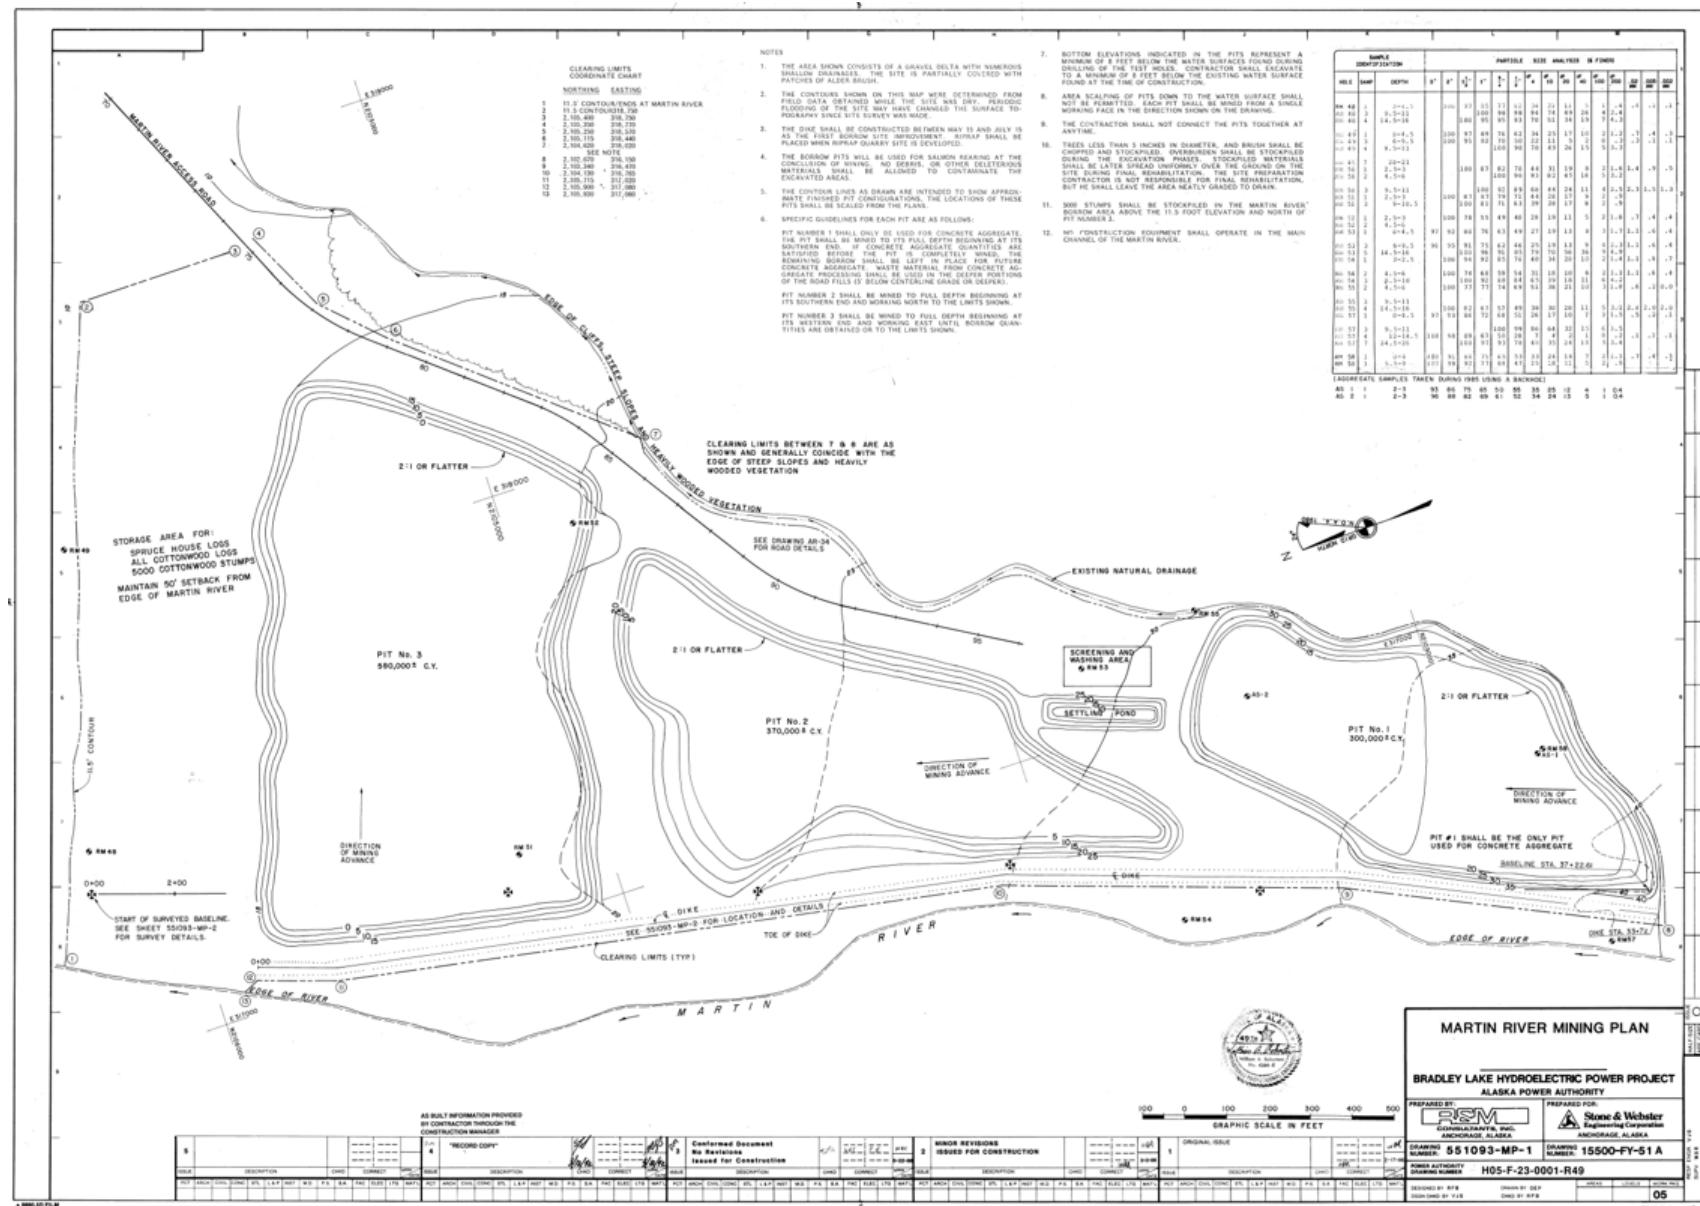
Figure 3-9 As-built Drawing of Martin River Mining Plan (ponds).

the river at the breach location at time of construction, and borrow pits were dug 15 to 35 feet deep (Figure 3-8 and Figure 3-9). The levee was constructed with rip rap armoring on the river side but filled and topped with native material. It was anticipated that the Martin River would aggrade and eventually breach the levee based on assessments at the time (Parry and Seaman 1994).
